**GROUND INVESTIGATION REPORT FOR
PROPOSED RELOCATABLE BUILDING**

633 RANGITUKIA ROAD, TIKITIKI, GISBORNE

Project Reference: 15934
4 June 2019

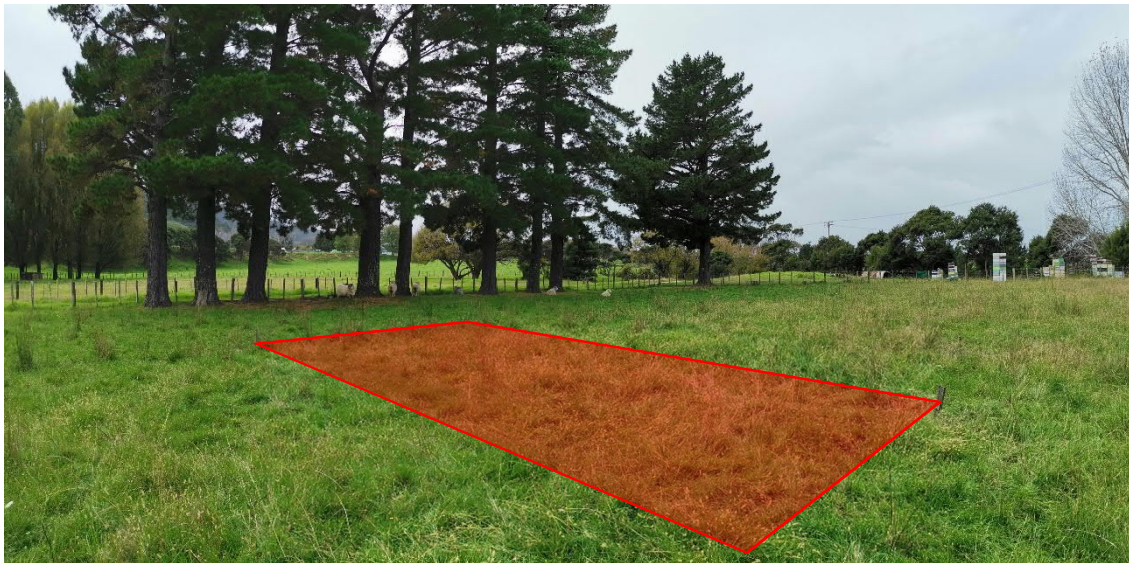
Figure 2: View northeast over approximate location for proposed dwelling (in red).

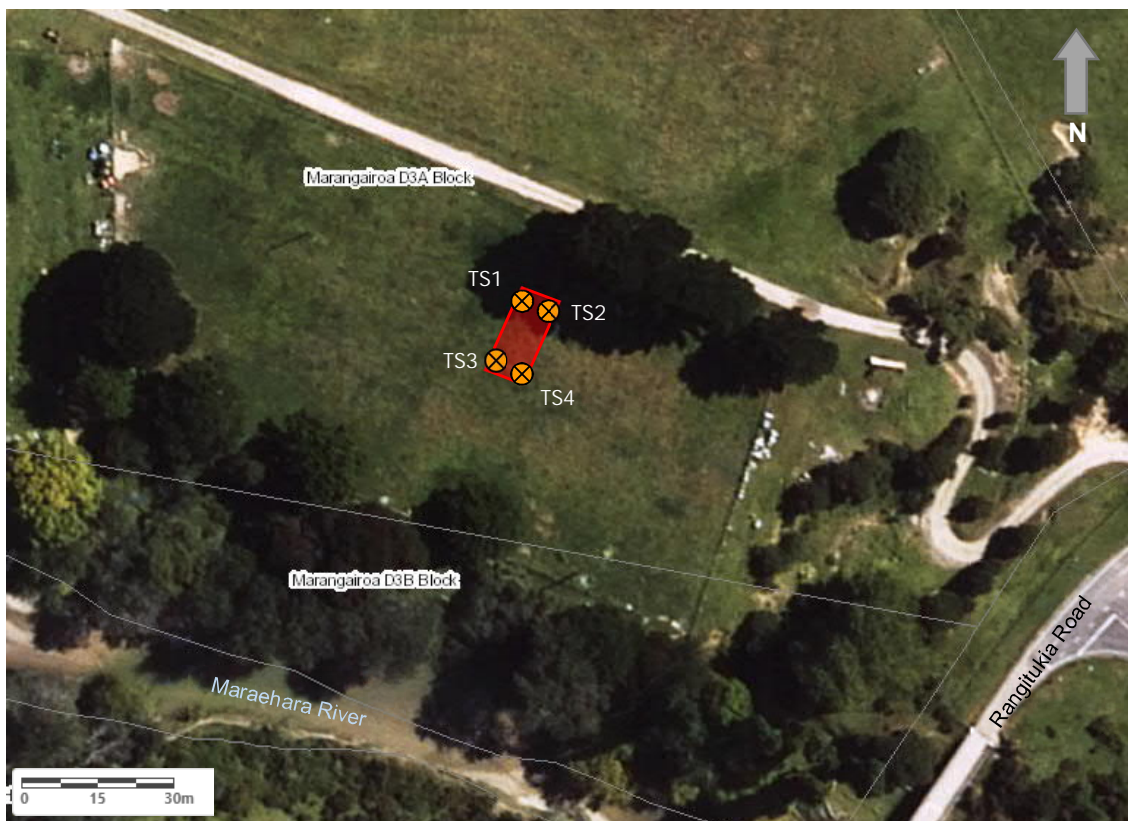
Figure 3: Site investigation plan. “TS” represents a test site where each borehole was put down.

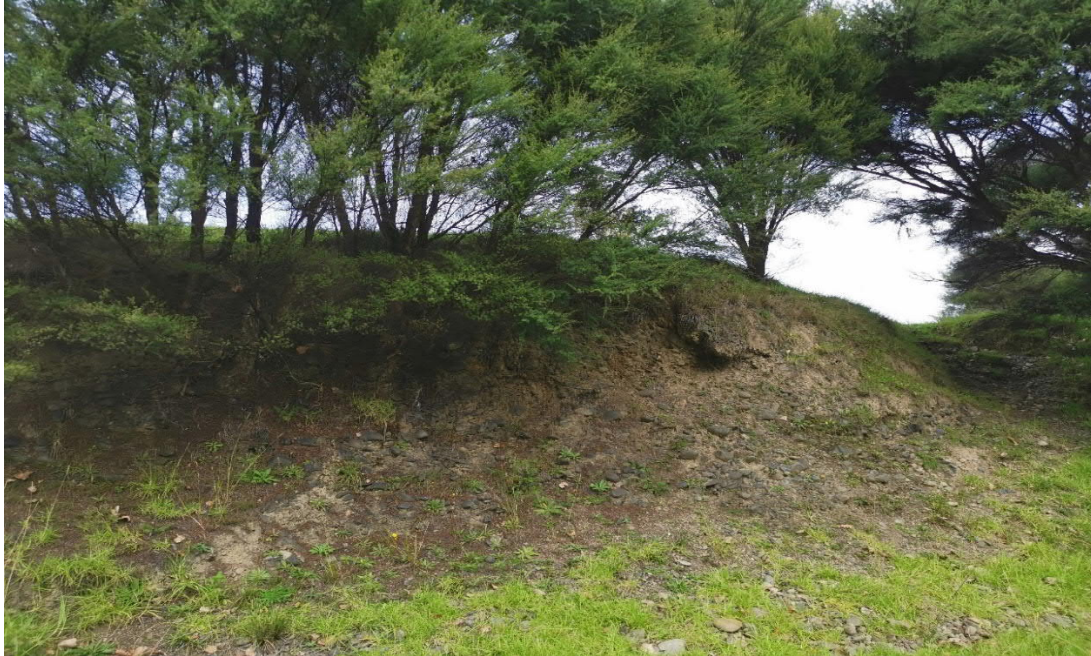
Three of the hand auger tests encountered high-density material preventing their advancement to the target depth of 2.5m. A road cutting approximately 60m to the east of the site contains gravel and cobbles within a silty and sandy matrix, as illustrated in Figure 4. The soil units observed above these materials are consistent with those encountered under the proposed building site and the sharp contact preventing advancement of three of the site tests is also consistent with encountering high density gravel/cobbles as exposed at the road cutting, at approximately the same elevation.

Being a terrace landform, depositional environments are considered likely to be the same, thus the coarse gravel/cobble unit is expected to pass under the proposed building site.

Figure 4: River gravels exposed in nearby cut bank.
