TECHNICAL REPORT

Vibration Analysis of Exhausters

CUSTOMER: M/s. SAIL, BHILAI STEEL PLANT

Report No: NVD/2023-24/011A

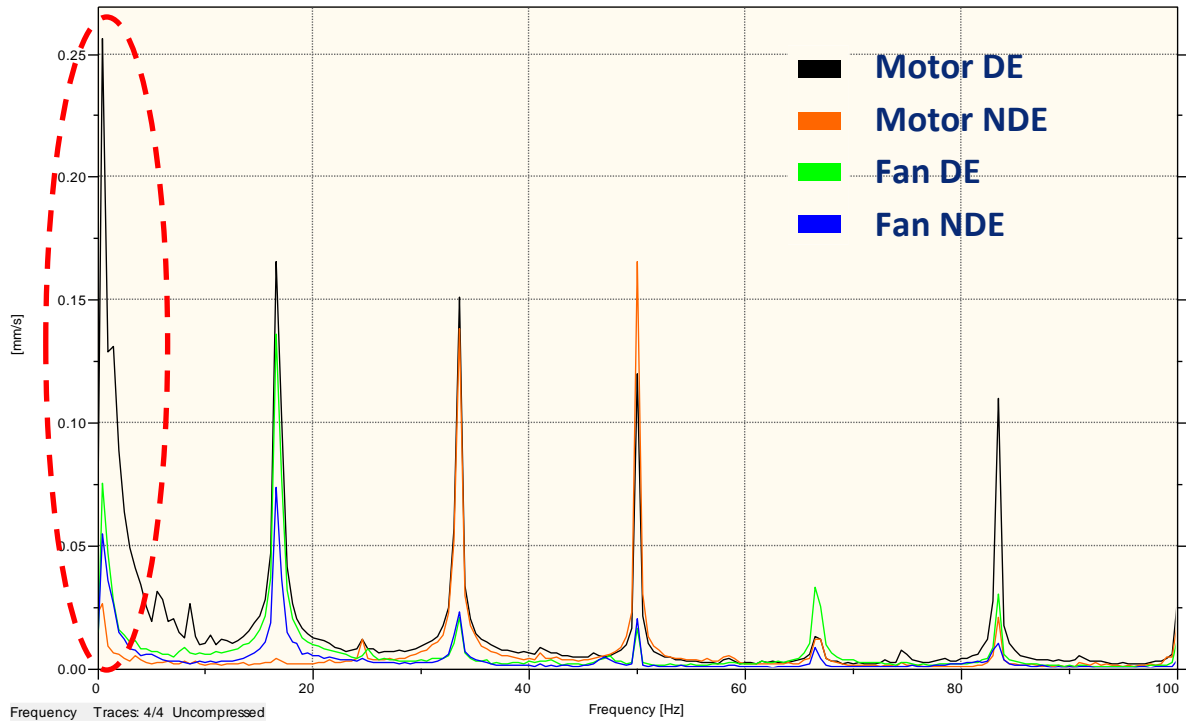
Graph 1: Vibration velocity v/s frequency spectrum of Exhauster unit 1 in X axis

The motor DE shows presence of 1x vibration components followed by distinct and dominant harmonic peaks upto the 5th multiple of the fundamental frequency (around 17Hz/1000 RPM) of the motor rotation. Observe from the Graph 1 above that the 1x vibrations are higher in radial-horizontal direction (identified as X-axis) at the Motor DE and at the Fan DE ends.

While the 1x vibration frequency is distinctly indicated in the vibration spectrum at motor DE and Fan DE hinting at possible unbalance in the system, the absolute magnitudes (of under 0.2mm/sec) do not strengthen the case as these are allowable values for the equipment of this size and kilowatt rating (refer ISO 20816 standard).

Both the radial and axial direction vibrations tend to show significantly lower values at Motor NDE and Fan NDE locations thus indicating that there are likelihood problems around the DE bearings of Motor and Fan with the coupling as an interface.

The fan support bearings have sleeve / journal type with self-aligning capability and thus exhibit lower vibrations. The probability of the residual unbalance and misalignment induced vibrations showing predominantly at the motor DE bearing are a good possibility since they have rigid bearings (rolling elements).

Since the motor bearing housing, motor body and the connected mounting structure are adequately rigid, the relatively less rigid member of the system, which in this case is the motor shaft connected to the visco-elastic coupling, is responding with higher shaft vibrations.

- On both the exhausters, it is highly recommended to disconnect the coupling completely from the motor shaft, conduct vibration studies on the motor independently (including conducting balancing) and establish its performance both for housing and shaft vibrations.

- Once this is done, connect the coupling and align them as per SOP and establish alignment limits as prescribed. With this done, a complete assembly balancing of fan + motor is to be conducted, identifying the plane separations correctly. A multi-plane balancing is highly recommended to assess the unbalance coefficients and their phase responses and make corrections in all possible planes simultaneously; this is an effective approach to contain Z-axis vibrations where multiple bearing supports are involved.

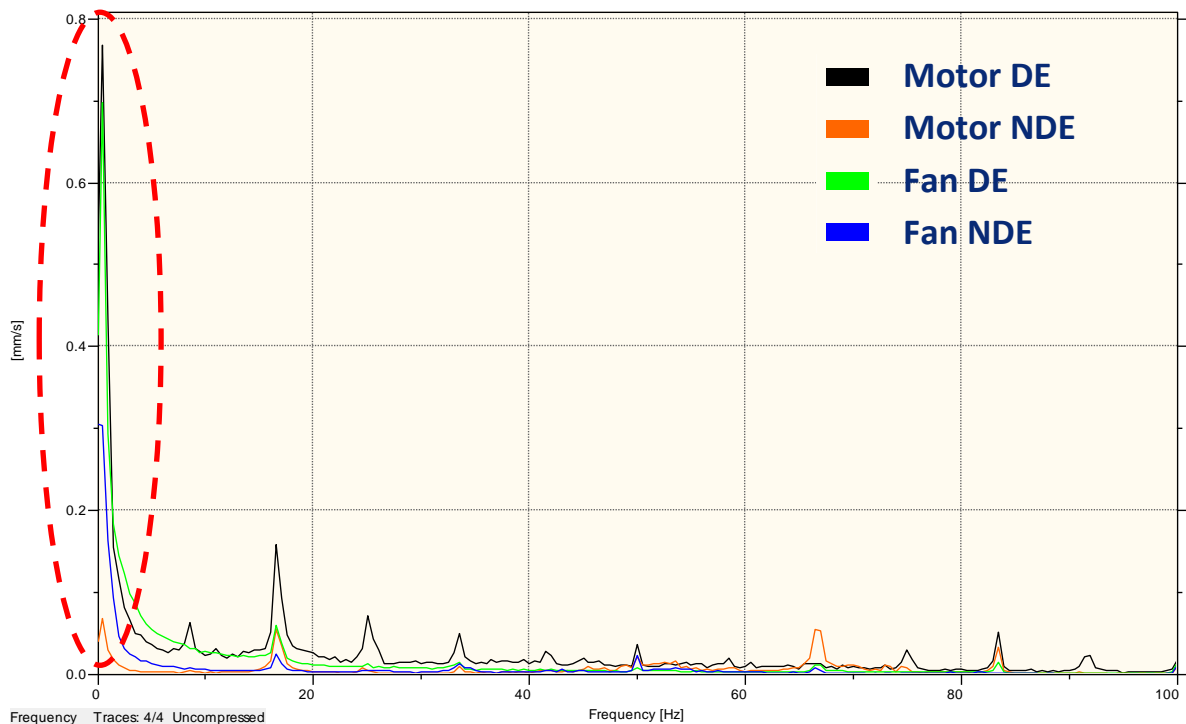
Graph 2: Vibration velocity v/s frequency spectrum of Exhauster unit 1 in Z axis

The axial direction measurements (identified as Z axis) in the Graph 2 above also show higher 1x frequency vibrations at Motor DE and Fan DE whose magnitudes are as same or higher than radial direction vibrations, which is unusual. The initial inference from such a vibration behavior indicates that there is a possible misalignment between the fan DE bearing support to the motor DE bearing support.

The Z-axis (axial direction) vibration graph also indicates presence of very low-frequency (sub- 1Hz) vibrations (circled in the graphs above). This usually indicates loss or change in lateral (axial) stiffness of the shaft axis.

- From the detailed vibration analysis, it is inferred that the most possible cause of higher shaft vibrations at Motor DE in Exhauster-1 is due to a combination of residual unbalance in the motor / coupler / fan assembly combined with higher Z-axis vibrations caused by misalignment. Thermal gradient on the shaft axis across the coupling and depletion of physical characteristics of the coupling unit are also likely to be contributing to higher shaft vibrations in Exhauster-1.

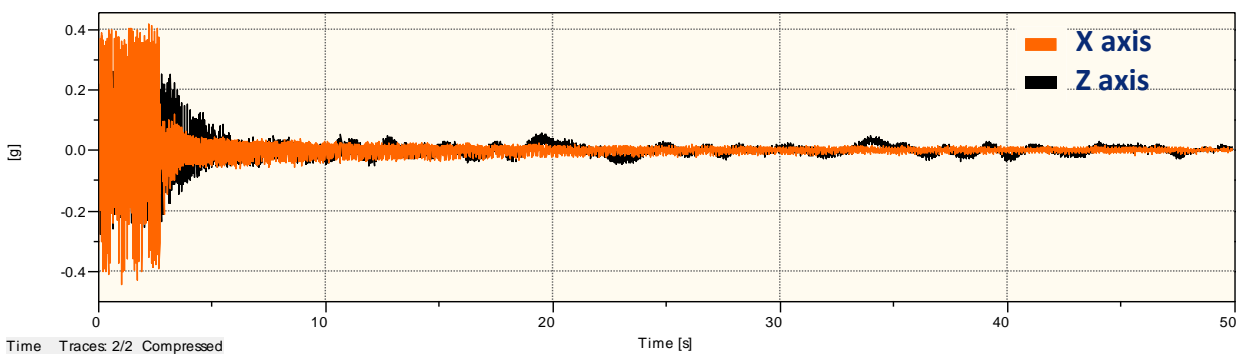
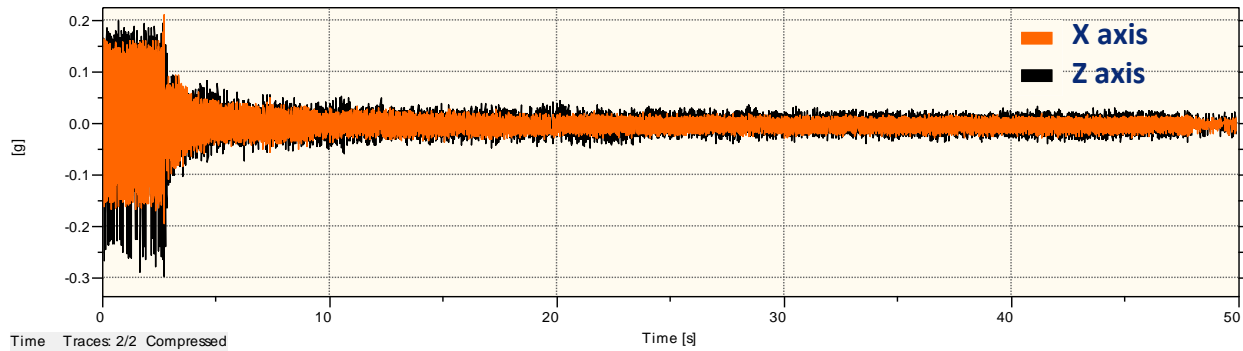
Graph 3 and Graph 4. The results indicate normal response with no critical speed behavior shown anywhere through the coast down period till the motor comes to a stop. This test and its results confirm that the motor / fan units are operating within the rigid rotor concept and the critical frequency remains beyond the maximum operating speed of the system.

Effectively, the Exhauster-1 took under 25 minutes to fully stop from its start of power-off and Exhauster-2 had a coast down time of over 35 minutes; this is a fringe observation that points to higher inertial resistance in Exhauster-1 due to misalignment in the axis that resists the rotational movement.

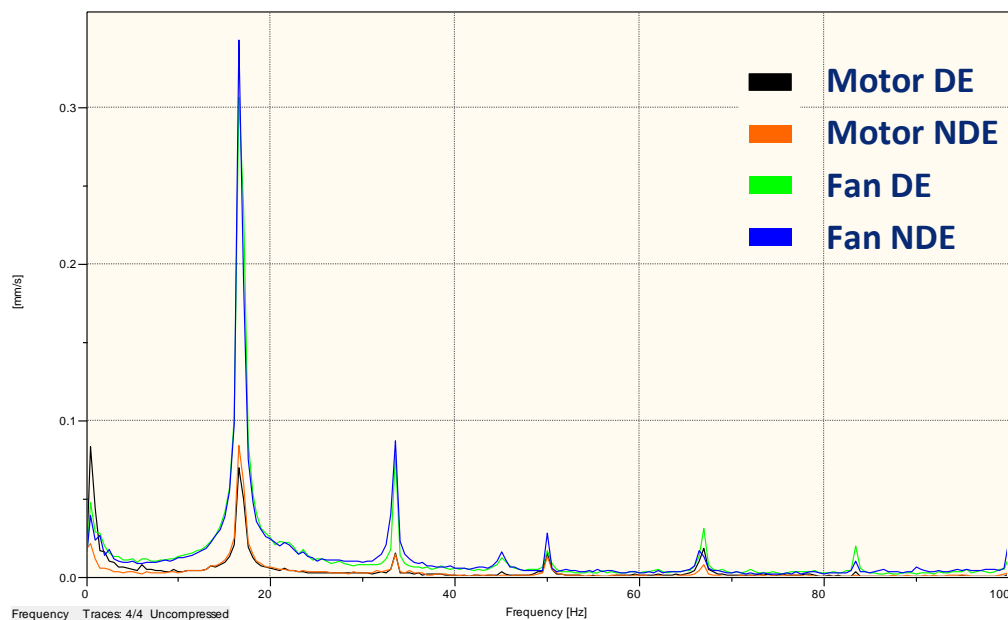
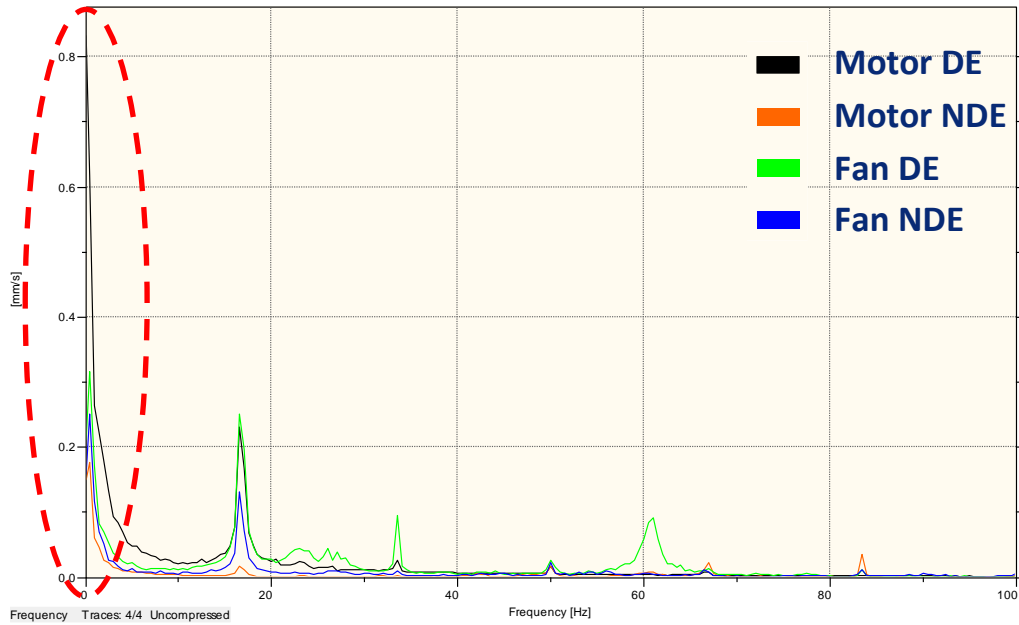
The Exhauster-2 exhibits lower axial vibrations at all the measured bearing support locations and has lower harmonic vibrations in the radial direction. The 1x RPM vibration that typically represents the residual unbalance in the motor units is under 0.4 mm/sec, which can be addressed by conducting site balancing activities. From this observation, it can be established that the shaft vibrations in this motor are lower as compared to the Exhauster-1 motor (due to the absence of higher harmonic vibrations).

It is also observed that the low frequency (sub 1Hz) vibrations do show up at the Z-axis (axial) and in the X-axis (radial) show up with lower magnitudes, indicating better alignment between the Motor DE and the Fan DE axis.

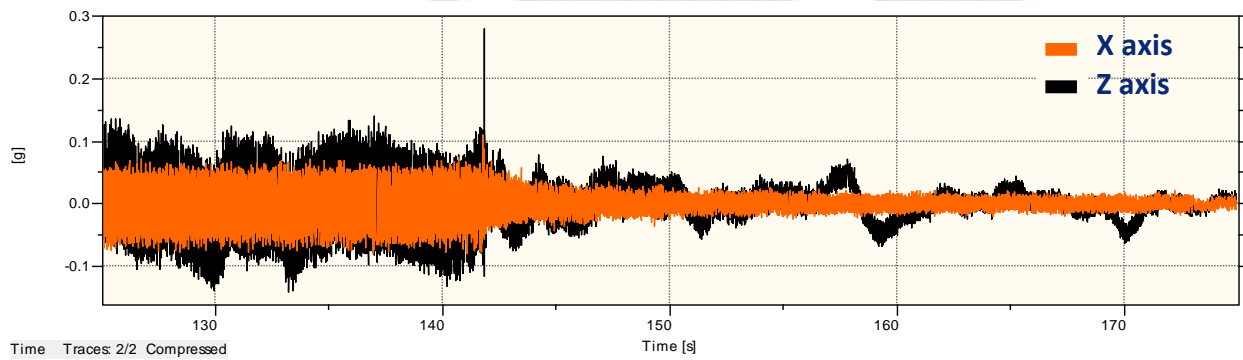
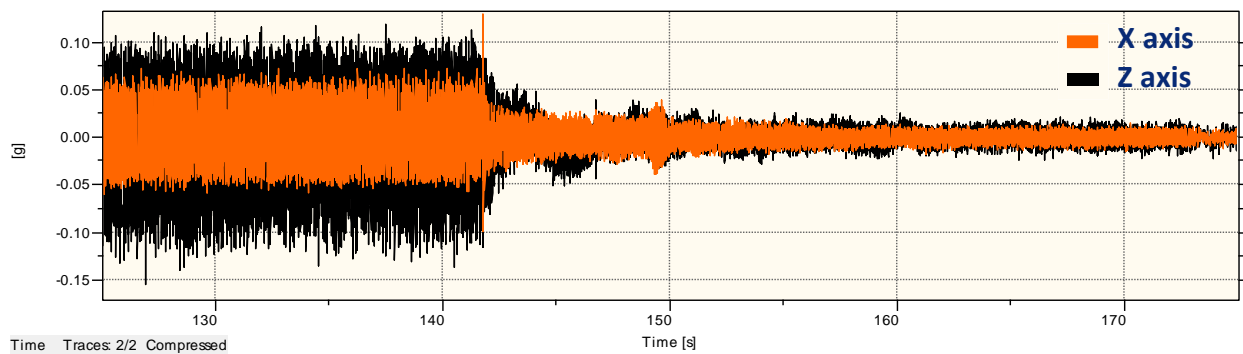
As in the case of Exhauster-1, both the run-down tests and impact response tests did not indicate any possible presence of natural frequency and resonance conditions influencing the vibration behavior on the Motor / fan unit.
