1. Test setup:-

Hardware used: - B2-SP25-IDCEvo

2.1. Frequency of PCIe_REFCLK_P, PCIe_REFCLK_N

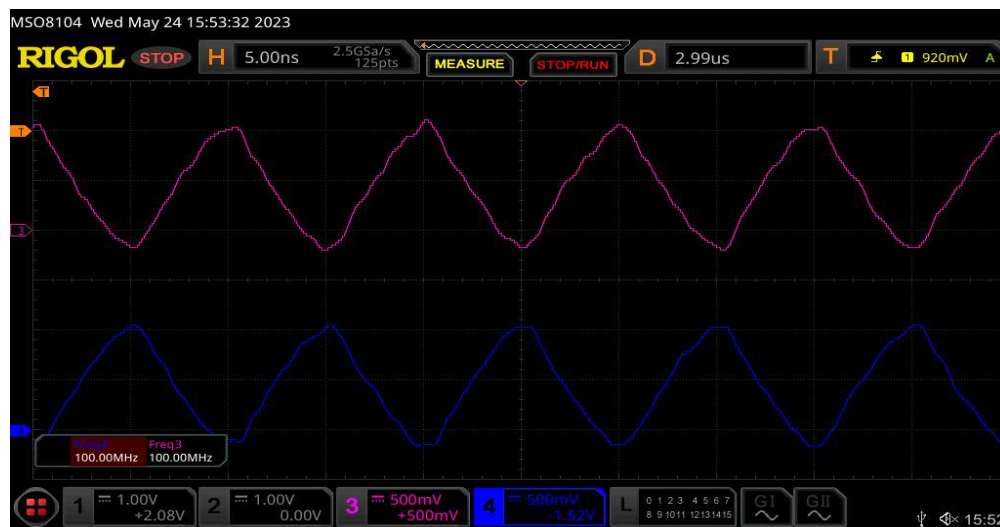
Result: - PCIe Clock frequency = 100MHz

The PCIe standard specifies a 100 MHz clock (Refclk) with at least ± 300 ppm frequency stability for Gen 1, 2, 3 and 4, and at least ± 100 ppm frequency stability for Gen 5, at both the transmitting and receiving devices.

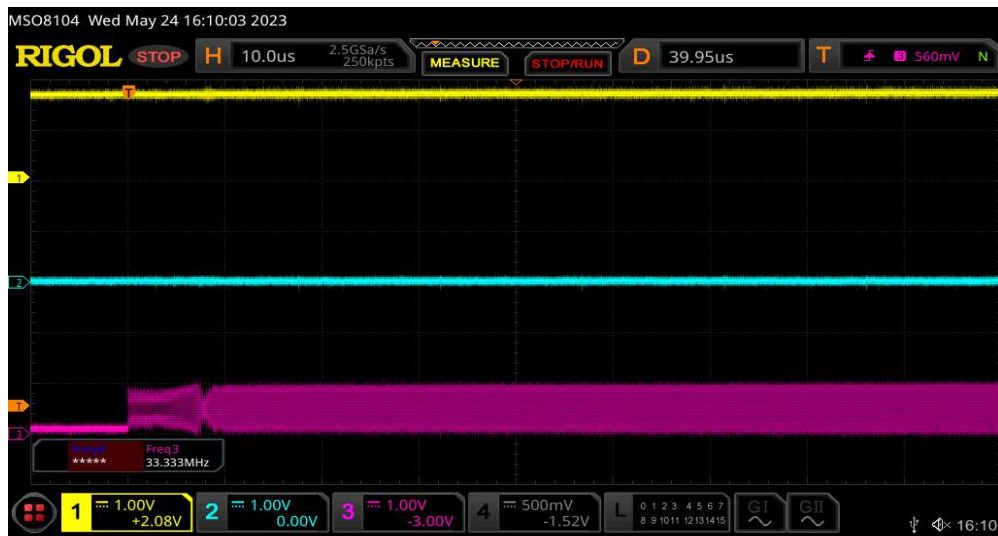
2.2. Rough estimation of PCIe_REFCLK stabilization:-

Result : - PCIe Clock stabilization takes around 20us.

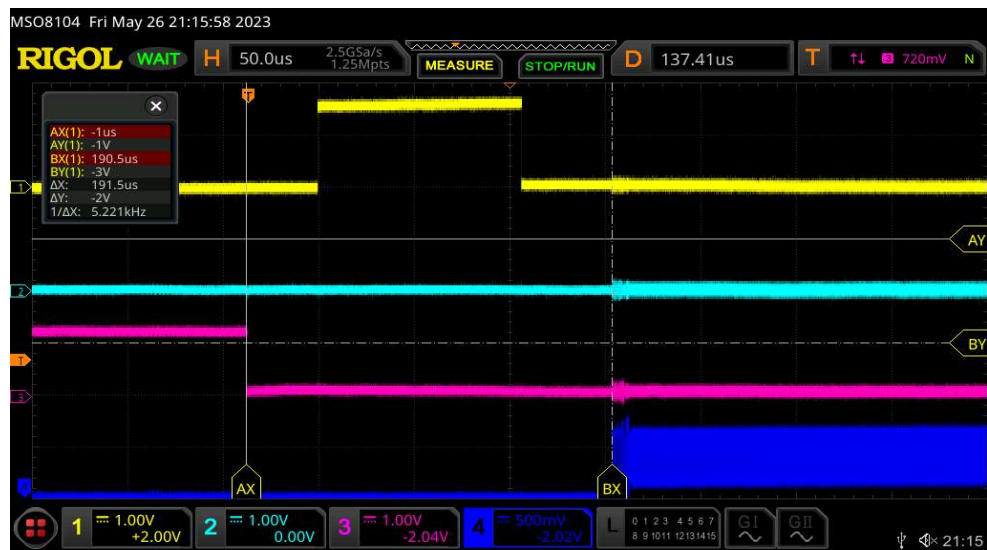
2.3. PCIe clock gating using CLKREQ line:-

Result: - PCIe CLKREQ line is used to enable and gate the PCIe clock. When CLKREQ line is low, then PCIe clock is enabled and when it goes high then PCIe clock can be disabled.

Time to enable PCIe clock from falling edge of CLKREQ line is 191.5 us (approx.).

When PCIE_CLKREQ_L pin of wifi chip is made High, then clock is gated or turned off.

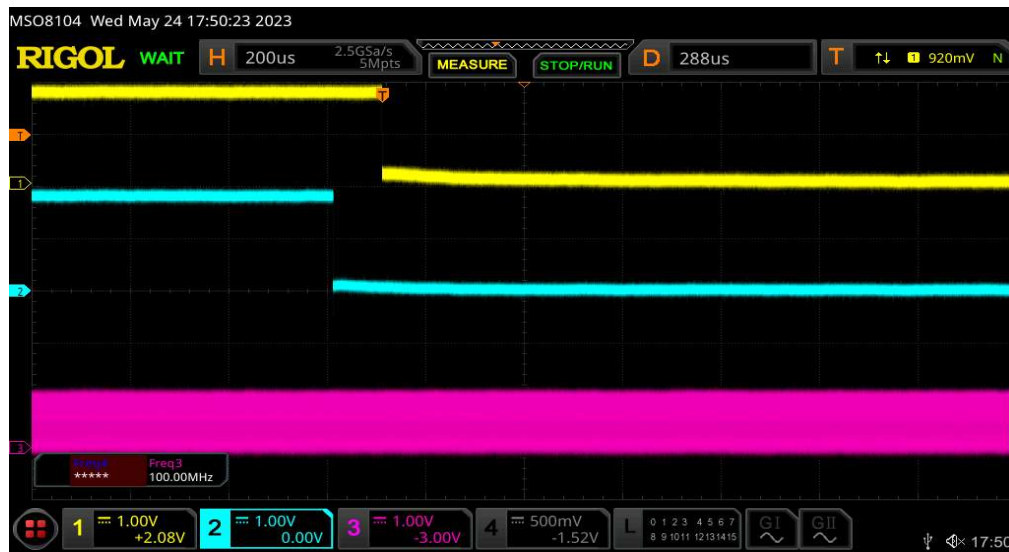
2.4. PCIe Clock is maintained even after PCIe enumeration fails:-

Result: - PCIe clock is maintained, even after PCIe enumeration fails.

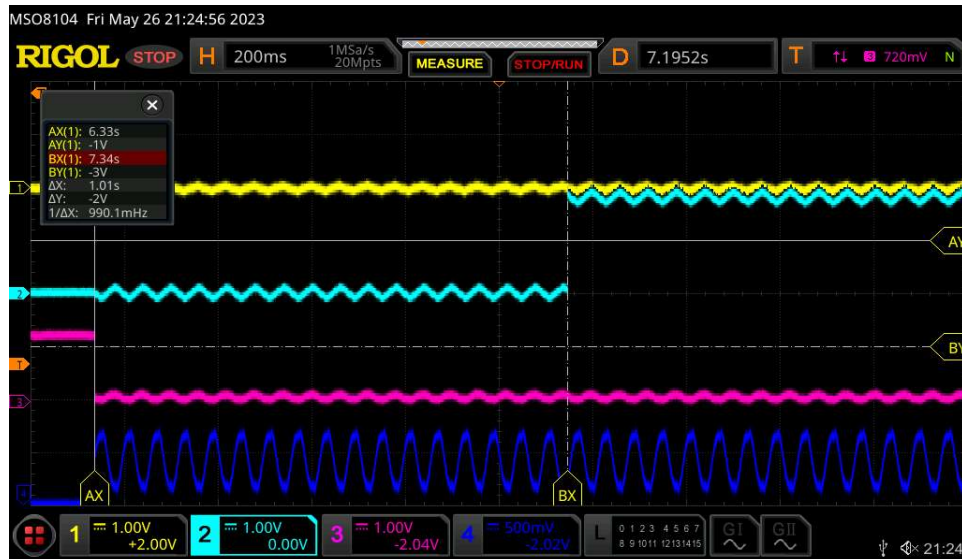
2.5. Time gap between PERST and CLKREQ

Result: - Time gap between falling edge of CLKREQ line and rising edge of PERST# line is 1.01 seconds.

PERST# line is PCIe Reset line, which is made high in probe function of PCIe controller driver.

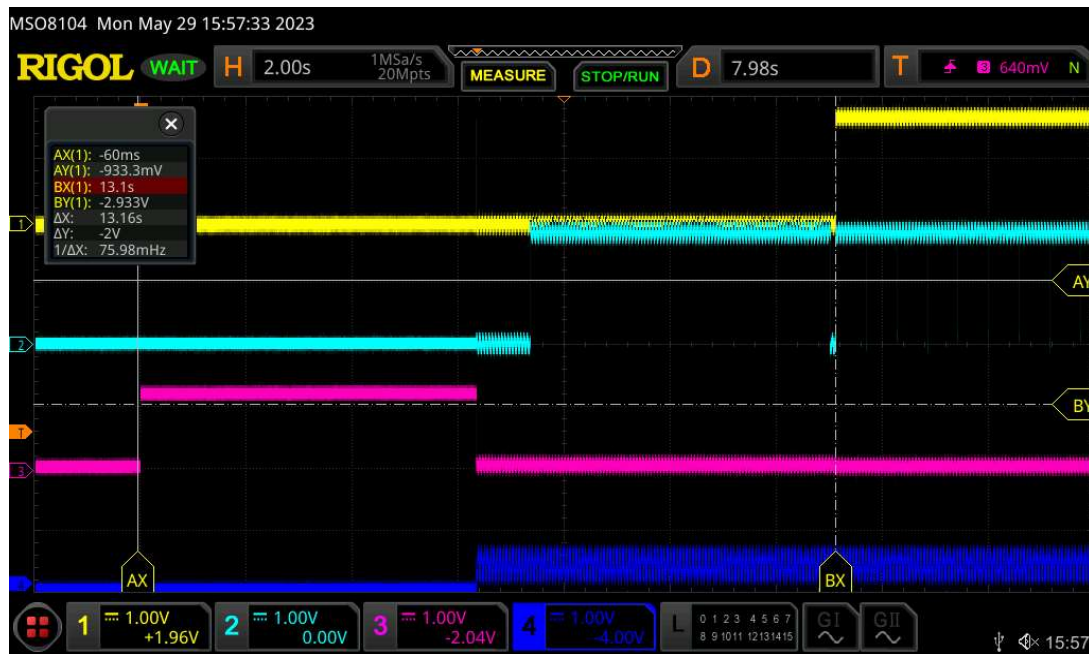
2.6. Time sequence of various signals on normal power up of target:-

Result: - Time gap between rising edge of CLKREQ and rising edge of Power-On-GPIO be 13.16 seconds. In this case, Power-ON-GPIO is asserted due to "PCIe enumeration command" running in init.wifi.rc. Here, falling edge of CLKREQ line is taken as reference only.

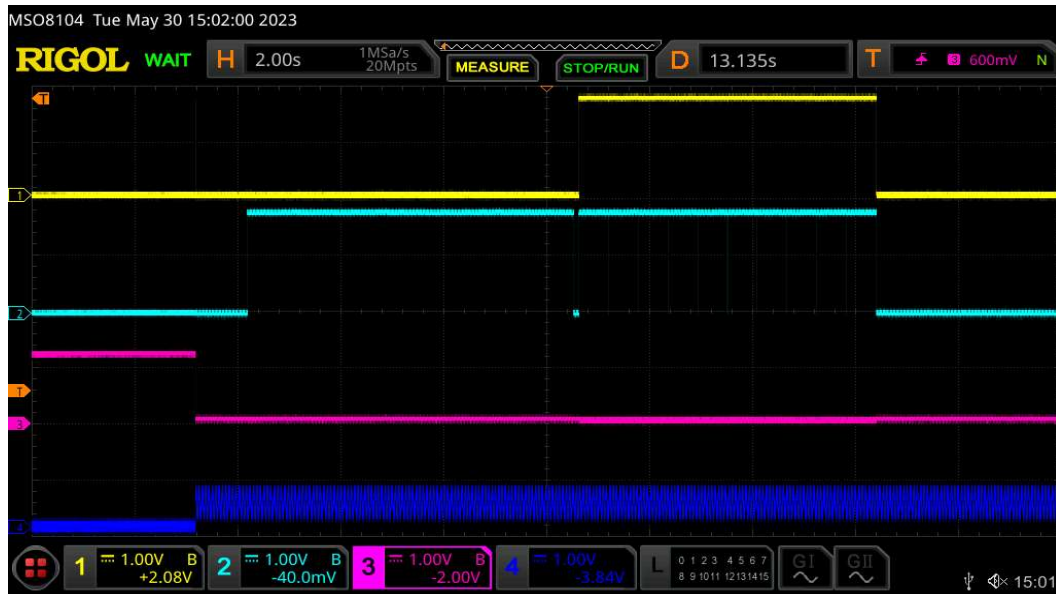
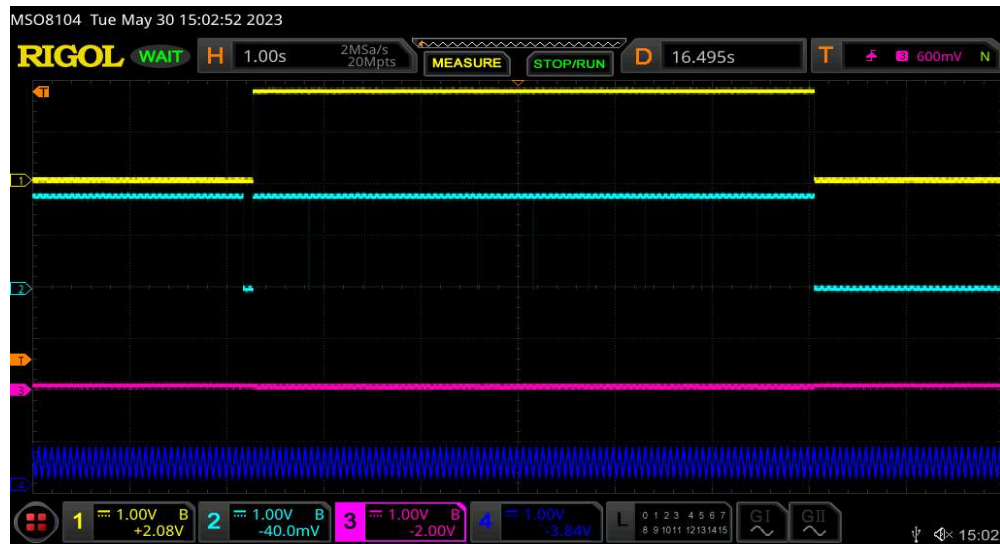
2.7. PCIe enumeration fail waveform at Power ON:

Result: - At Power On, PCI enumeration is triggered using a command in an init.rc script, if enumeration does not pass, then 10 times retries are done, which can be seen as PERST# line coming LOW 10 times in above waveform. The expanded view is shown below.

Note: - In above waveform with Cyan colour, we can see PERST# signal coming LOW for 10 times.

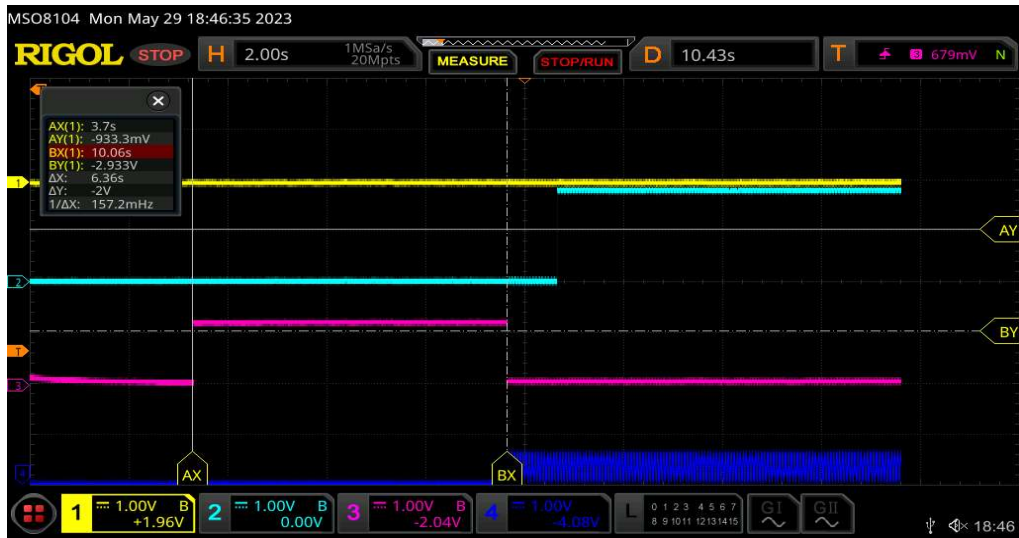
2.8. Time gap between CLK REQ rising and falling edge at Power-On:

Result: - CLKREQ line is high for 6.36 seconds at Power On.

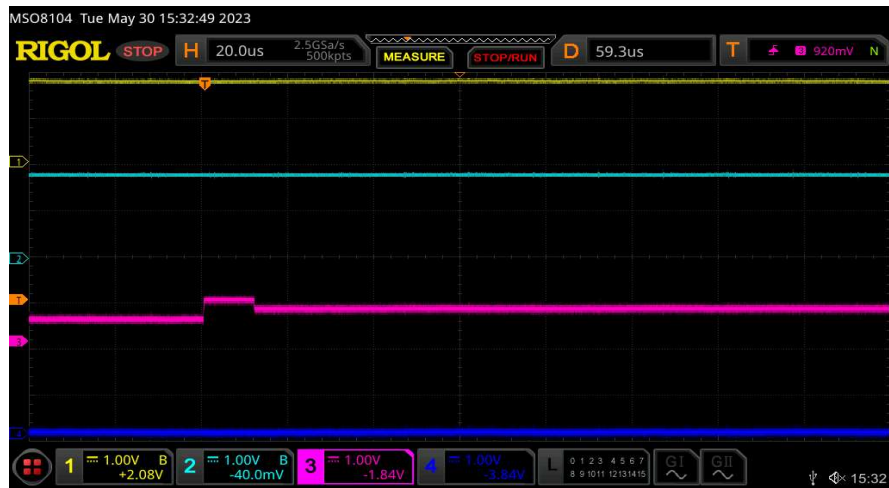
2.9. Waveform for PCIe_TXD and PCIe_RXD line:-

When target was powered up to capture data lines, it generates panic. Panic log back trace is as below. Waveform is also shown below but it is of no use.

When CRO probe was removed from TXD and RxD lines of PCIe, then it booted normally without any panic.

Result: When CRO probe was connected to PCIe TxD and RxD lines, then it is generating panic. When CRO probes are disconnected then it boots without panic.
