ES_SAF400x

Errata sheet SAF400x

Rev. 0.6 — 10 October 2017

This document describes the functional or performance deviations of the SAF400x (nickname: Mercury) from the datasheet.

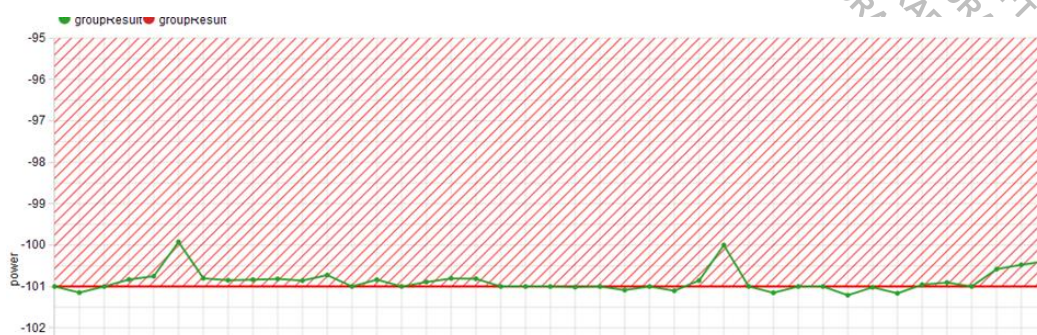
Figure 1 DAB sensitivity

DAB sensitivity is lower compared to the target specification of -102 dBm (typical).

- For DAB channels 6B and 11C, the sensitivity will be around -100 dBm.
- The sensitivity for the other channels will be around -101 dBm.

Figure 1 shows the measured sensitivity for Mercury ES1. The green line represents the measured values.

A hardware update is implemented in Mercury ES2 such that:

- the noise figure for DAB is improved,
- the gain of the signal is increased.

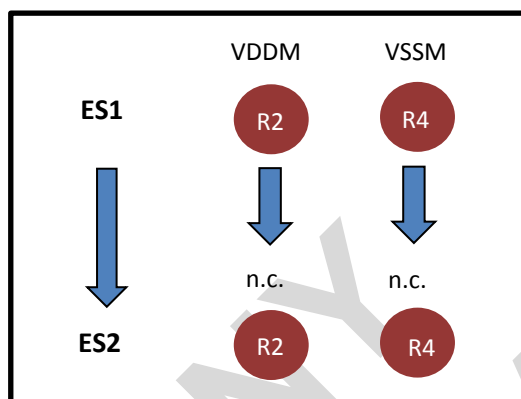
Figure 2 Pin change ES1 and ES2

A power pair for VDDM (memory supply pins) will not be connected in ES2. Affected pins are R2 and R4. The figure below shows the different pinning between ES1 and ES2.

The memory power supply pair can result in interferences in AM, FM and DAB. These interferences can degrade the tuner performance.

Pins R2 and R4 are not connected in ES2. Board design for ES1 is compatible to ES2. Corner silicon for ES2 is being validated.

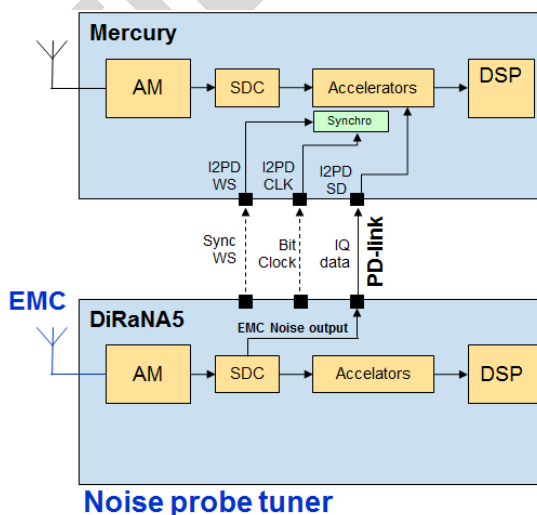
Figure 4 AM Wideband Noise Cancellation

AM cancellation requires a noise probe (DiRaNA5 in diagram). In order to reduce the noise from an AM broadcast, Mercury subtracts the probe signal from the received AM signal.

The added hardware is available in Mercury ES2 to perform noise cancellation. Signal decimation is done in HW (using accelerators) as this is MIPS intensive. Cancellation is done in software on a DSP for flexibility and algorithm refinements. The I2PD interface is used for IQ data and control bits and synchronization is done in Mercury (in the set-up of Figure 4). The software is under development.

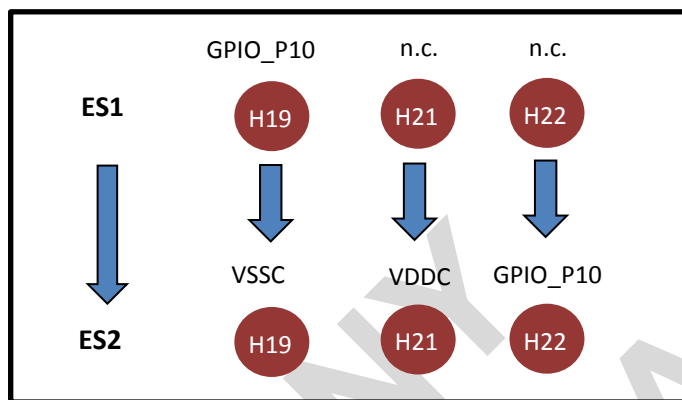
Figure 5 Pin change ES1 and ES2

Mercury ES2 will have an additional power pair for VDDC_1V2. The affected pins: H19, H21 and H22.

- 1V2 supply needs to be between 1.19V – 1.25V (voltage on pin).
- Pin GPIO_10 cannot be used in ES1.
- VSSC/VDDC can be connected to H19/H21, but no current will flow over VDDC power lines in ES1

Board design for ES1 is compatible to ES2. The figure below shows the different pinning between ES1 and ES2.

The restriction on the supply voltage is relaxed (1.14V – 1.3V).

Pin GPIO_10 can be used in ES2.

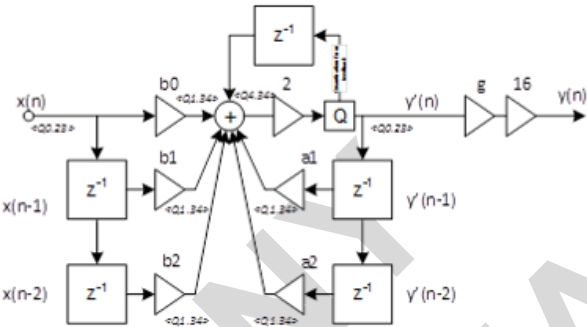
Figure 6 BiQuad accelerator

The following biquad implementation is available as special instructions on HiFi3 for ES2:

The added hardware is available in Mercury ES2. HiFi3 software for ES1 is compatible to ES2.
