**SETTING THE SHIFT STROKE OF 3RD - 4TH 'SHIFTER LEVER' or GEAR
CHANGE LEVER IN MAZDA P66M MANUAL 6 SPEED TRANSMISSION.**

INSTALLED IN NC MIATA MX-5 + 2009-2012 Series II MAZDA RX-8.

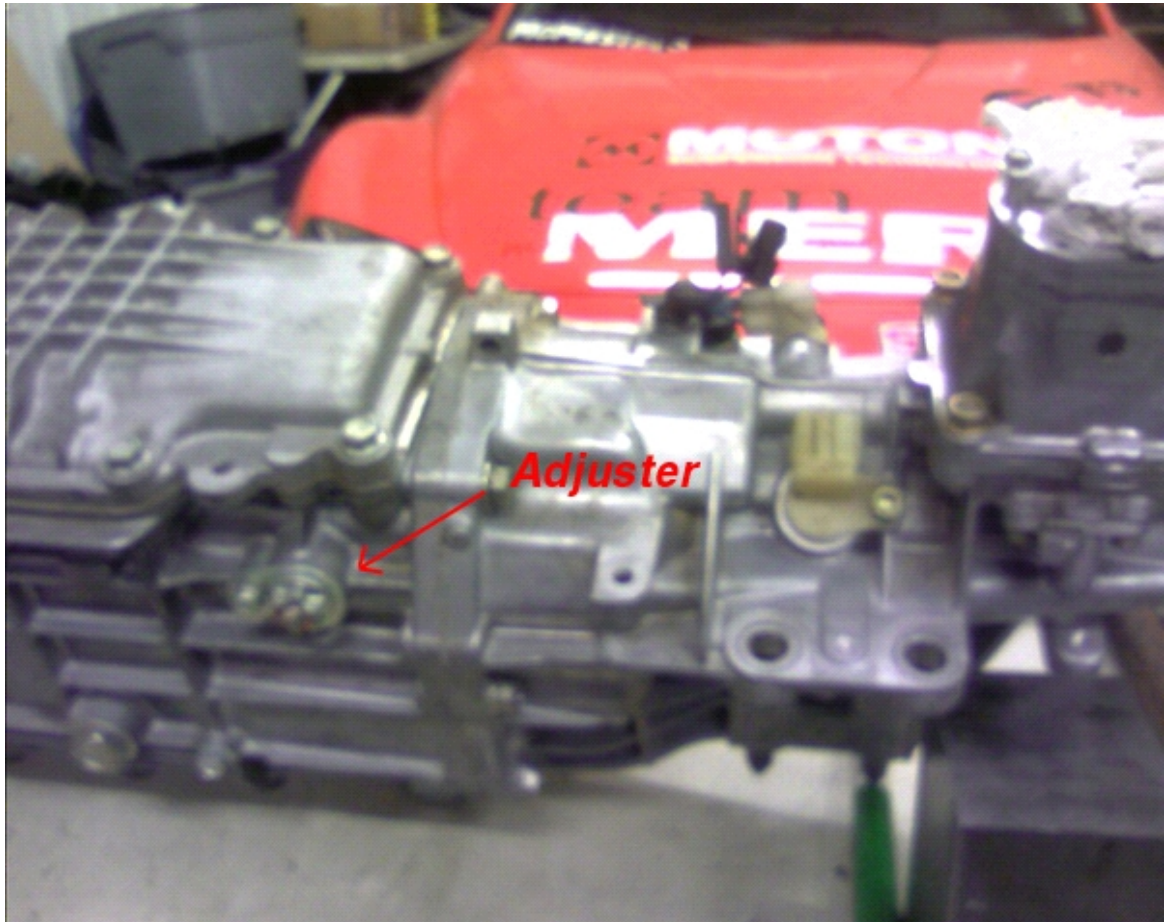
THIS SHOWS THE LOCATION OF THE **COUNTER LEVER SHAFT ADJUSTER** WHICH IS POSITIONED ON THE LEFT SIDE OF OUTER TRANSMISSION CASE.

It's not accessible from the top, you must get under car to adjust. It helps to have the entire car up on stands and to remove the lower cross-member brace to ease access.

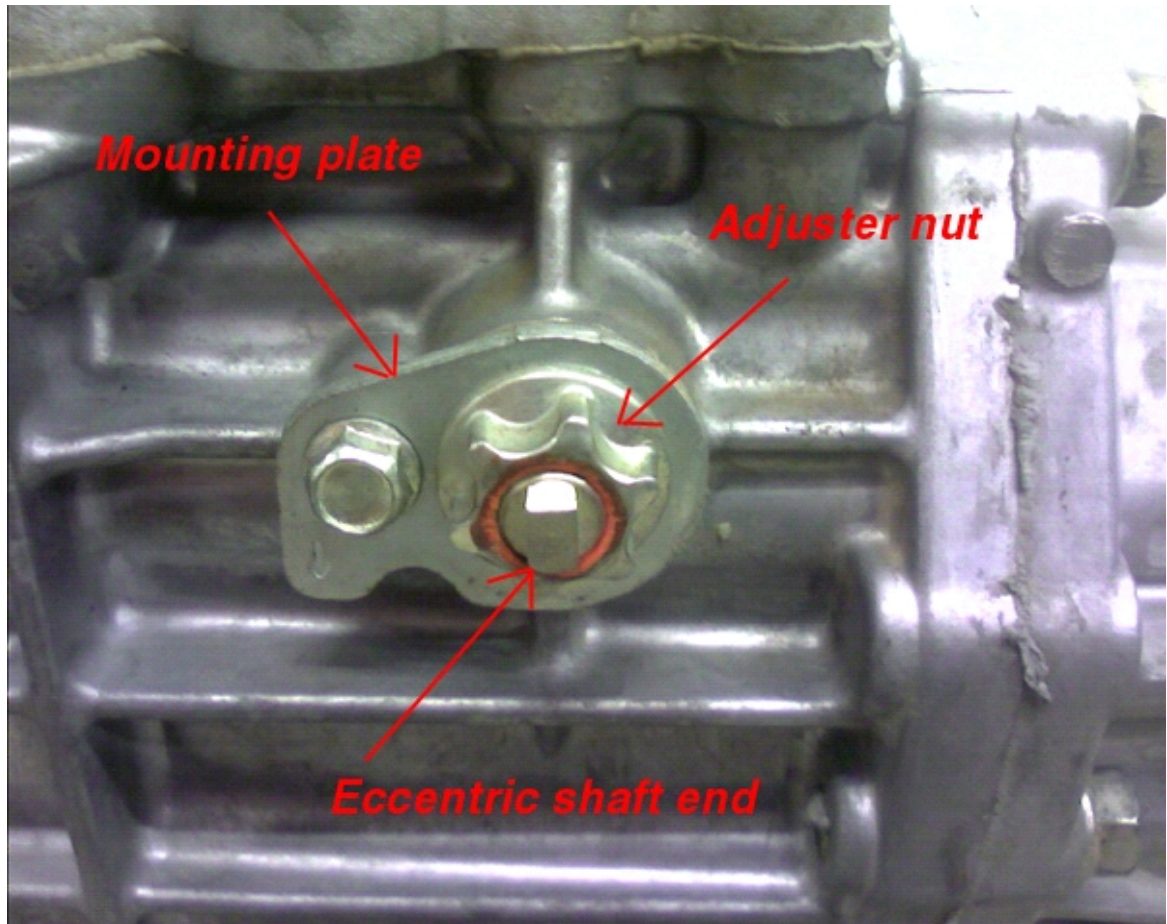
ADJUSTER CLOSE UP.

It's a 19mm 12-pt so you can use a box-end wrench to adjust it.

The eccentric shaft controls the position of the 3rd/4th extension lever that actuates the shift fork. By rotating it, you can change the fore/aft position of the lever versus the shifter mechanism.

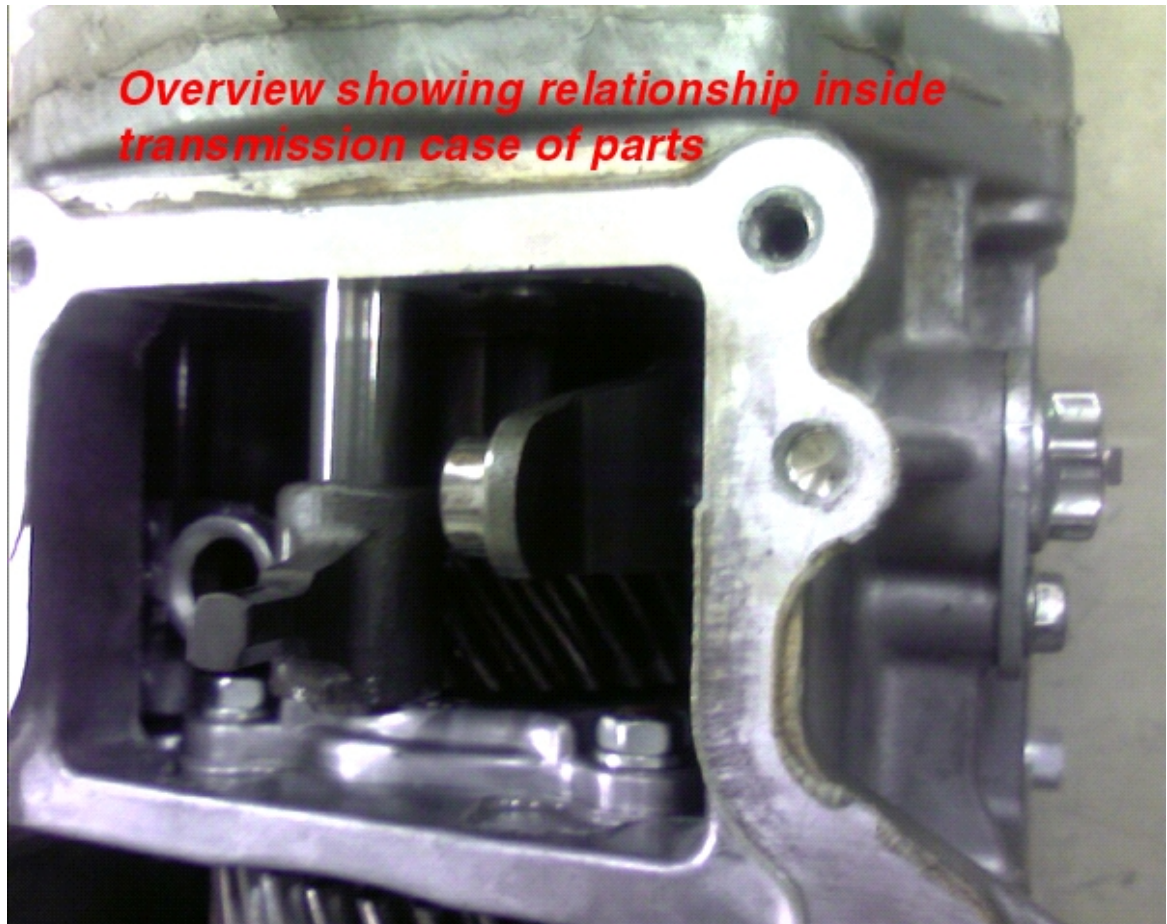
INTERNAL PICTURE OF THE ADJUSTER.

The position of the adjuster in the transmission case with the top cover removed. You can see that the adjuster goes through to the 3rd/4th extension lever.

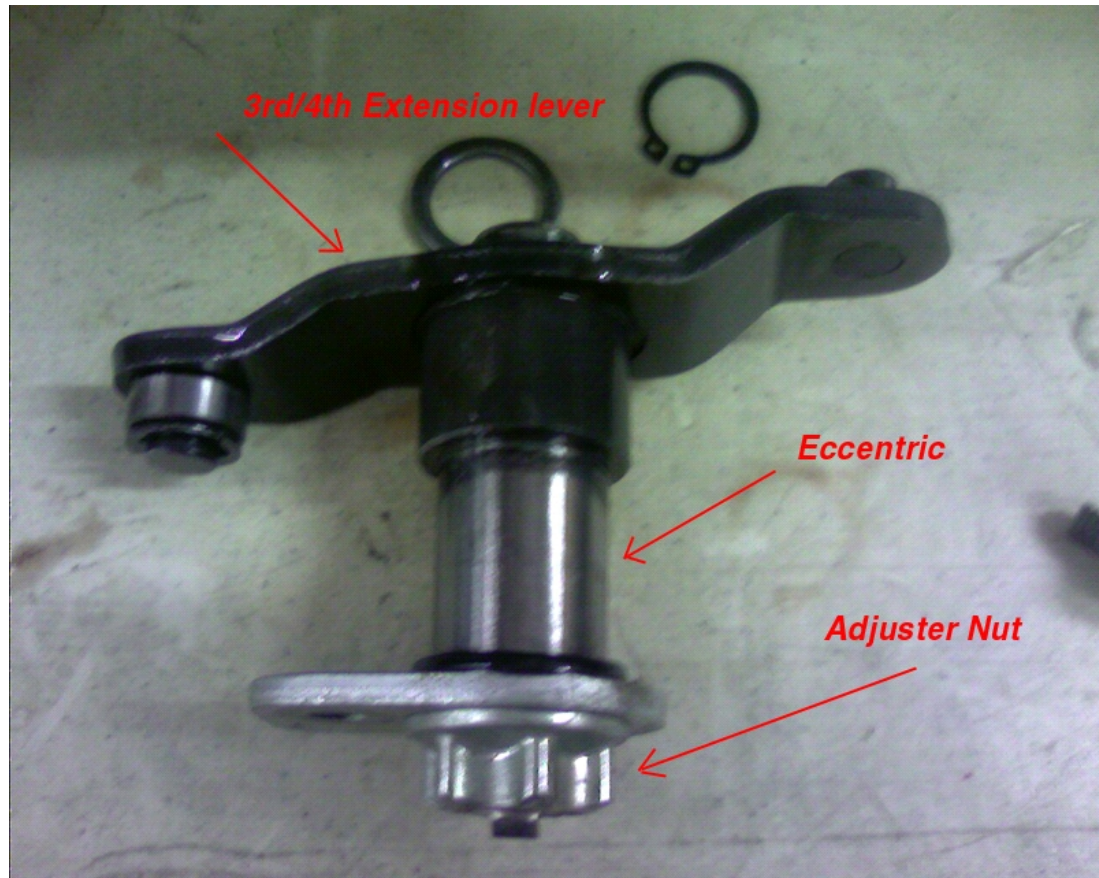
COUNTER LEVER SHAFT ADJUSTER AND 3/4 EXTENSION LEVER REMOVED.

As you can see, there is an o-ring to seal, and you can see where the eccentric portion of the shaft rides in a bore in the trans case.

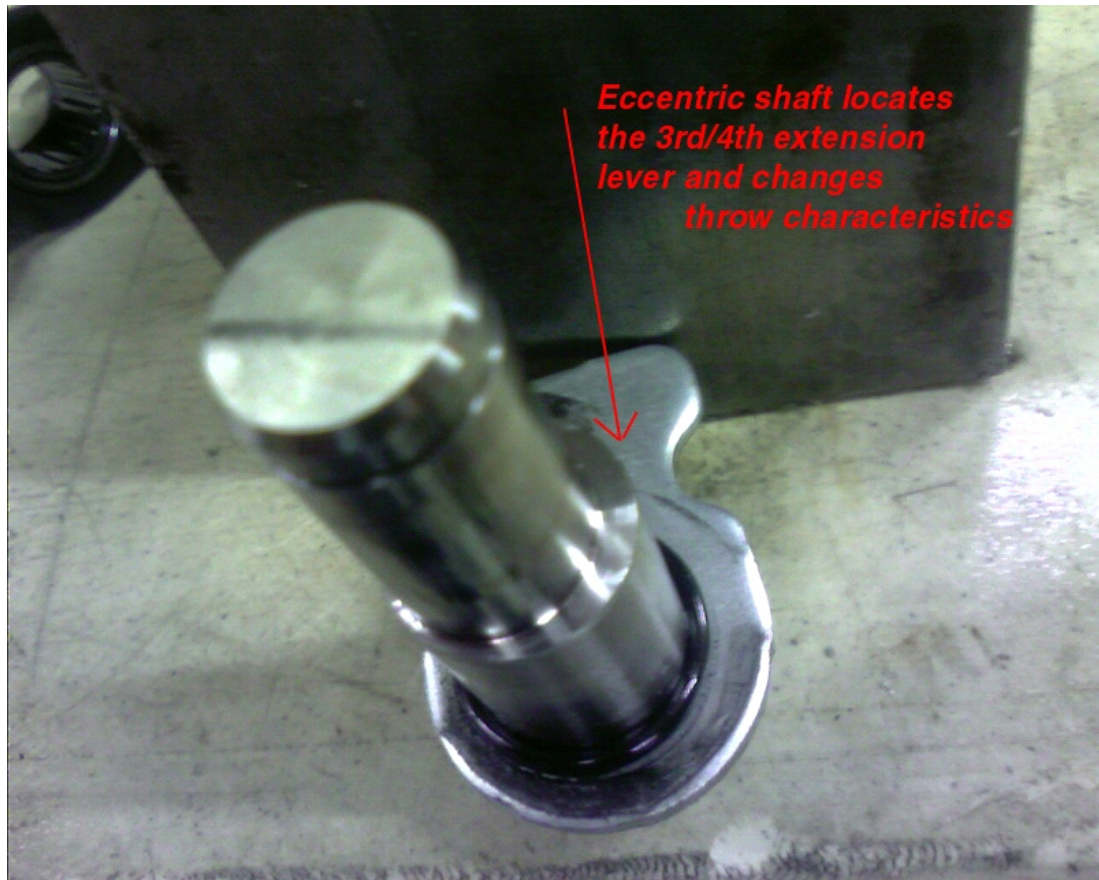
ECCENTRIC SHAFT.

The eccentric shaft lobe portion of the shaft.

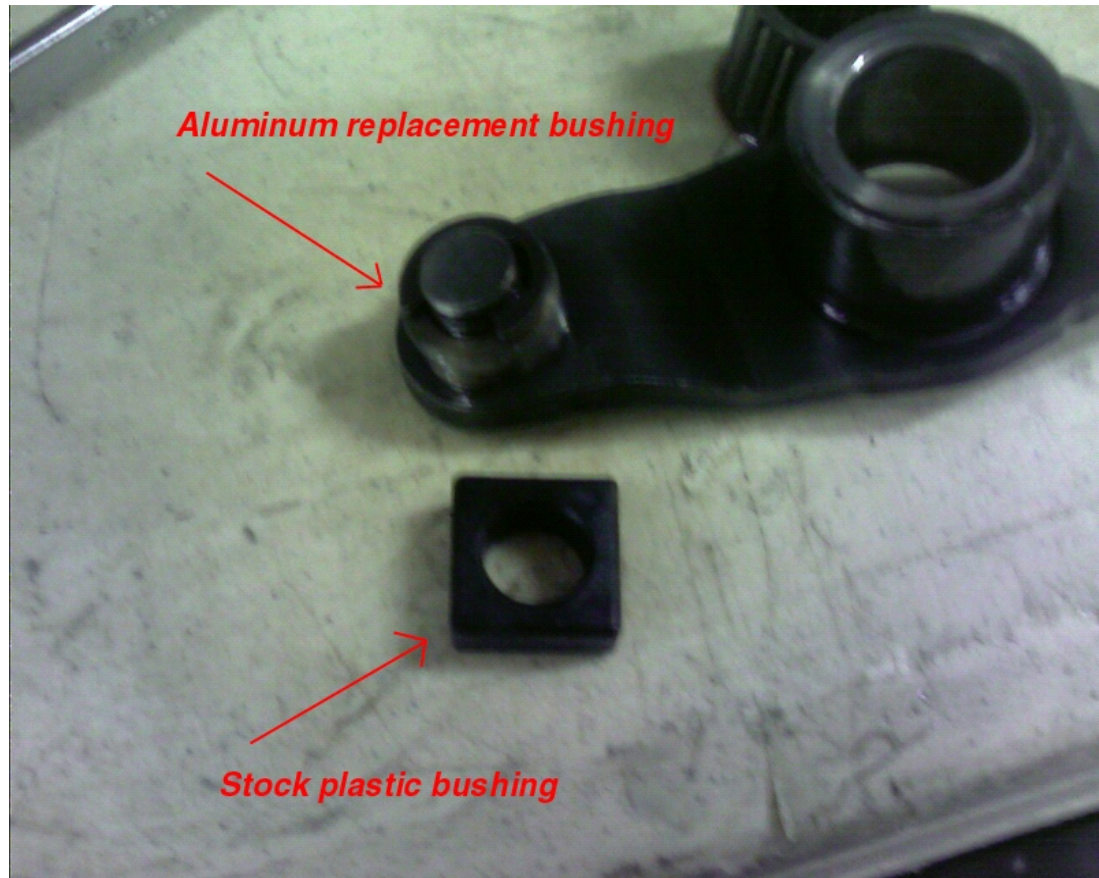
3/4 LEVER BUSHING.

Many racers renew the OEM stock installed square plastic bushings with either a round aluminum or locally fabricated brass square bush as the hard plastic bush tends to crush wear under extreme track conditions.

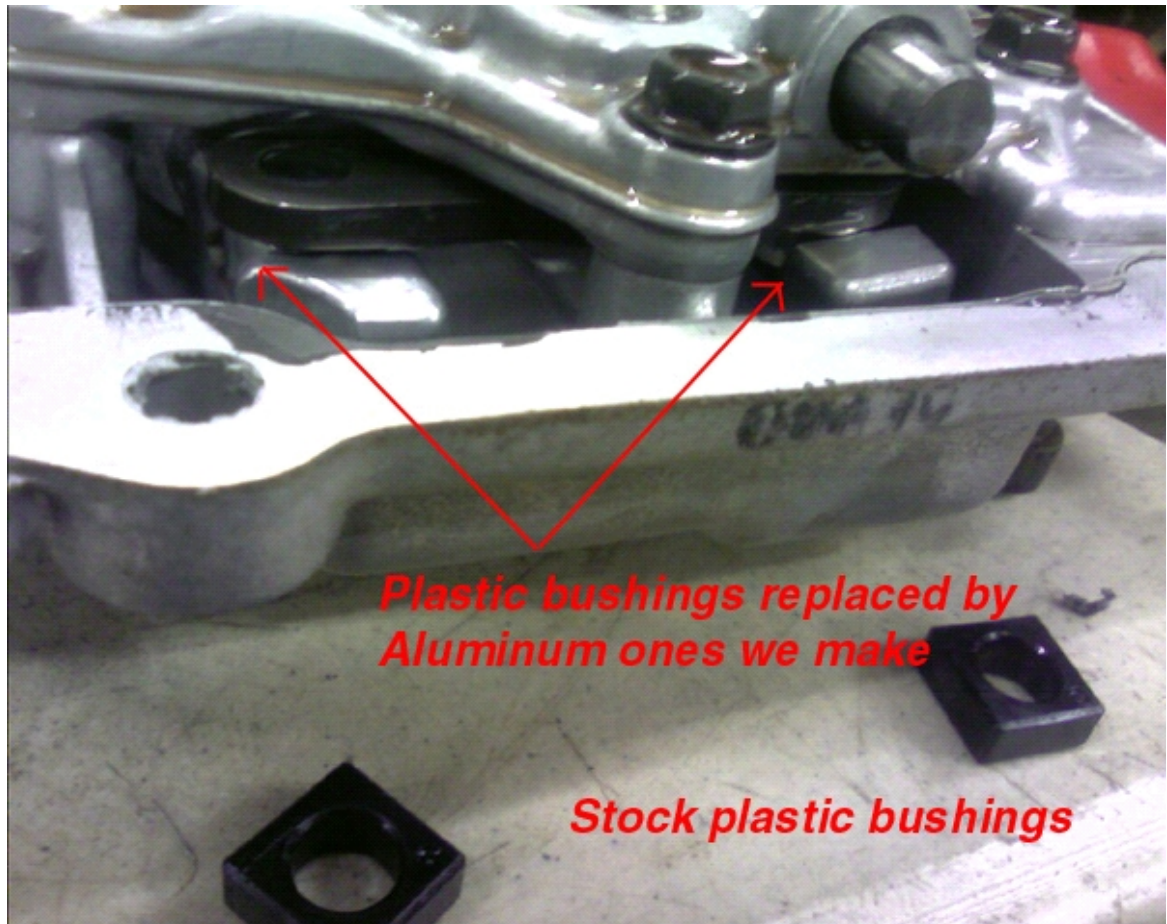
*Plastic bushings replaced by
Aluminum ones we make*

Stock plastic bushings

OEM BUSH REPLACEMENT WITH LOCAL FABRICATED ONES.

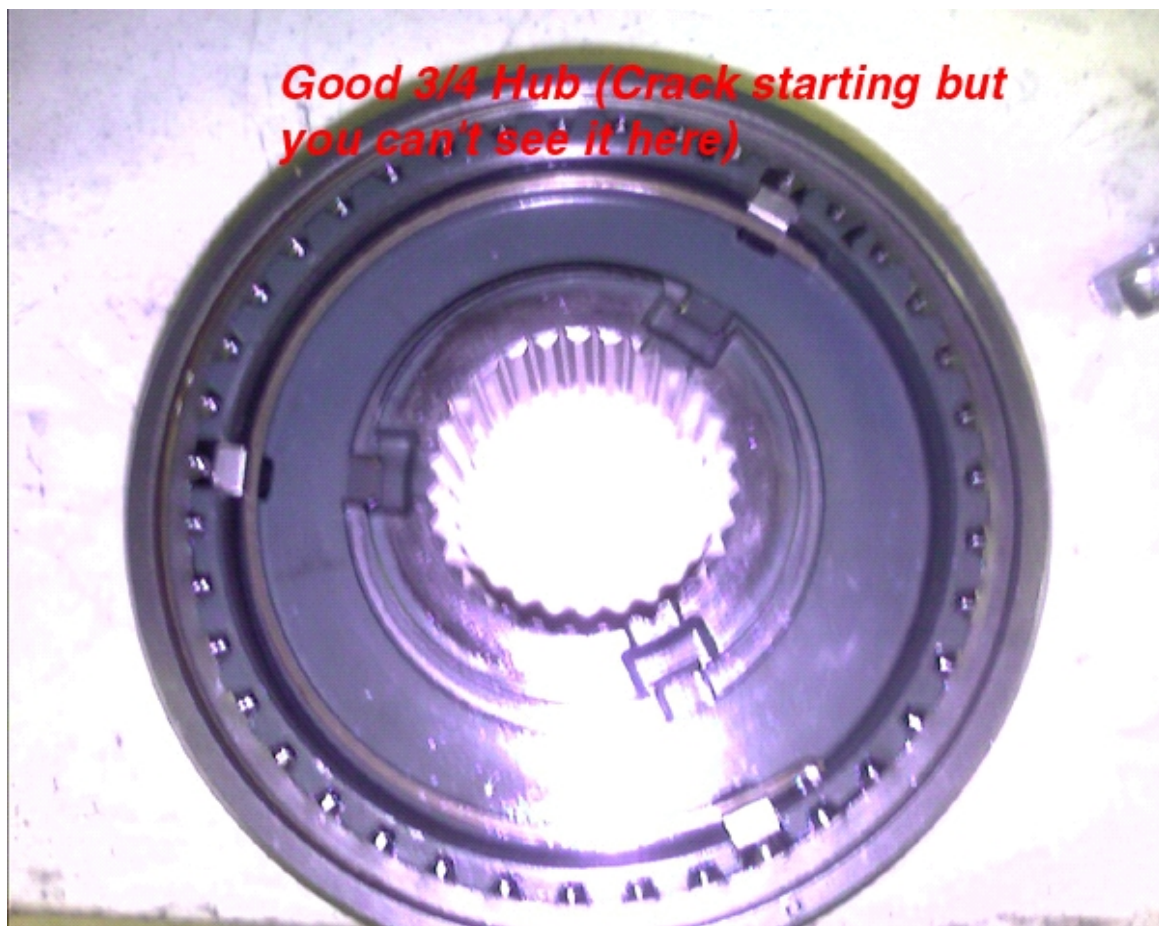
3/4 SHIFT HUB PICTURE.

This is a normal 3rd/4th shift hub which were know to give problems (cracking) on some early P66M Miata Transmissions. These Hubs have since been upgraded from February 2008 production.

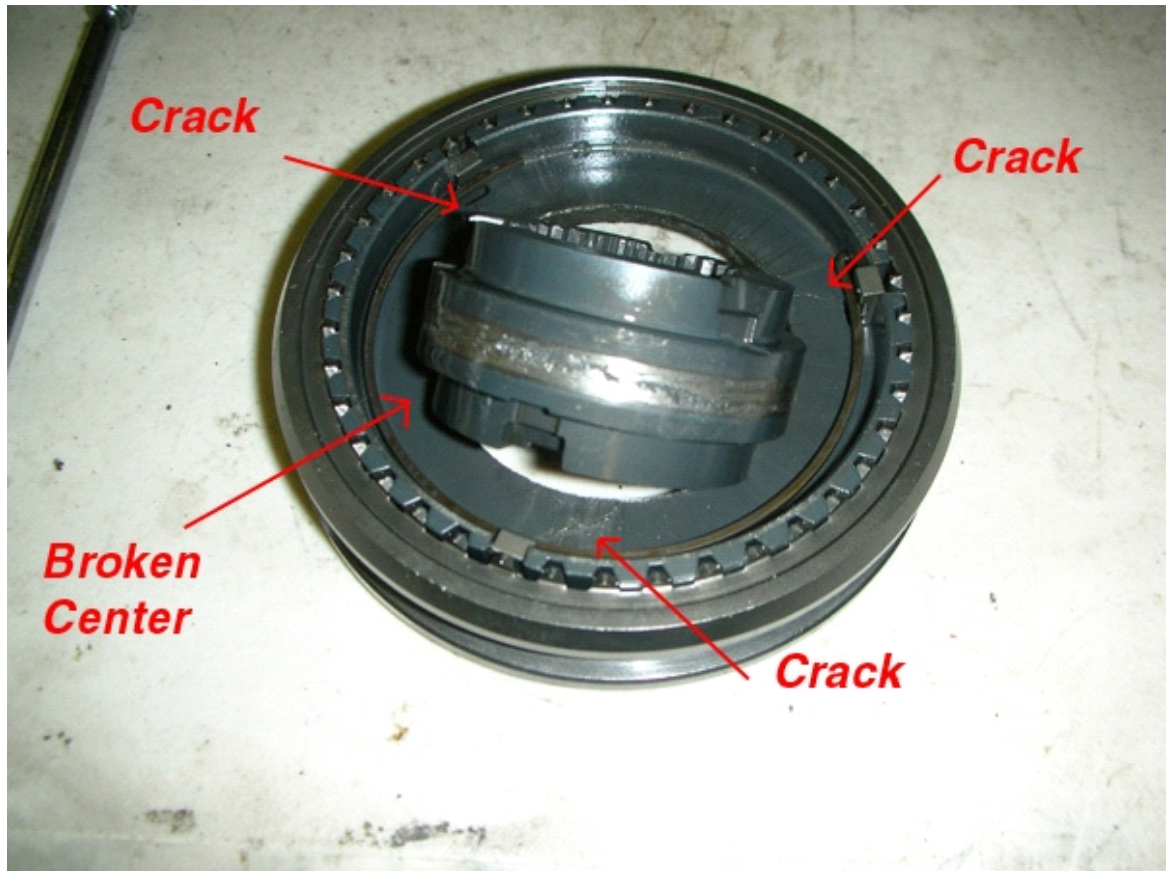
DAMAGED 3/4 HUB SET.

Remember this picture is taken from a racing P66M Miata Transmission. A normal domestic Miata/MX-5 should not normally see this type of wear damage.

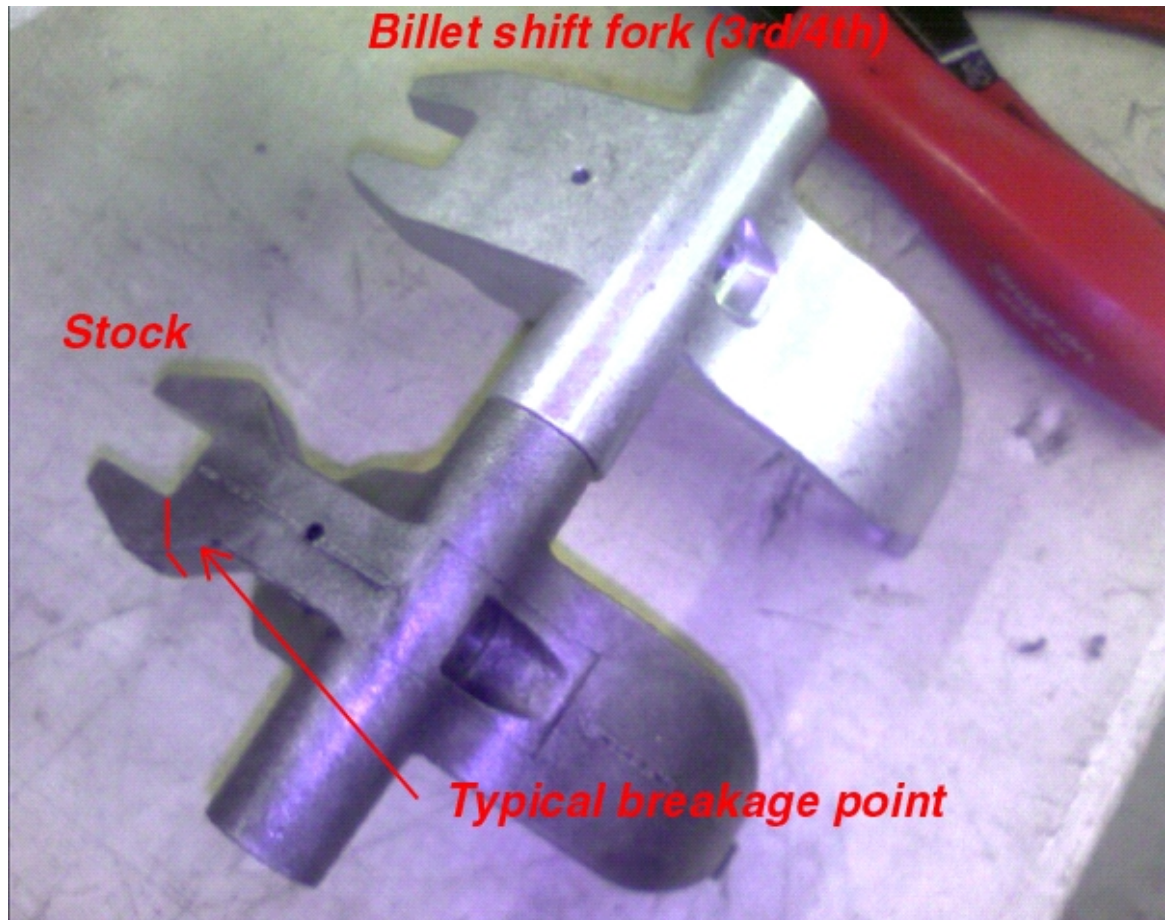
SHIFT FORKS HAS ALSO BEEN UPGRADED FROM February, 2008.
