4052/4054 HARD COPY QUALITY

It has been found that power supply noise from the +5 volt output board in 4052's and 4054's has been degrading hard copy quality. A mod has been generated to reduce the noise from the +5 volt supply, thus increasing hard copy quality.

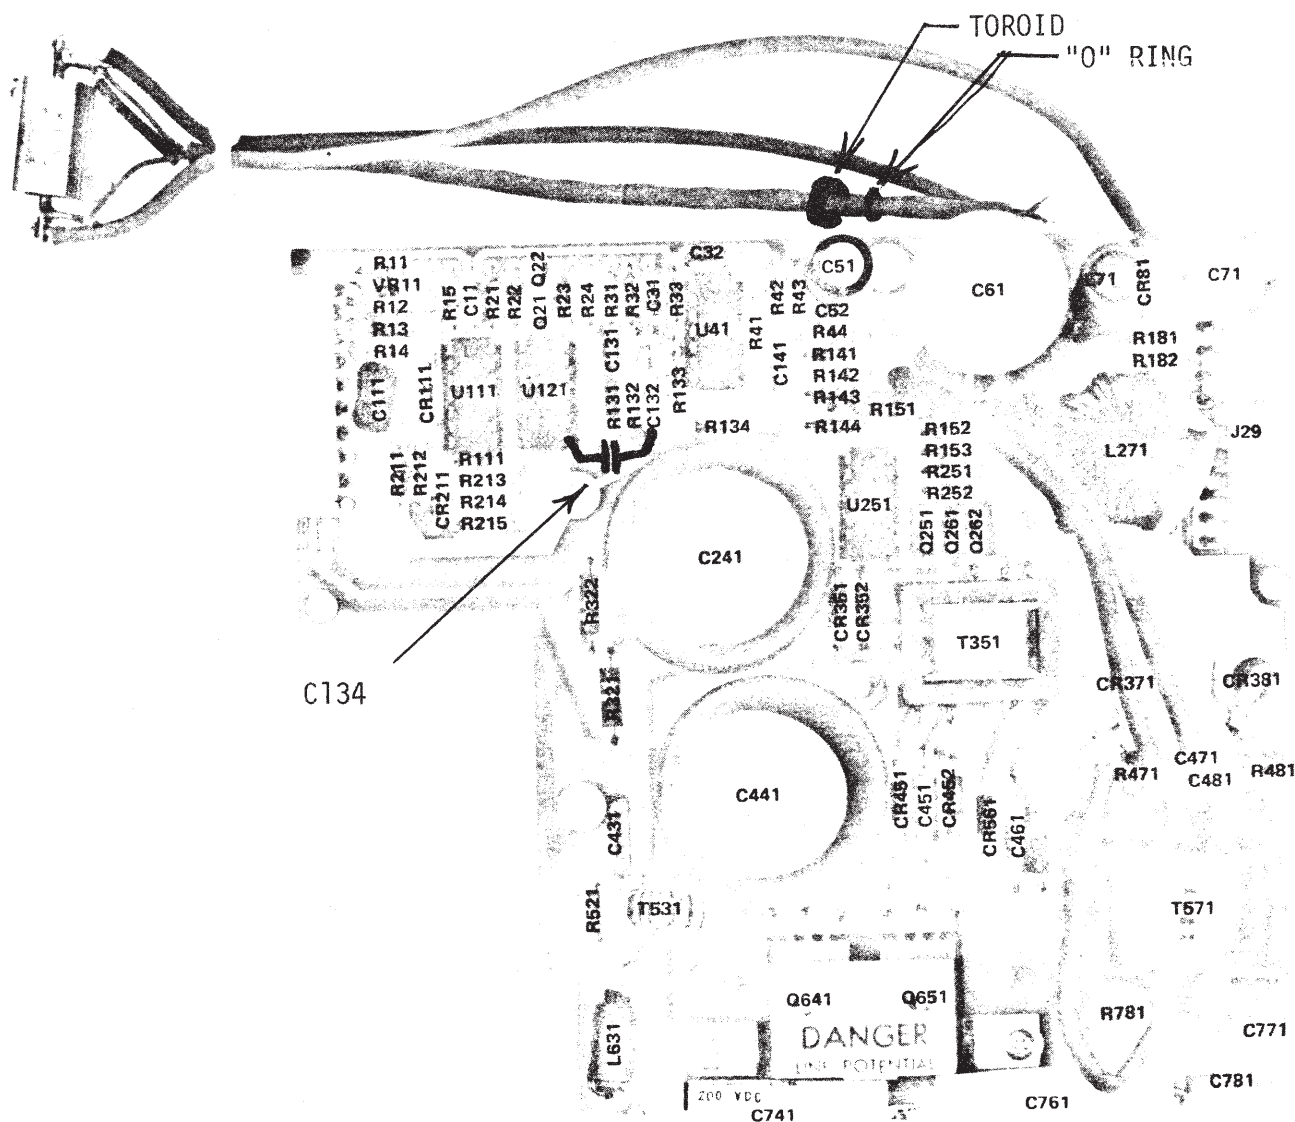
(FIGURE 1)

+5 Volt Output Component Location (067-5622-00).

Corporate Mod #39429 adds a capacitor and a toroid to the +5 volt output board. For the 4054 the board level changes from a 670-5622-00 to a 670-5622-01. The board for the 4052 is 672-0833-00. Procedure: (refer to figure 1)

1. Add a 2 μ f CAP C134 P/N 283-0212-00 from the junction of C132, R133, R131 to ground (pin 8 U121)
2. Unsolder the grey cable with the small red and black leads. The red lead attaches to the right side of R134, the black lead attaches to the eyelet under U41. It is important that this be unsoldered at the board, DO NOT UNSOLDER it at the resistor on the back panel.
3. Put the toroid T1003 P/N 276-0640-00 on the gray cable then put an "O" ring 354-0538-00 on the cable to keep the toroid away from the circuit card.
4. Resolder the red and black leads to the circuit card. Red lead to the right side of R134 and the black lead to the eyelet hole under U41.
