4054/618 DEFLECTION AMP BOARD (672-0783-02) MODIFICATION #M39710 & #M38624

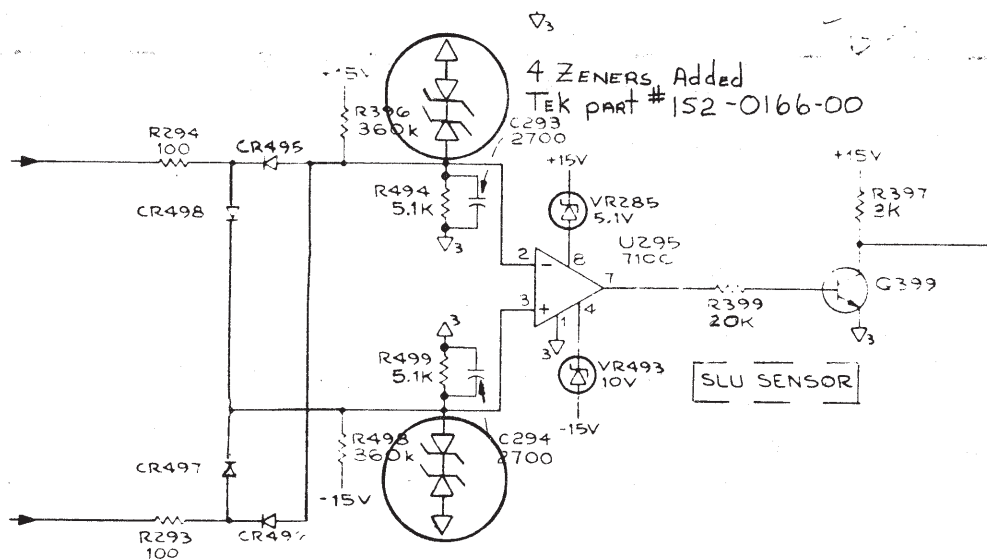
Some 4054s demonstrate graphics break-up while operating in the refresh mode. There was a correction to the Deflection Amp of the 4054 only to solve the refresh graphics break-up (672-0782-02 level board & below). The modification number is #M39710 and the board level changed from -02 to -03 and was implemented in 4054s between serial numbers B010354 to approximately B010600 (refer to figure 1). The -03 level board is not compatible with the 618, and further evaluation of #M39710 proved that it did not correct all 4054s, therefore the implementation of this modification was dropped.

Figure 1 #M39710; Schematic 9-2 4054 Service Manual (070-2839-00)
Deflection Amp; SLU Sensor Circuitry

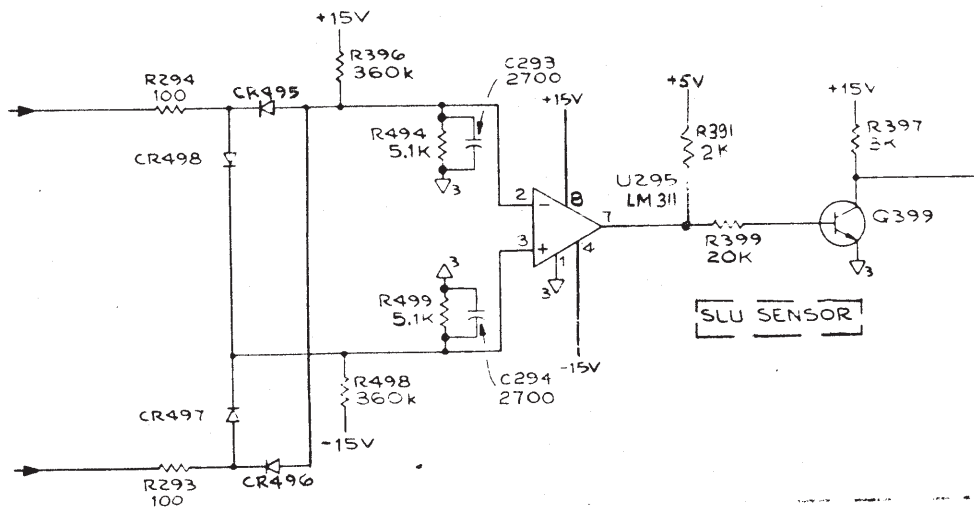
Figure 2 #M38624; Schematic 9-2 4054 Service Manual
Deflection Amp; SLU Sensor Circuitry

Modification #M39710 has been superseded and replaced by modification #M38624. Change #M38624 addresses both the -02 and -03 level Deflection Amp for both the 618 and 4054. This change is being implemented in both the 618 and the 4054 Deflection Amp and rolls both the -02 and -03 level boards to a -04 level board. There is a kit available which includes the instructions for the implementation of #M38624 and the kit number is 040-0977-00. In addition to correcting the refresh graphics break-up this new modification solves the insufficient resolution of the hard copy gain trim due to extreme range of the variable resistors. (Figure 2)
