Technical Service Bulletin

| Subject: NOISE FROM FRONT DOOR PANEL WHEN PLAYING AUDIO SYSTEM | Bulletin No.: 09-012/17 |
| | Last Issued: 04/13/2017 |

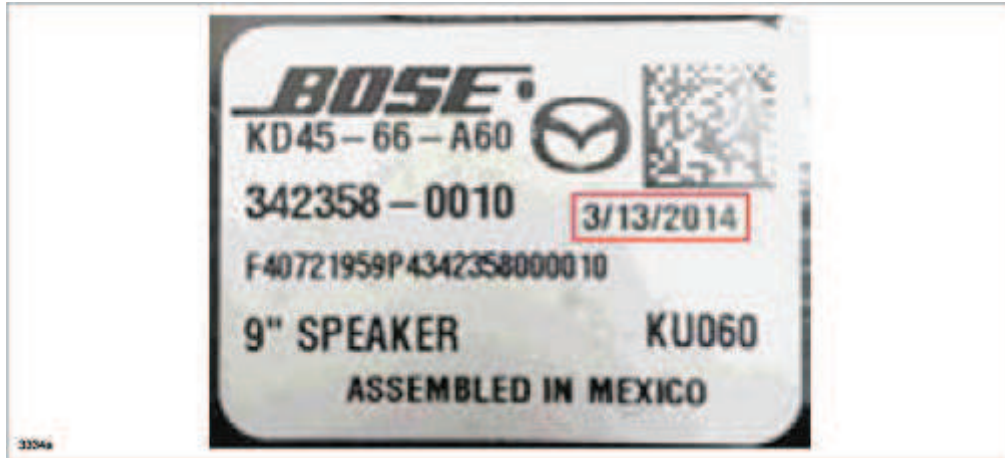
Verify the modified part according to the production date shown on the label.

Example: 3/13/2014 = MM/DD/YYYY

DO NOT replace the speaker if the date is 11/13/2015 or later.
