INSPECTION REPORT				Page 1 of 6
EVO Job No: 68931-5	Report No: IR-02	Date of Report: 01 May, 2020	Customer : BHP Olympic Dam

P. O. Status:	<input checked="" type="checkbox"/> Complete <input type="checkbox"/> Incomplete
				Project Name:	
				<b>OD Equipment Inspection A</b>	
Primary Contact:	Cornelius Castle			Materials/Items Inspected:	
Phone:		E-mail :	Rossi Gearbox (Drawing J1589-01-00)		
Sub-supplier:	NA				
Sub-Supplier Job No:	NA				
Location:	NA				
Primary Contact:	NA			Pre-Inspection Meeting Summary Attached:	<input type="checkbox"/> Yes <input checked="" type="checkbox"/> No
Phone:	NA	E-mail :	NA	Summary Report Attached:	<input type="checkbox"/> Yes <input checked="" type="checkbox"/> No
<b>INSPECTION DISPOSITION:</b> <input type="checkbox"/> Accept <input checked="" type="checkbox"/> Nonconformance(s) Identified <input type="checkbox"/> Placed on Hold <input type="checkbox"/> Other (Explain)					
<b>INSPECTION SUMMARY AND CONCLUSION:</b>					
<p><u>Inspection summary:</u></p> <p>The Inspector has carried out inspection on 01 May 2020 according to 4508631918 as below:</p> <p>Visual inspection to ensure not has damage on painted surface and base material.</p> <ul style=

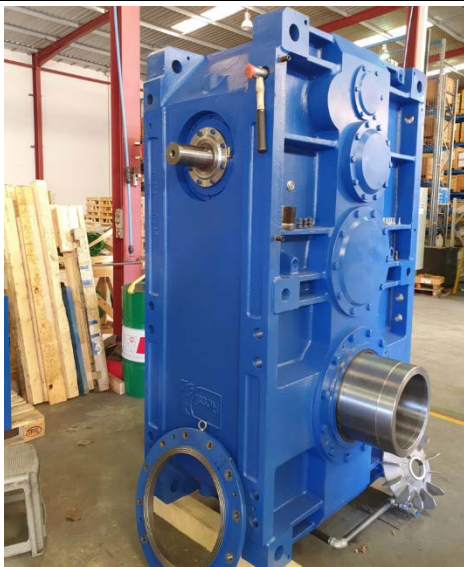
Exposed Gearbox once unwrapped

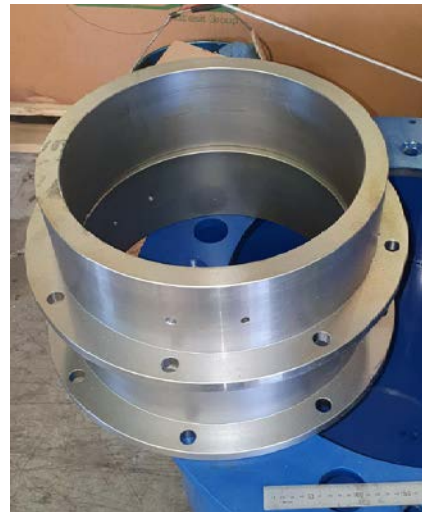
Exposed Flange assembly once unwrapped

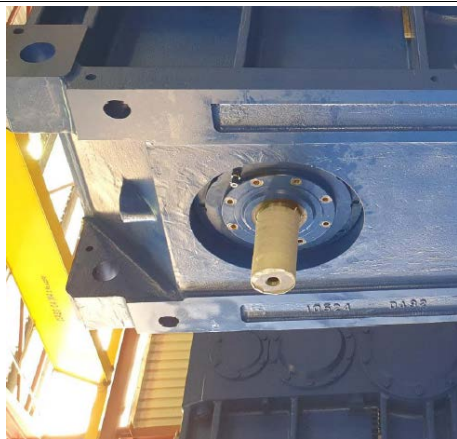
Exposed with corrosion protection applied

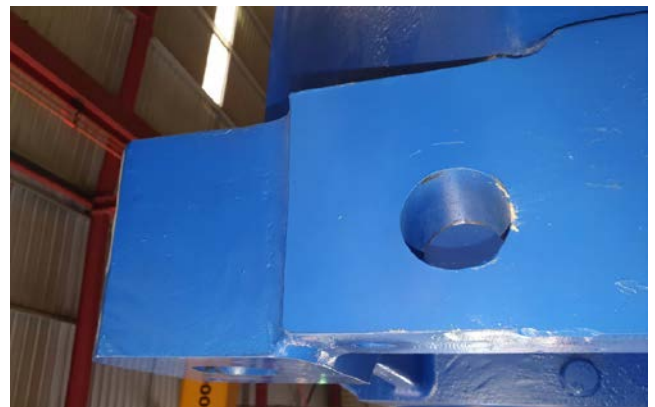
Gearbox M60 bolt hole once unwrapped

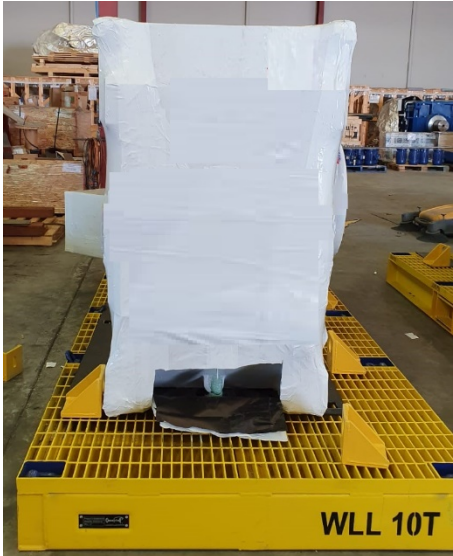
<p>Gearbox while still wrapped</p>

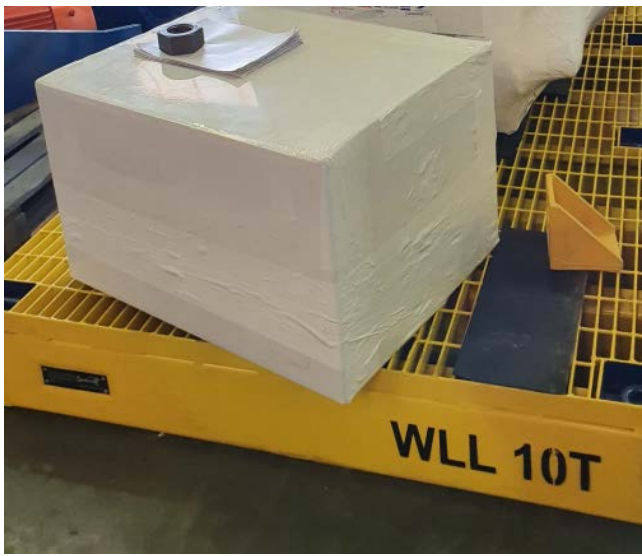
<p>Additional Flanges prior to unwrapping</p>

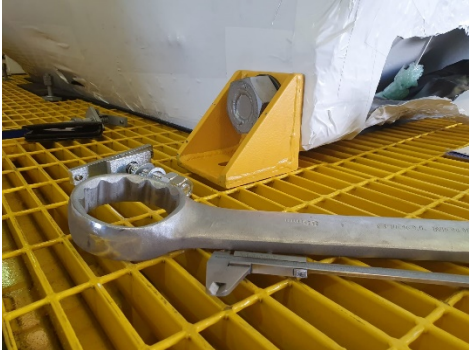
<p>M56 Bolts in place prior to de-assembly</p>

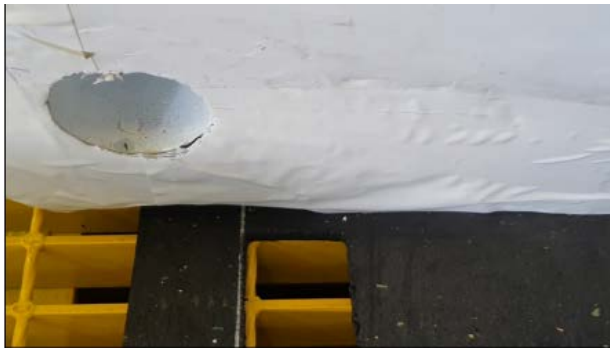
<p>M60 hole after M56 bolts removal</p>

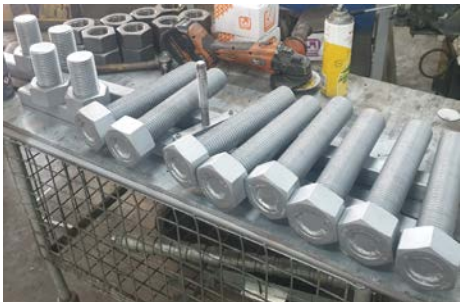
INSPECTION REPORT				Page	4 of 6
EVO Job No: 68931-5	Report No: IR-02	Date of Report: 01 May, 2020	Customer : BHP Olympic Dam		
04	M56 loose and matting requiring replacement	01/05/20	Pending

<p>M56 Bolts during inspection</p>

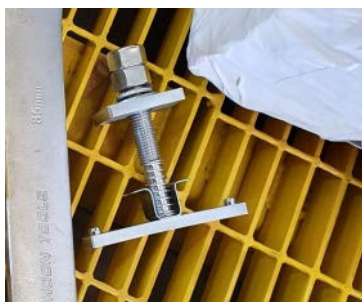
<p>M20 Bolts during inspection</p>

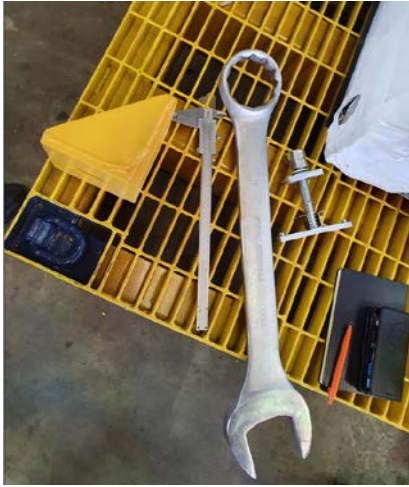
M20 bolt after removal

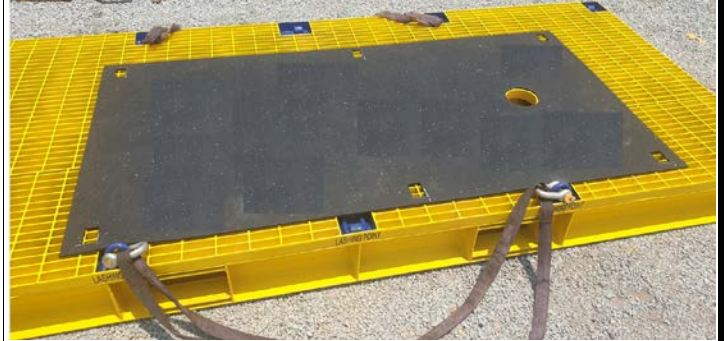
Pallet after Gearbox removal
