INSPECTION REPORT				Page 1 of 6
EVO Job No: 68931-5	Report No: IR-02	Date of Report: 01 May, 2020	Customer : BHP Olympic Dam

P. O. Status:	<input checked="" type="checkbox"/> Complete <input type="checkbox"/> Incomplete
				Project Name:	
				OD Equipment Inspection A	
Primary Contact:	Cornelius Castle			Materials/Items Inspected:	
Phone:		E-mail :	Rossi Gearbox (Drawing J1589-01-00)		
Sub-supplier:	NA				
Sub-Supplier Job No:	NA				
Location:	NA				
Primary Contact:	NA			Pre-Inspection Meeting Summary Attached:	<input type="checkbox"/> Yes <input checked="" type="checkbox"/> No
Phone:	NA	E-mail :	NA	Summary Report Attached:	<input type="checkbox"/> Yes <input checked="" type="checkbox"/> No
INSPECTION DISPOSITION: <input type="checkbox"/> Accept <input checked="" type="checkbox"/> Nonconformance(s) Identified <input type="checkbox"/> Placed on Hold <input type="checkbox"/> Other (Explain)					
INSPECTION SUMMARY AND CONCLUSION:					
<p><u>Inspection summary:</u></p> <p>The Inspector has carried out inspection on 01 May 2020 according to 4508631918 as below:</p> <p>Visual inspection to ensure not has damage on painted surface and base material.</p> <ul style="list-style-type: non

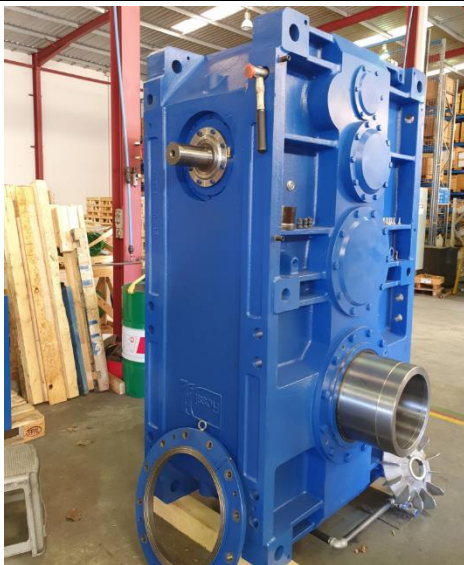
Exposed Gearbox once unwrapped

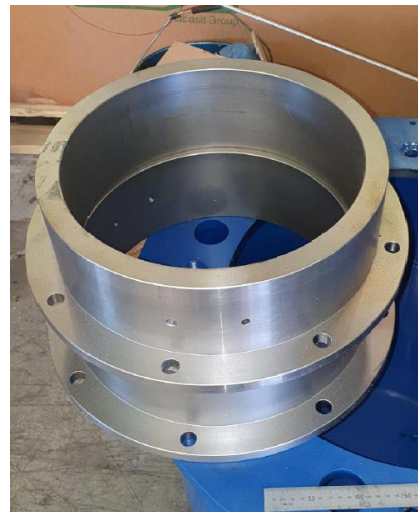
INSPECTION REPORT				Page	4 of 6
EVO Job No: 68931-5	Report No: IR-02	Date of Report: 01 May, 2020	Customer : BHP Olympic Dam		
02	Pitting evident on fan	01/05/20	Pending		
03	Mild damage to machined flange attachments	01/05/20	Pending		
04	M56 loose and matting requiring replacement	01/05/20	Pending

Exposed Flange assembly once unwrapped

RECOMMENDED ACTION:					
- Advise vendors to re-machine critical metal surfaces on relevant equipment flagged in PDT.					
INSPECTION TIME :		<input checked="" type="checkbox"/> DAYS <input type="checkbox"/> HOURS	01	TRAVEL HOURS :	08
				DISTANCE: <input type="checkbox"/> MI <input checked="" type="checkbox"/> KM	460
Technical Specialist:	Dean Terry	Date:	05 May, 2020	Project Coordinator :	Martin Smith
<i>This report is made solely on the basis of the Client's instructions and/or information and materials supplied. It is not intended to be a recommendation for any particular course of action. Omni-tuff does not accept a duty of care or any other responsibility to any person other than the Client in respect of this report and only accepts liability to the Client insofar as is expressly contained in the terms and conditions governing Omni-tuff's provision of services. Omni-tuff makes no warranties or representations either express or implied with respect to this report save as provided for in those terms and conditions.</i>

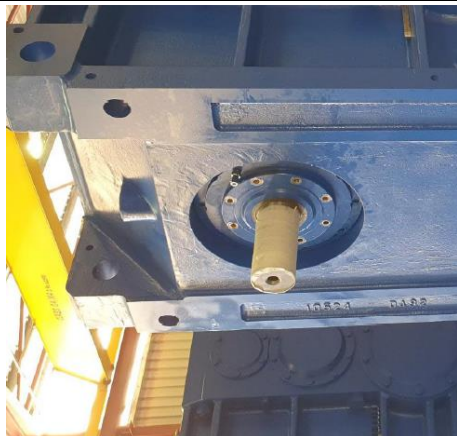
Exposed with corrosion protection applied

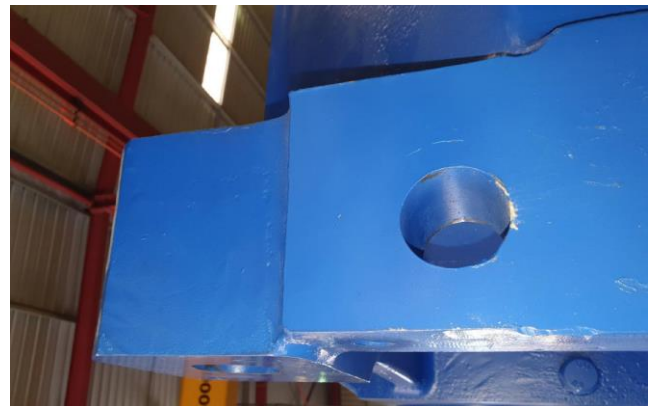
Gearbox M60 bolt hole once unwrapped

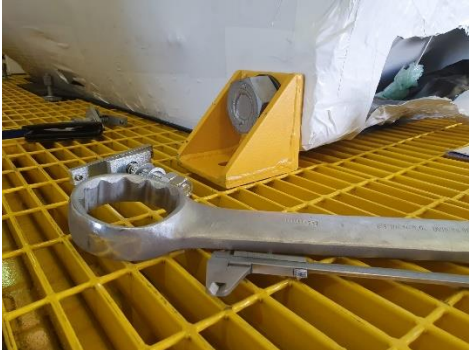
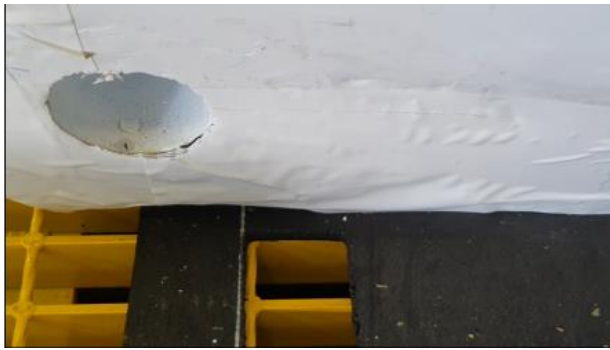
M56 Bolts in place prior to de-assembly		M60 hole after M56 bolts removal

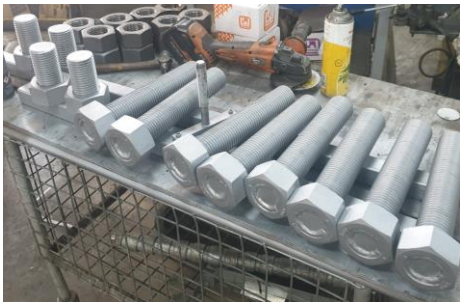
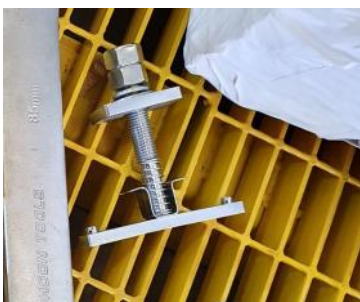
M56 Bolts during inspection		M20 Bolts during inspection

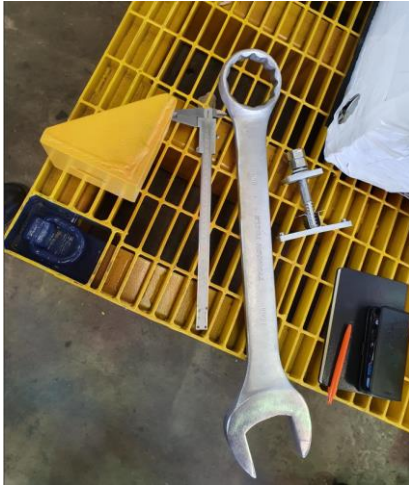
M20 bolt after removal

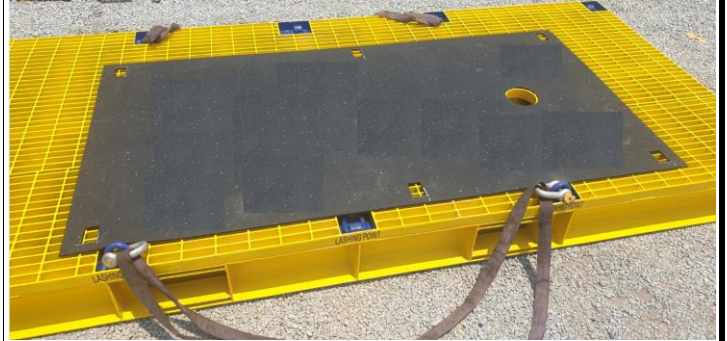
Pallet after Gearbox removal
