Corrective Action Form

Customer Name:	SSB ENGINEERS PVT LTD	Supplier Name:	Arora Iron & Steel Rolling Mills Pvt Ltd.
Complaint:	SURFACE DEFECT	Complaint Date	10-02-2025
TDC no.	DANA Spec. Q.F. 1001 - R3, Dated-14.06.24	Submission Date:	17-02-2025
Heat NO.	A33266	Contact Name	Mr. B. D. Chawla (HOD-QA) Prateek Sharma(Marketing)
Grade	40CrMo4	Phone:	Mr. B. D. Chawla - 9914503980 Mr. Prateek Sharma - 9899948804
Size	80 mm dia	E-mail:	bdchawla@arorairon.com prateeksharma@arorairon.com

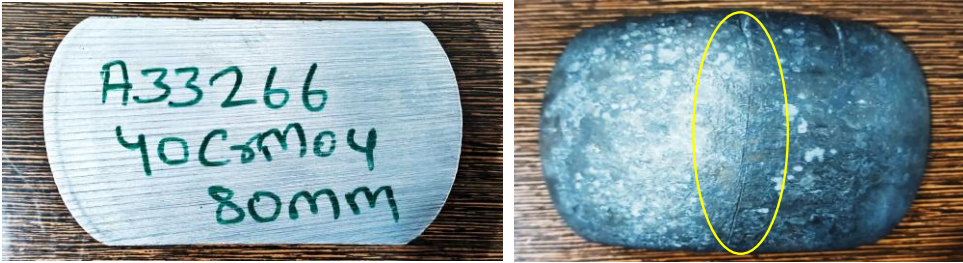
- 1) AISRM has supplied as rolled material to M/S-SSB ENGINEERS. Heat No.-A33266, Size- 80 mm Ø, Grade- 40CrMo4, Quantity- 33.760 MT.
- 2) Customer has observed surface defect in forged sample.

- 1) 01 defective sample received through courier on dated 15.02.2025 for metallurgical analysis as shown below in photograph.

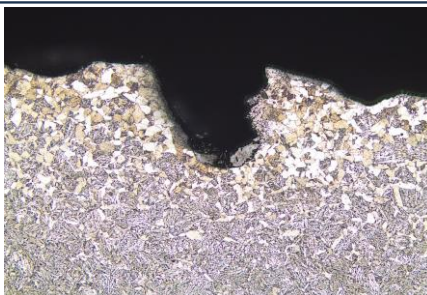
MICROSCOPIC ANALYSIS

1. Micro structure :- Pearlite + Ferrite + Bainite
2. Decarb :- No decarb observed around the defect location
3. Depth of defect :- 0.35 mm approx(after forging)
4. Nature of defect :- Scratch Line

1. We have conducted our microanalysis and observed that the defect appears to be scratch line with scale, which were generated during the hot rolling process and opened during forging. However, we are taking further action to address this.

Step 5 - D5 Implement Corrective Action			
1) Samples shown to all concerned inspection team for awareness of defect at customer’s end.			
2) Re-inspection will be carried out after grinding of bars to avoid mission of such defect.

3) To avoid rolling scratch line, we are working on modification of rolling table/conveyor of rolling mill.			
Start Date:	Target Completion Date:	Actual Completion Date:	Responsible Person:
15-Feb-25	22-Feb-25	16-Feb-25	Mr. B. D. Chawla
Step 6 - D6 Verify Corrective Action / Long Term Corrective Action
