APU SERIAL NUMBER: P-2273

VIDEO BORESCOPE REPORT

MSN:	33370
AIRCRAFT TYPE:	B777-212ER
APU TYPE:	331-500[B]
POSITION:	APU
LOCATION OF INSPECTION:	SIN
DATE OF INSPECTION:	15 Feb 2020
REASON FOR INSPECTION:	Customer Request
WORK ORDER NUMBER:	5022/2020BCC

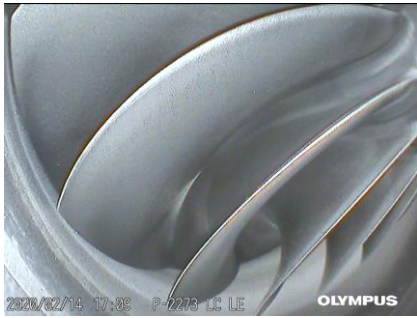
STAGE	FINDINGS
Load Compressor <i>No. of Blades; 11</i>	Nil Significant Damage Found. SERVICEABLE
First Stage Compressor <i>No. of Blades; 17</i>	Nil Significant Damage Found. SERVICEABLE
Second Stage Compressor <i>No. of Blades; 21</i>	Nil Significant Damage Found. SERVICEABLE
Combustor	Nil Significant Damage Found. SERVICEABLE
First Stage Turbine Nozzle Vanes	Nil Significant Damage Found. SERVICEABLE
First Stage Turbine Blades	Nil Significant Damage Found. SERVICEABLE
