Alert

Description: **980 g rear diff**

ID: 402009

Sample ID: 25286276018

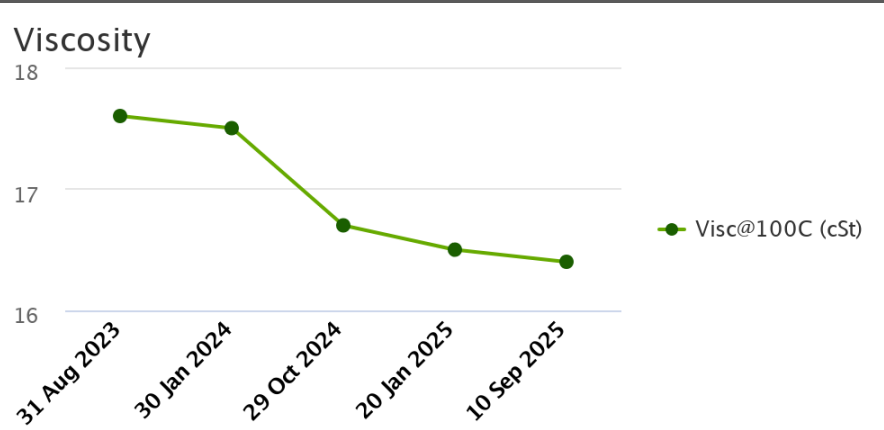
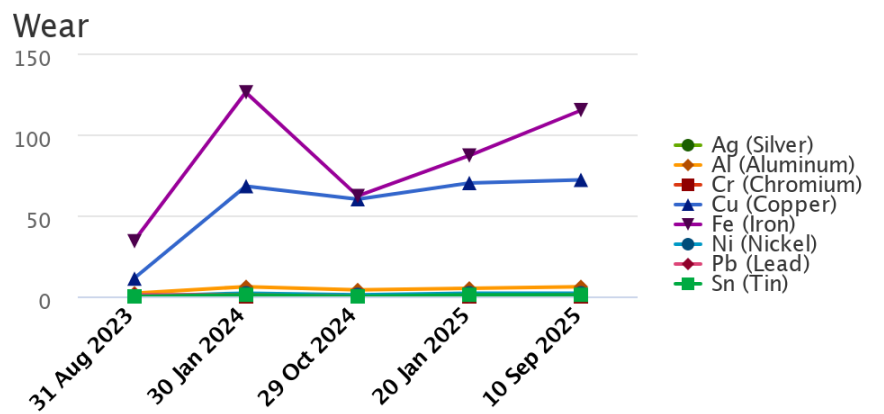
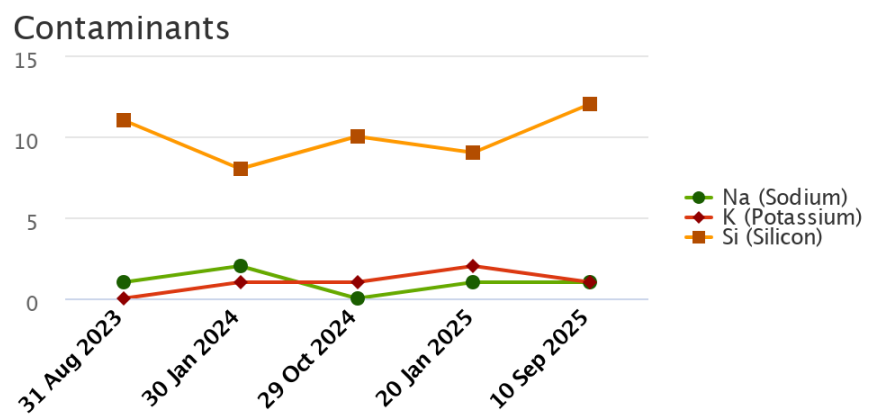
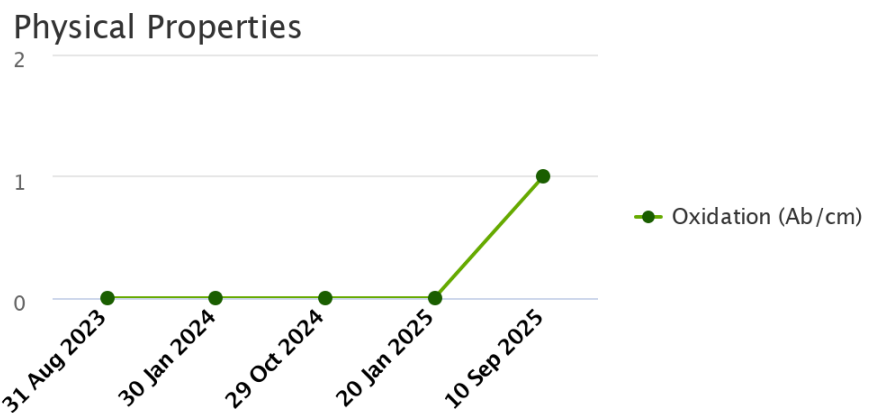
Sample Info	Report Status	Normal	Alert	Alert	Alert	Alert
	Sample ID	23264173004	24039165001	24330195074	25059439045	25286276018
	Service Level	Essential	Essential	Essential	Essential	Essential
	Bottle ID	a029580277	a030122683	a033552516	a033584450	a037068313
	Tested Lubricant	MOBILTRANS HD 50	MOBILTRANS HD 50	MOBILTRANS HD 50	MOBILTRANS HD 50	MOBIL DELVAC MODERN OFF-HIGHWAY TRANS FLUID 50
	Sampled	31 Aug 2023	30 Jan 2024	29 Oct 2024	20 Jan 2025	10 Sep 2025
	Reported	25 Sep 2023	12 Feb 2024	26 Nov 2024	04 Mar 2025	15 Oct 2025
	Equipment Age	54582	57117	58702	59445	61231
	Equipment UOM	Hours	Hours	Hours	Hours	Hours
	Oil Age					
	Make-up Volume					
	Oil Changed	No		No	Yes	Yes
Filter Changed	No		No	Yes	No	
Lubricant	Contamination Rating	Normal	Normal	Normal	Normal	Normal
	Equipment Rating	Normal	Alert	Alert	Alert	Alert
	Lubricant Rating	Normal	Normal	Normal	Normal	Normal
	Visc@100C (cSt)	17.6	17.5	16.7	16.5	16.4

Oxidation (Ab/cm)	0	0	0	0	1
	Water (Vol.%)	NotDetected	NotDetected	NotDetected	NotDetected	NotDetected
Wear (ppm)	Ag (Silver)	0	1	0	0	0
	Al (Aluminum)	2	6	4	5	6
	Cr (Chromium)	0	0	0	0	0
	Cu (Copper)	11	68	60	70	72
	Fe (Iron)	34	126	62	87	115
	Mo (Molybdenum)	1	1	1	1	1
	Ni (Nickel)	0	2	1	2	2
	Pb (Lead)	1	1	0	0	1
Contaminant (ppm)	Sn (Tin)	0	1	0	1	1
	K (Potassium)	0	1	1	2	1
	Na (Sodium)	1	2	0	1	1
Additive (ppm)	Si (Silicon)	11	8	10	9	12
	B (Boron)	2	3	1	3	7
	Ba (Barium)	0	0	0	0	0
	Ca (Calcium)	3261	3213	3357	3192	3200
	Mg (Magnesium)	16	16	14	13	11
	P (Phosphorus)	1079	925	983	910	867
Zn (Zinc)	1073	1025	1026	1035	1015

ACTION REQUIRED - ELEVATED WEAR METALS LEVELS. Determine cause of elevated wear metals levels and take corrective action. If the wear metals levels are elevated for the first time with no history of an increasing trend, then resample immediately to confirm condition. Because silicon levels are not also elevated, abrasive dirt is not the cause of this condition. Possible causes of elevated wear metals include: a. Worn of oil-wetted parts; b. Contamination from previous fill; c. Over-extended oil service life; d. Normal break-in of new equipment. Continue to closely monitor the equipment and oil for signs of further condition regressions. Contact your ExxonMobil representative for further assistance if necessary.
