Sample Data & Trends

Caution	
	Unit ID: 5-BM-2	Asset ID: 50074753
	Description: Kiln 1 Ball Mill Gear Box	
Account Information	Sample Information	Equipment Information
ID: 402009 Name: Greer Lime Address: 1088 Germany Valley Limestone Road, Riverton, WV 26814-0000 US Parent Account: MATTHEWS LUBRICANTS, INC.	Sample ID: 25343187037 Service Level: Essential Bottle ID: a003623323 Tested Lubricant: MOBIL SHC GEAR 220	Asset Class: Gear Drive Manufacturer: FALK (REXNORD) Model: 1090FC2 Lubricant: MOBIL SHC GEAR 220
Continued		
Recommendation/Comments

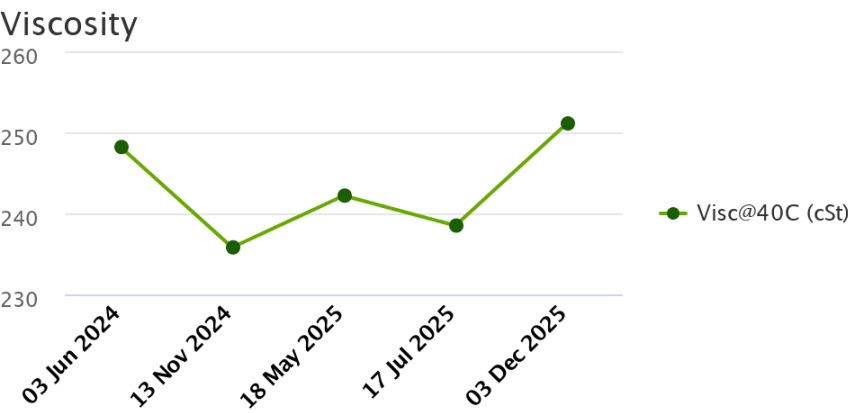
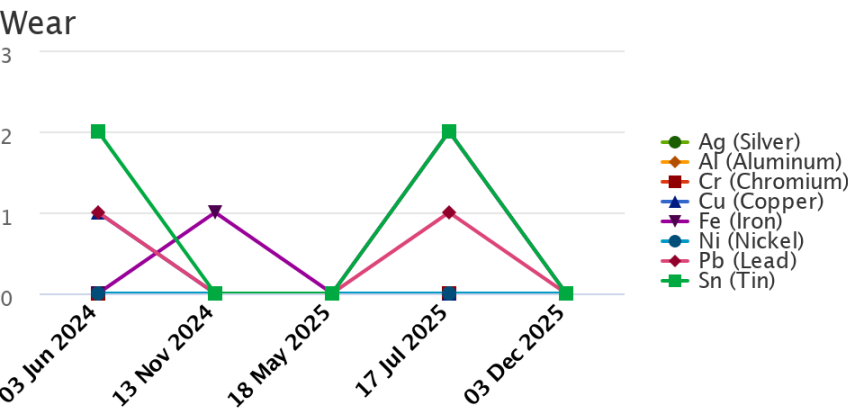
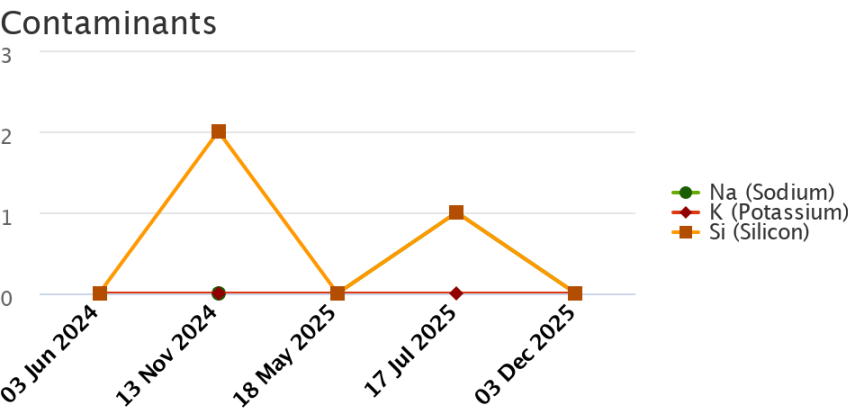
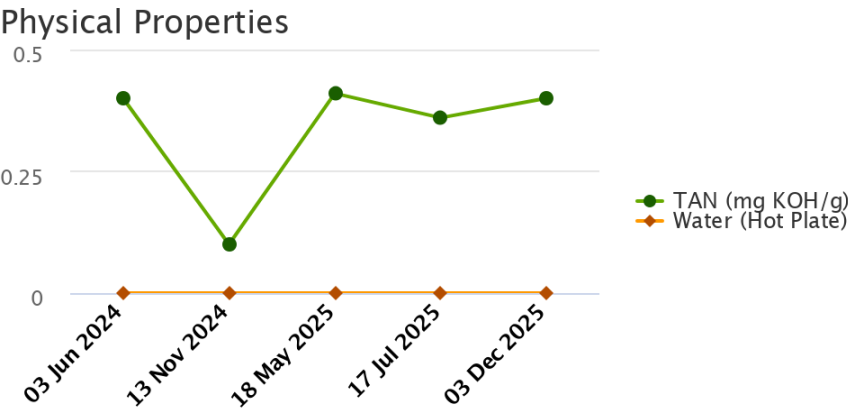
ACTION REQUIRED - ELEVATED OIL VISCOSITY. Determine cause of elevated oil viscosity and take corrective action. Elevated viscosities can interfere with the cooling process of components and restrict oil flow causing oil starvation and component wear. Possible causes of elevated viscosity include: a. Contact with oil that has a higher viscosity; b. High rates of oxidation and oil degradation; c. Excessive sediment; d. Coolant contamination. A partial drain and refill with fresh oil may rejuvenate the oil condition. Change the oil immediately if the condition escalates. Contact your ExxonMobil representative for further assistance if necessary.
