**STRUCTURAL INTEGRITY REPORT PERTAINING TO WALL CRACKS IN A
THREE-BED LINK DETACHED GROUND+FIRST+LOFT ROOF WITH FRONT &
REAR DORMER PROPERTY**

113 WATERSIDE LANE GILLINGHAM ME7 2ST

Reference: **SIR/2024/87/ST**

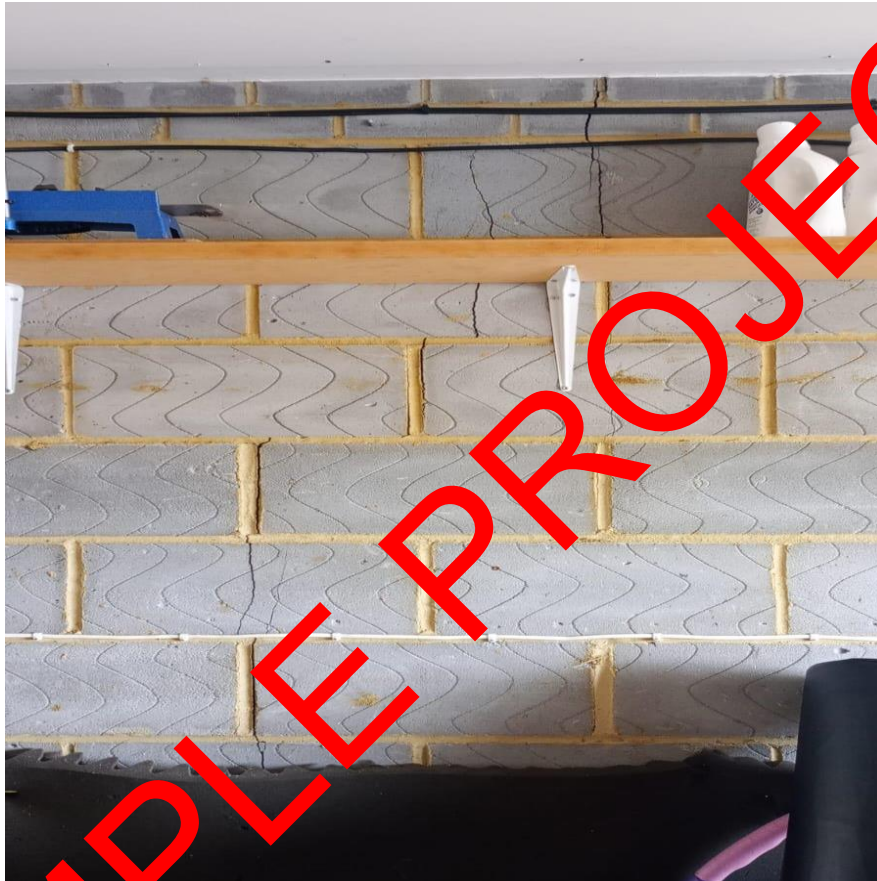
Photograph #1

- 1] Breeze block wall with two layers of bricks on top between the garage and the main house shows structural cracks throughout its height from the Floor finish to the ceiling level inside the garage. The cracks passing the blocks and bricks by cutting through them, please refer to photographs 1,2,3, and 4.

- 2] The cracks appear predominantly in the middle and at the corner junction of the wall. However, the cracks in the middle reflect foundation movement as appeared in photographs 1,2 and 3. whereas the cracks at the junction of the walls are predominantly caused due to shrinkage, please refer to photographs 5 and 6.

"The cracks in the middle of the garage walls are structural cracks cutting through the brick/blocks, such cracks reflect that the foundation below the wall is subjected to movement, any such movement in such location may have been caused due to inadequate foundation or shrinkage/swell in the subsoil, which is usually caused by a water source/tree vegetation, For such conditions there are several foundation/soil strengthening solutions are available such as, underpinning of the existing foundations followed by the repair of the existing cracks, the cracks at the corners which appear more to be shrinkage cracks can be repaired by using a non-shrink structural repair mortar/resin, it is also very much important to provide a flexible joint at the junctions to avoid such cracks from appearing again".

However, as mentioned by the existing owner of the house there has been no change in the cracks and the same cracks have been reported to the developer more than 20 years ago showing that the movement and settlement are not progressing, therefore the cracks are not live cracks. Hence, if considering this the cracks are to be monitored by a specialist crack monitoring vendor, and once it's established that the cracks are not live, repair the cracks without reinforcing the foundation or subsoil until the structural cracks appear to be live and progressing.
