## STRUCTURAL INTEGRITY REPORT

The property inspected: **XXXXXXXXXXXXXXXXXXXXXXXXXXXXXXXXXXXX**

Reference: **SIR/2024/107/ST**

Date of Inspection: **27-06-2024**

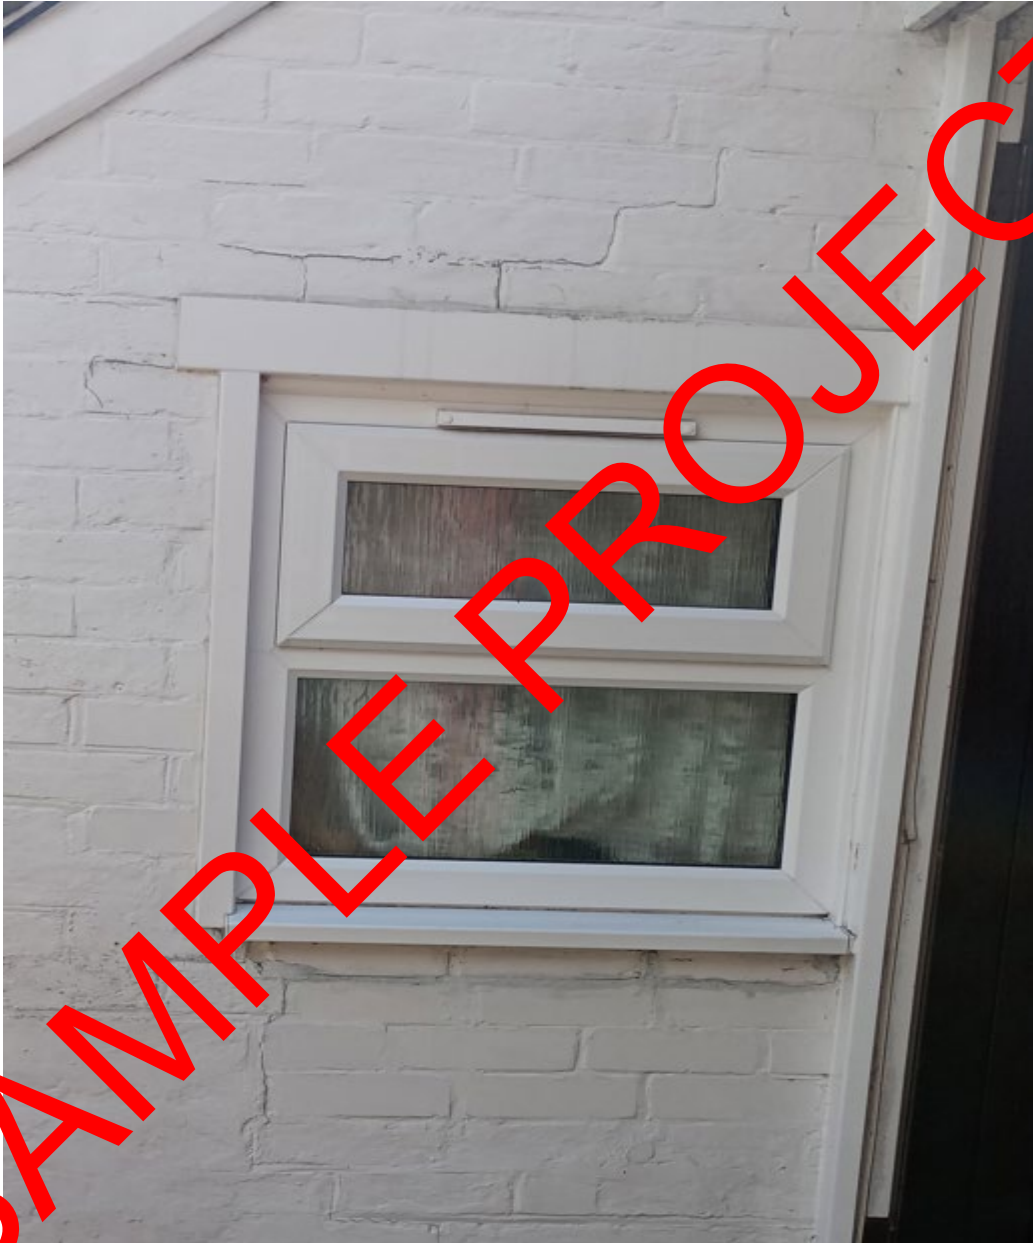
Photograph #1

1. The external walls are showing signs of foundation distress, and the structural cracks and repair works observed show that despite repair works the cracks repaired. Due to the reappearance of the cracks, it can be concluded that the foundations are subjected to settlement/subsidence. Please refer to photographs 1,2 and 3.

"The internal/external structural cracks reflected in the report shows structural damages to the existing load bearing structural walls of the property, such cracks are usually caused by the movement/settlement/subsidence of the foundations. Therefore, it is advised that a Geotechnical specialist to be appointed to further evaluate the existing condition followed by a design related to soil improvement or strengthening of the foundations. All such works need to be carried out by a specialist contractor in a workmanlike manner in accordance with the regulations followed thereof, The wall lintel can then be replaced and reinstated by replacing the lintels and reinforcing the walls with helical rebars.

The leading cause of such movement/settlement is the change in the water saturation of the subsoil which may get adversely affected in case of any source of water such as a leaking drain network/potable water supply or free rainwater discharge due to improper drain or damaged guttering. Therefore, it is advised to conduct a CCTV survey to check the underground drainage network and reinstate any damaged leak if found, similarly, all other sources of water are to be checked for proper functioning.

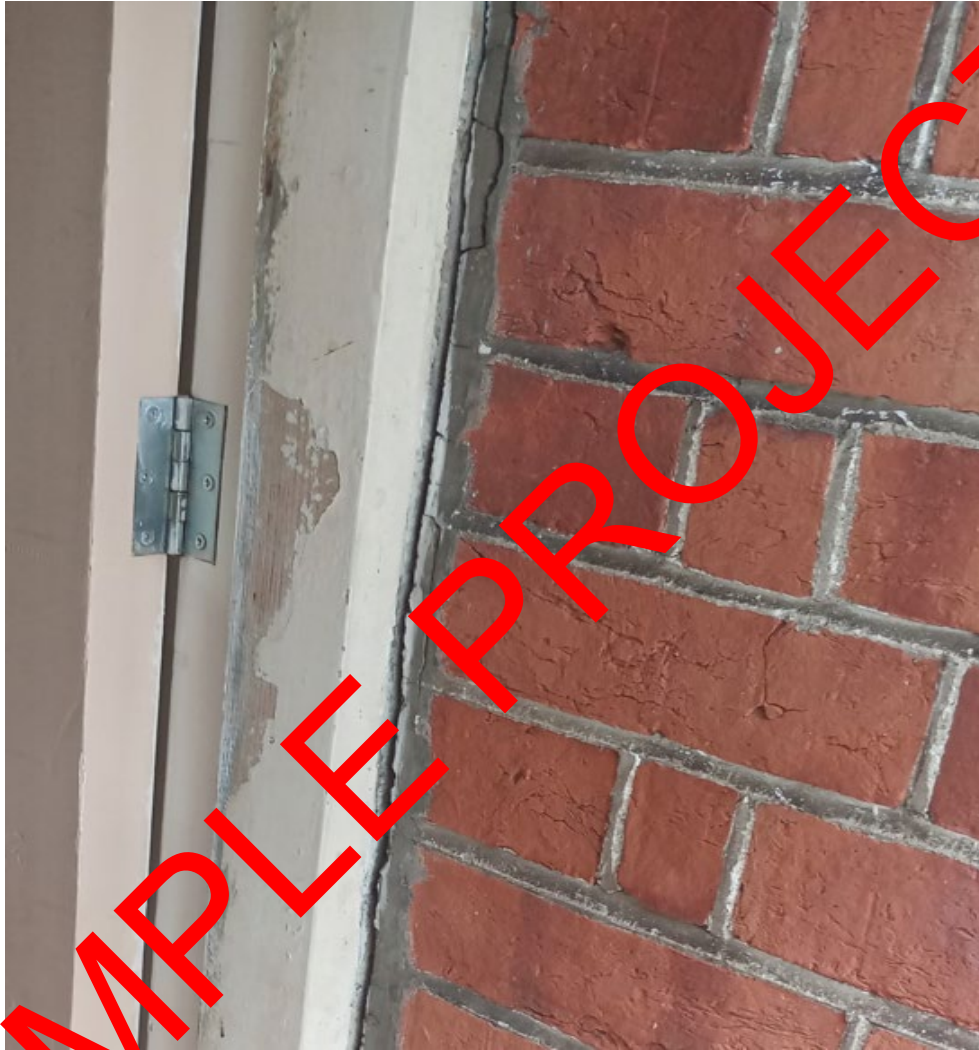
Photograph #4

2. The front porch is also showing the signs of settlement please refer to the photographs 4,5 and 6.
3. Similarly, the external walls' internal skin also reflects such structural cracks. Please refer to photographs 7,8,9,10 and 11.

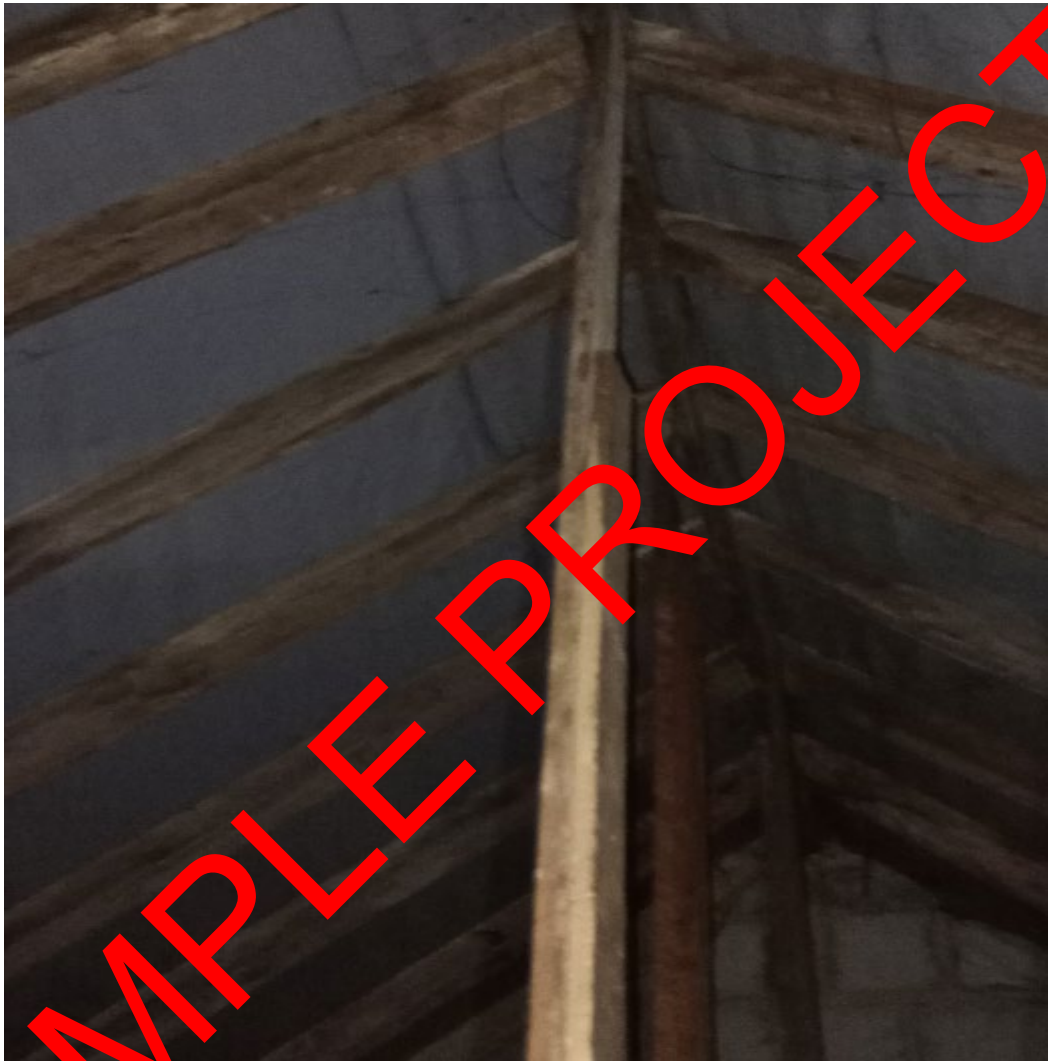
Photograph #12

4. The main building's roof structure shows significant structural damages, where the roof purlins, rafters, and supports are pulling away, similarly, the roof has been supported by temporary supports internally, the rafter shows signs of dampness, and the roof overall property shows the signs of infestation. The main roof structure also has a grey-colour polythene membrane which it's very unlikely to be a breathable membrane and hence will cause the wood to be damp and rot. The roof structure must be reinstated to avoid any collapse. Please refer to photographs 12,13,14,15,16,17 and 18.

The existing roof structure needs to be reinstated on an immediate basis it is advised to change all the rotten joists/supports which has been structurally damaged due to dampness, infestation, or under the loading of the roof to avoid any further damage which may lead to the collapse of the roof structure followed by the treatment of the wood to avoid any further infestation.

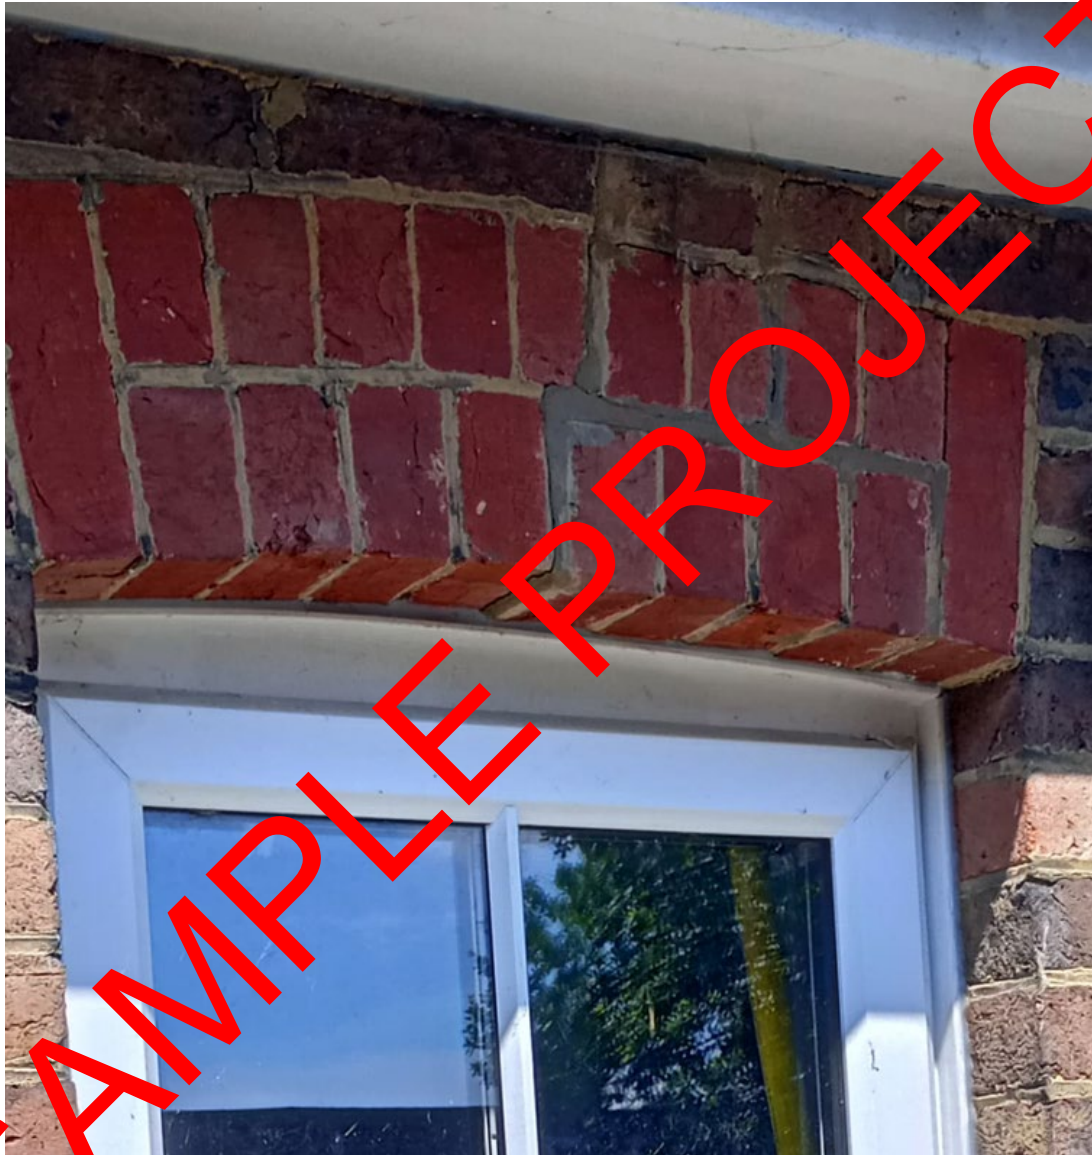
Photograph #19

5. The outbuilding shows significant signs of dampness and structural damage as well the wall mottels show signs of foundation movement, please refer to photographs 19,20,21 and 22.
