Damage Detection Report

Generated on: 2025-05-18 21:21:15

Total Images Processed: 6

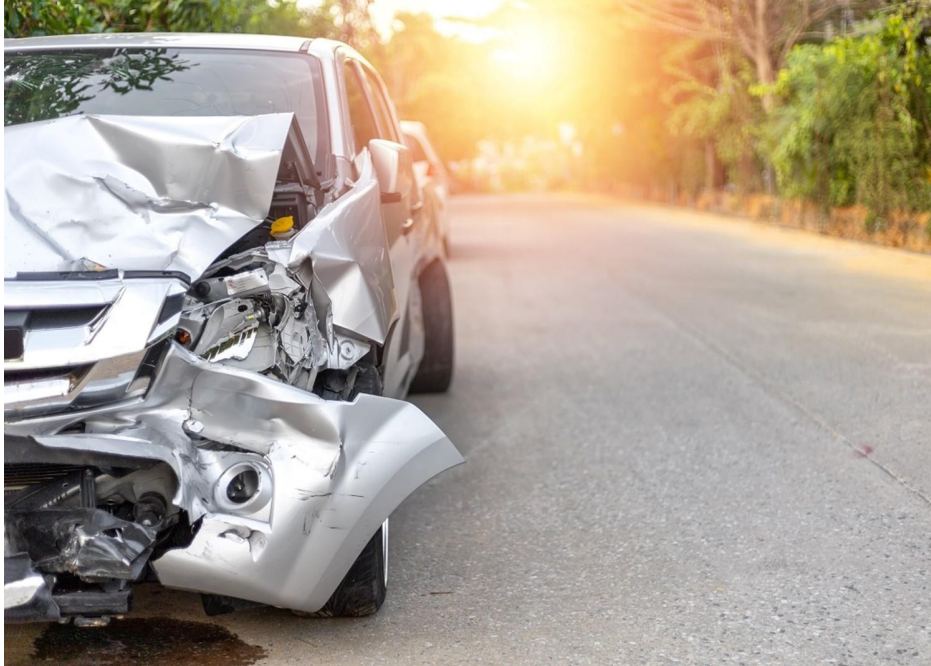
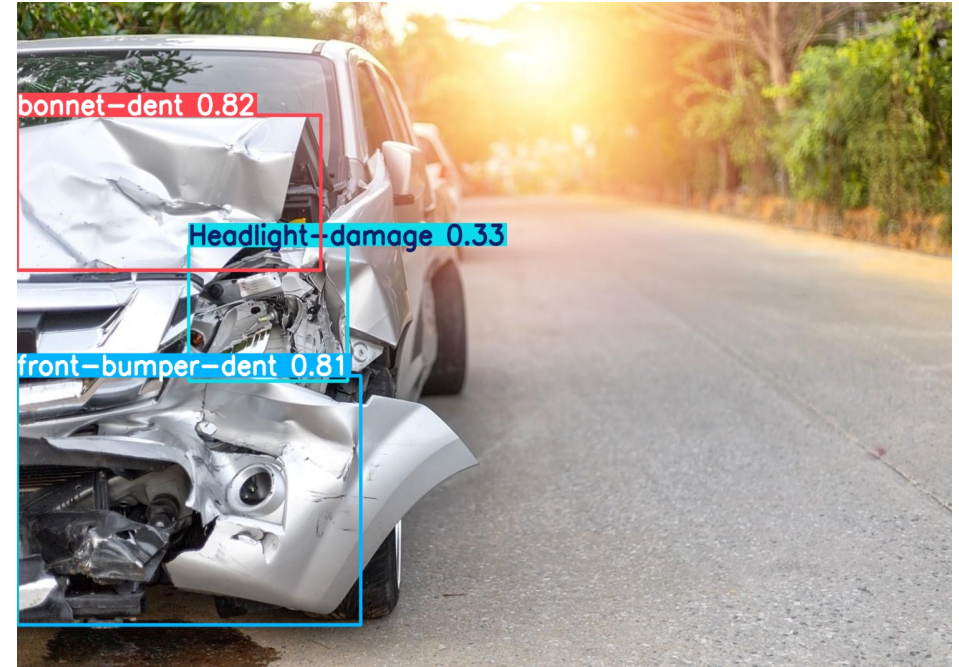
Image 5 of 6

Class	Confidence
bonnet-dent	0.82
front-bumper-dent	0.81
Headlight-damage	0.33
