Damage Detection Report

Generated on: 2025-05-18 21:25:40

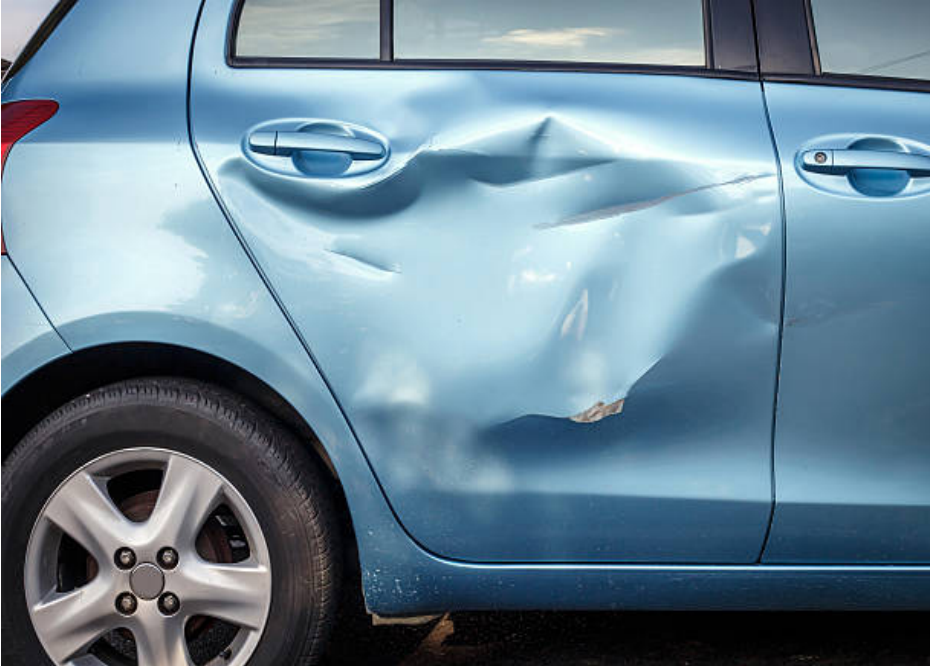
Image 2 of 6

doorrouter-dent

0.91

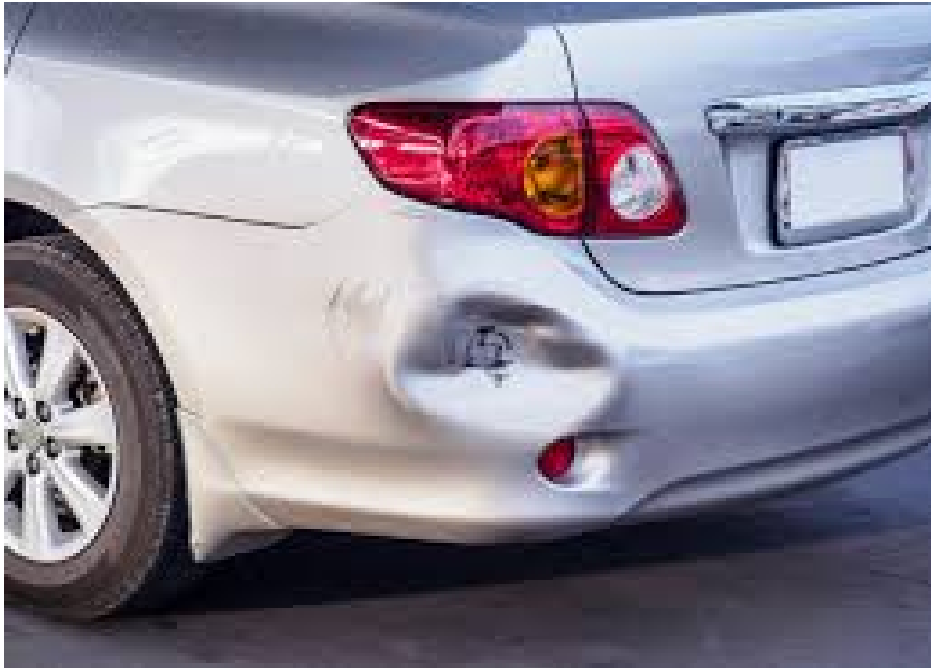
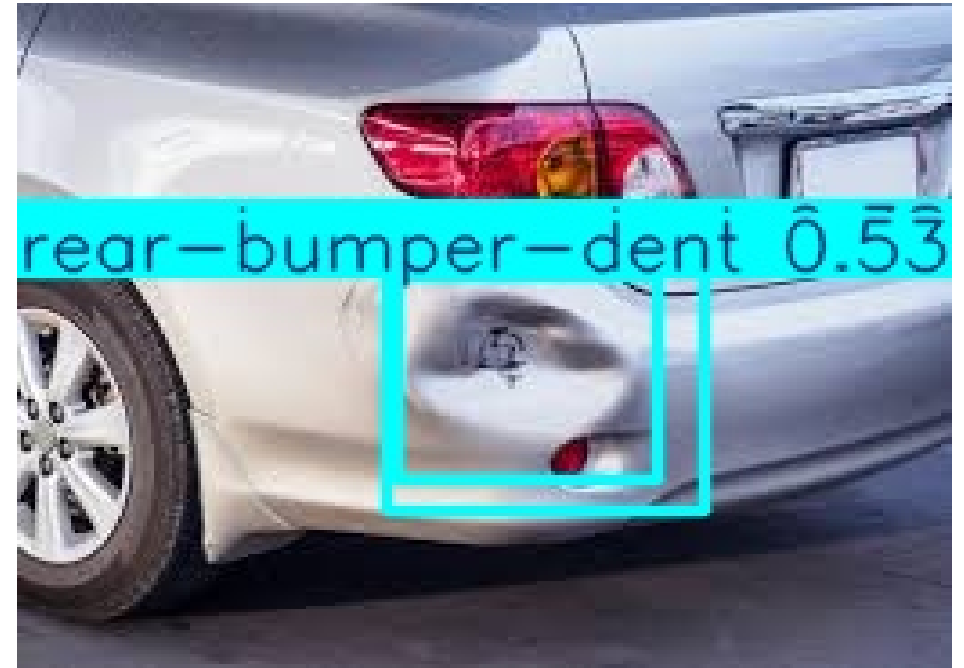
Image 3 of 6

Class	Confidence
rear-bumper-dent	0.53
rear-bumper-dent	0.38
