Damage Detection Report

Generated on: 2025-05-18 21:46:15

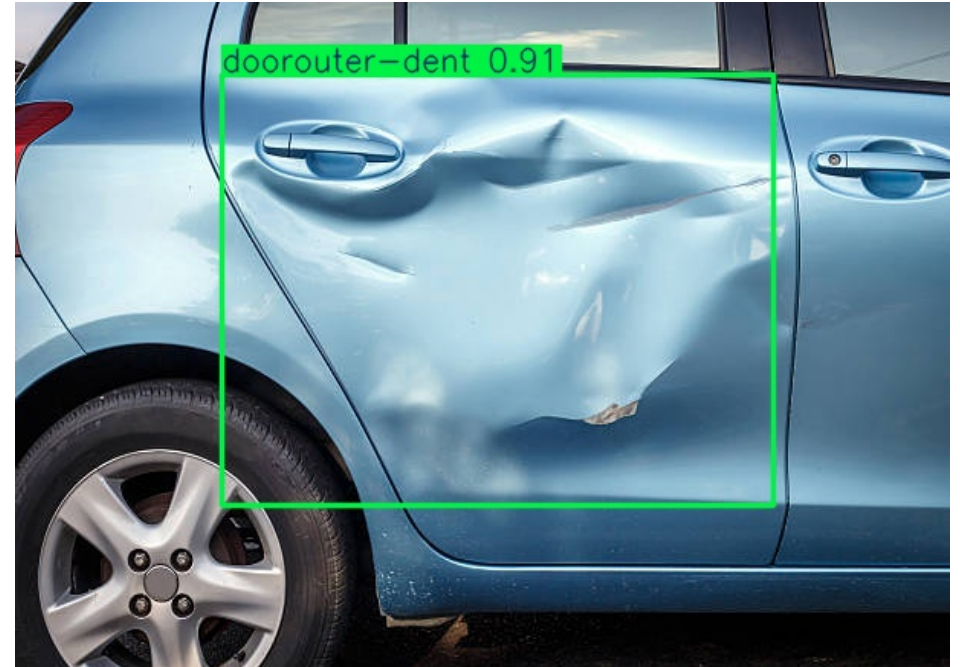
Image 2 of 4

doorrouter-dent

0.91
