# Damage Detection Report

Generated on: 2025-05-18 15:52:06

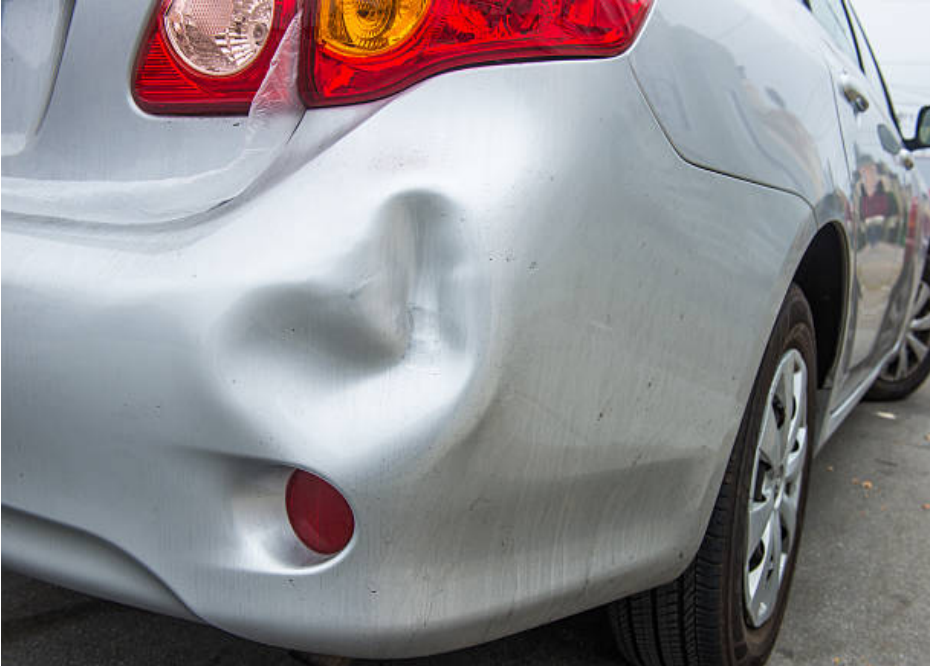
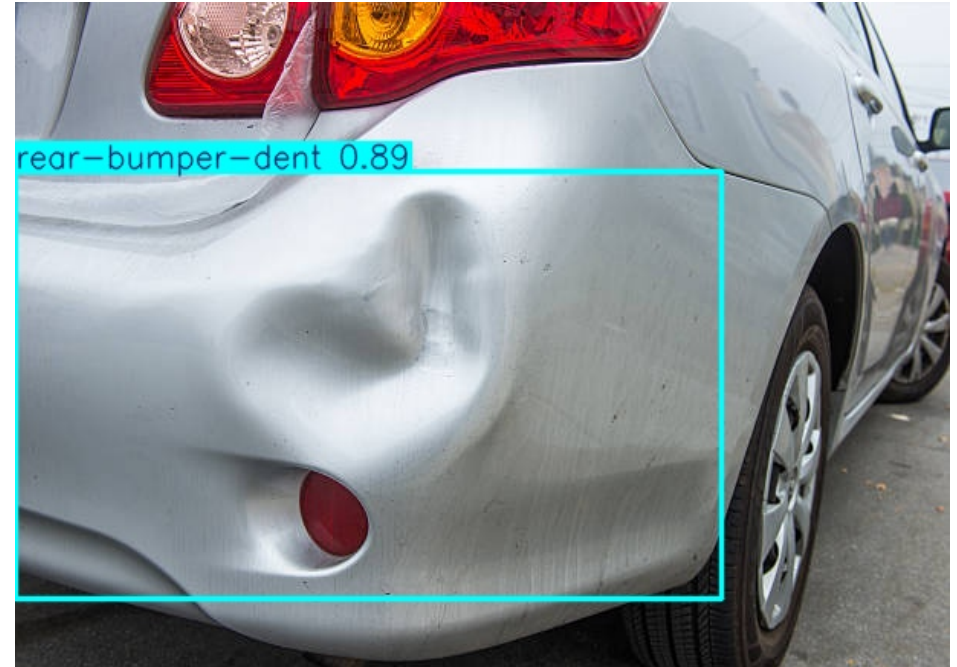
## Image 1 of 10

Class	Confidence
rear-bumper-dent	0.89

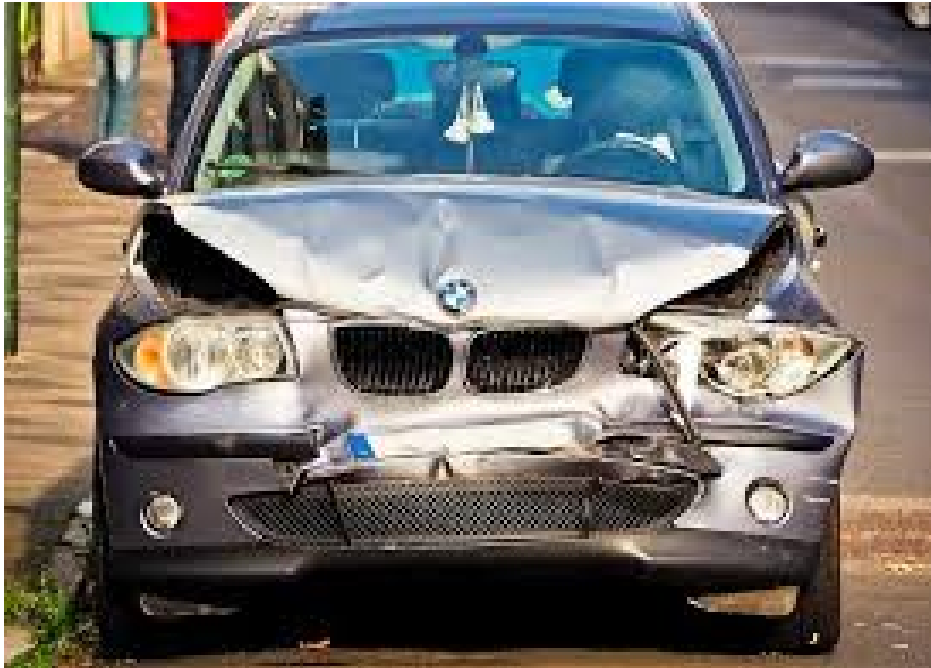
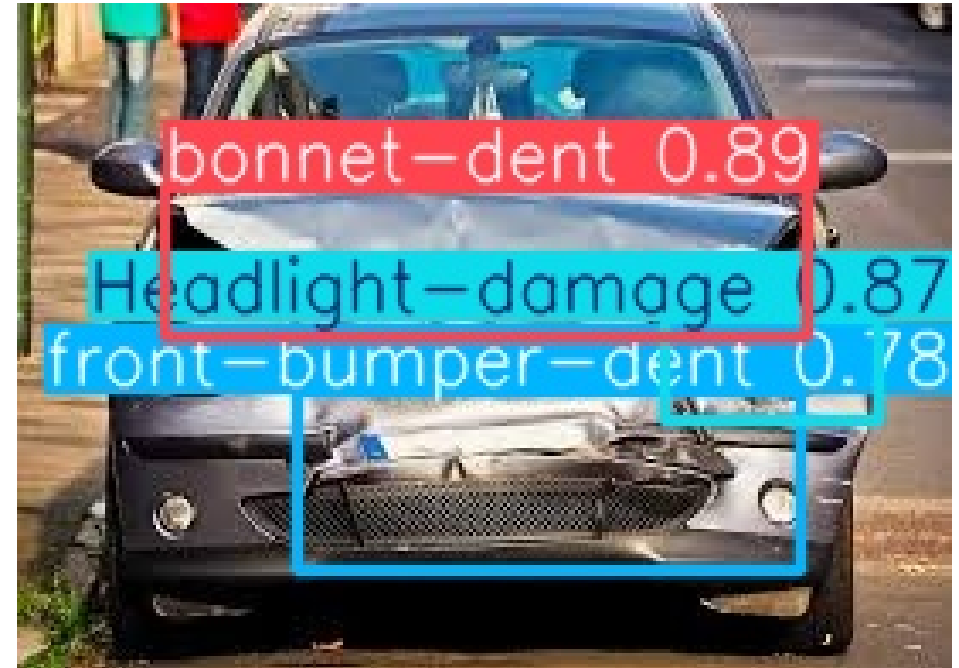
## Image 2 of 10

Class	Confidence
bonnet-dent	0.89
Headlight-damage	0.87
front-bumper-dent	0.78

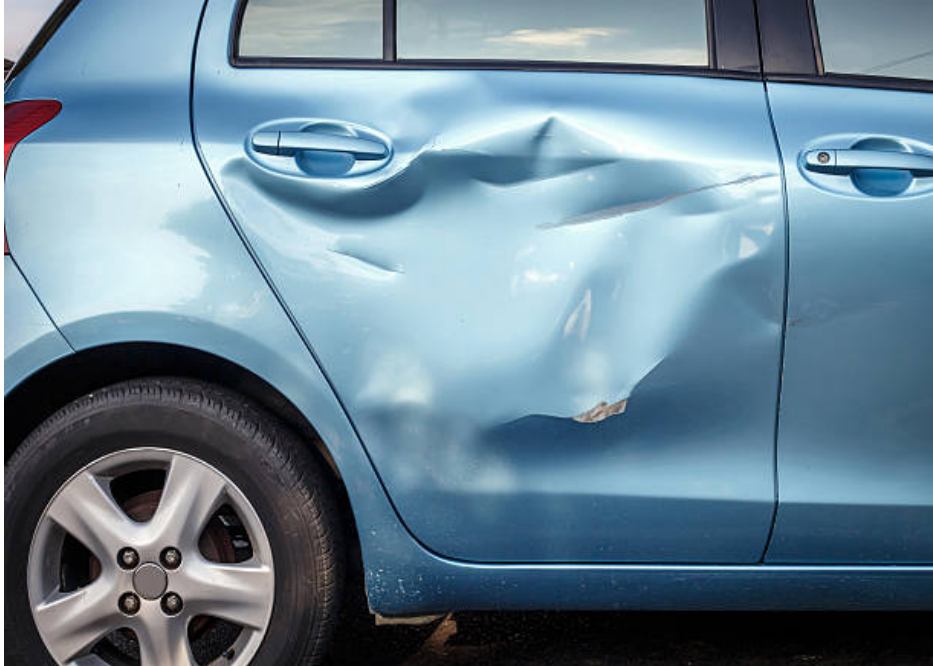
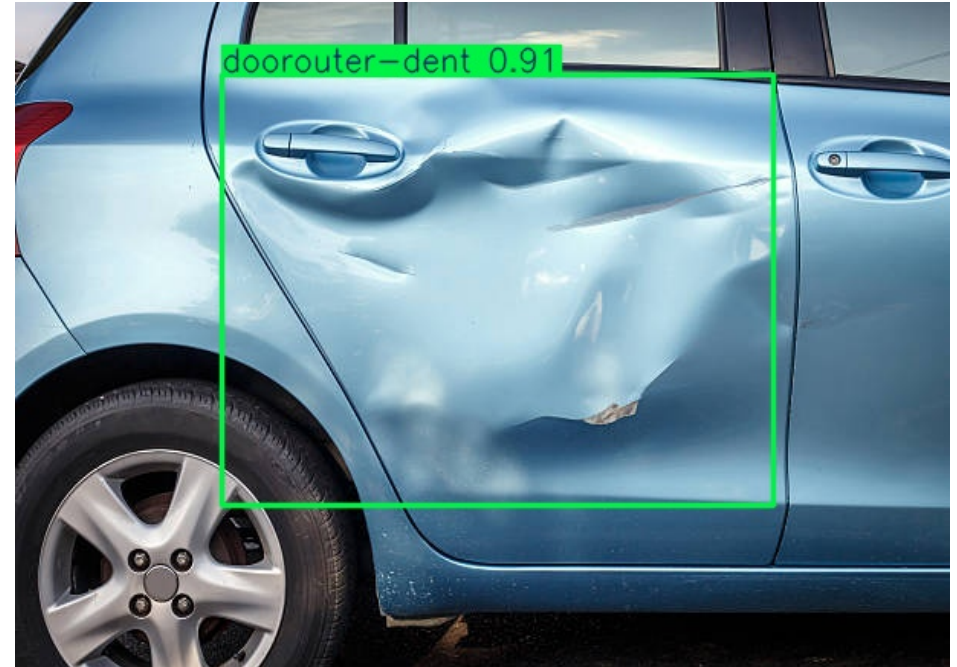
## Image 3 of 10

doorrouter-dent

0.91

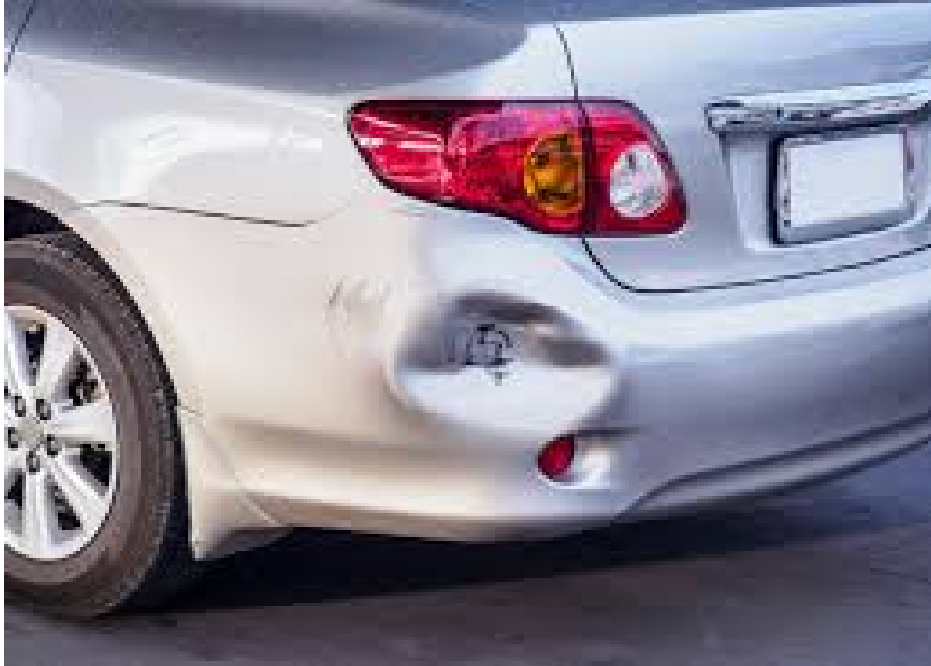
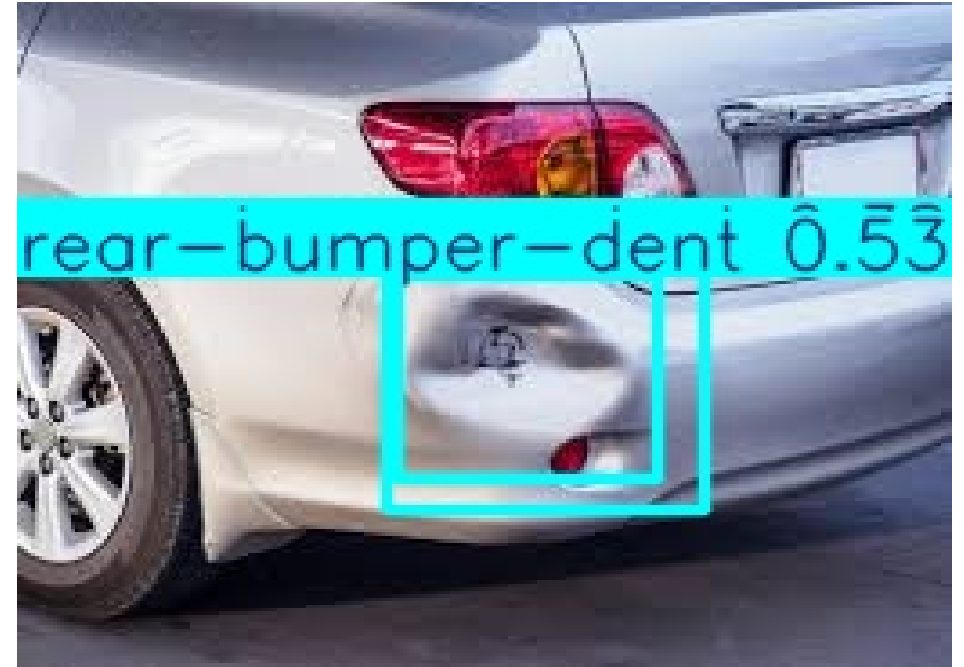
## Image 4 of 10

Class	Confidence
rear-bumper-dent	0.53
rear-bumper-dent	0.38

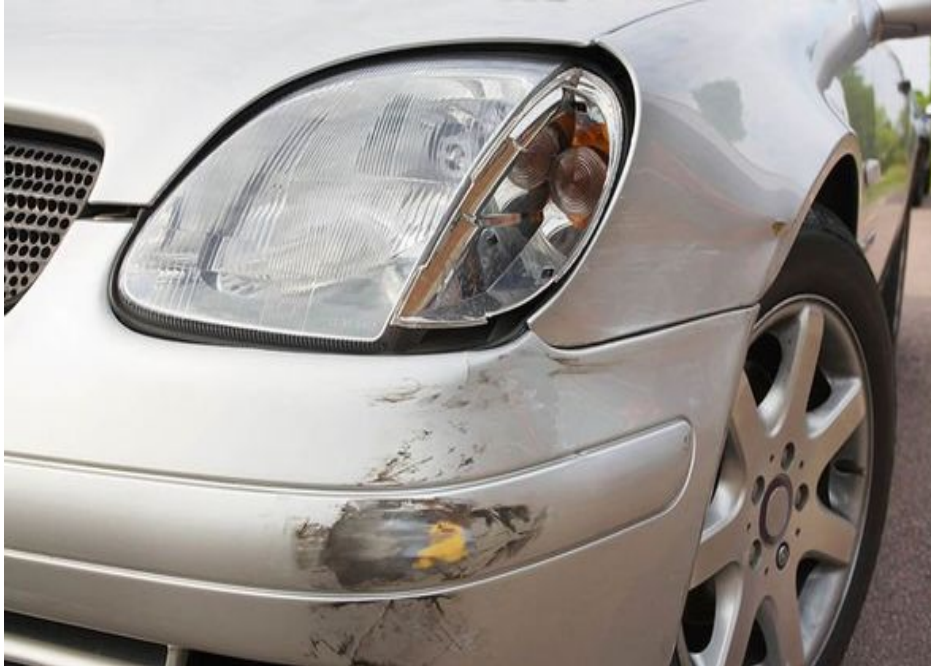
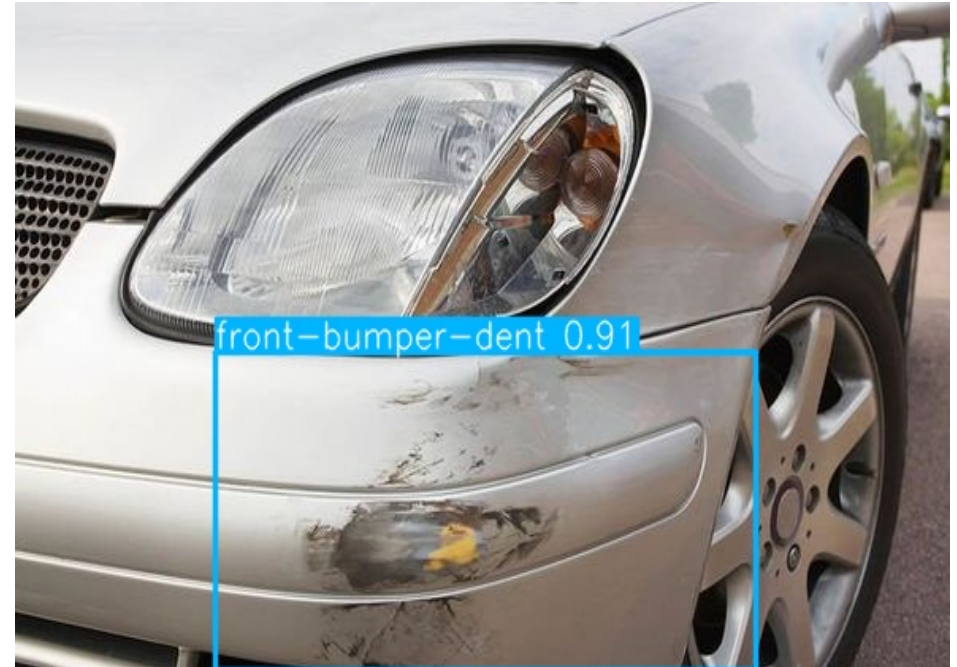
## Image 5 of 10

front-bumper-dent

0.91

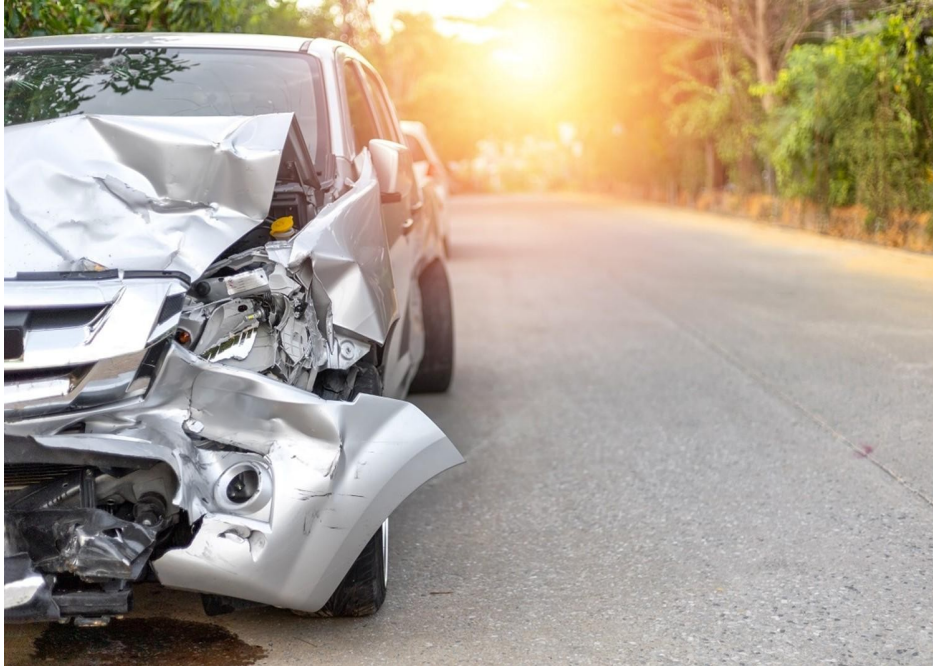
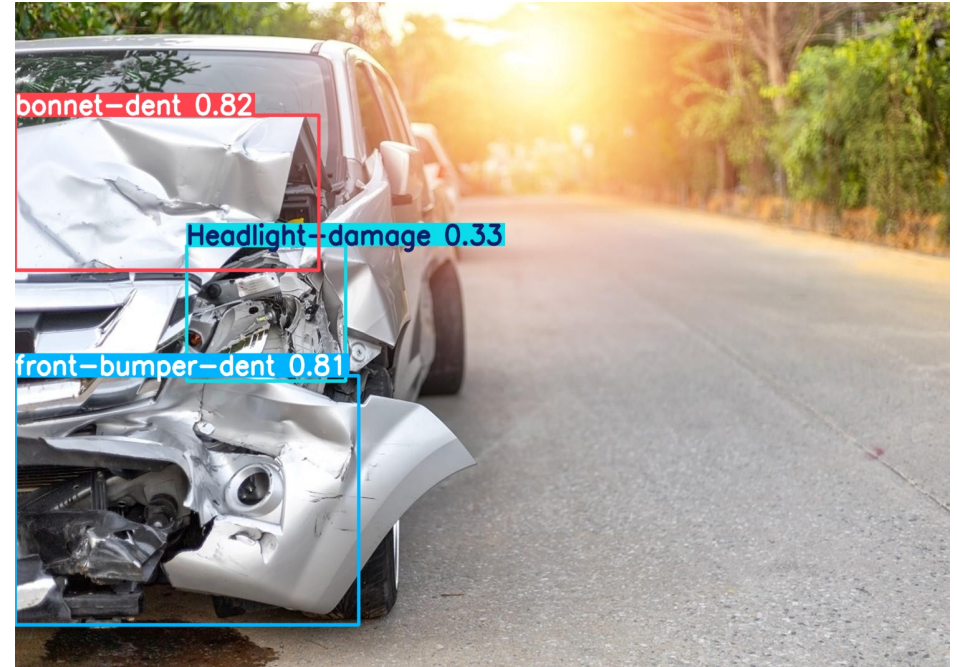
## Image 6 of 10

Class	Confidence
bonnet-dent	0.82
front-bumper-dent	0.81
Headlight-damage	0.33

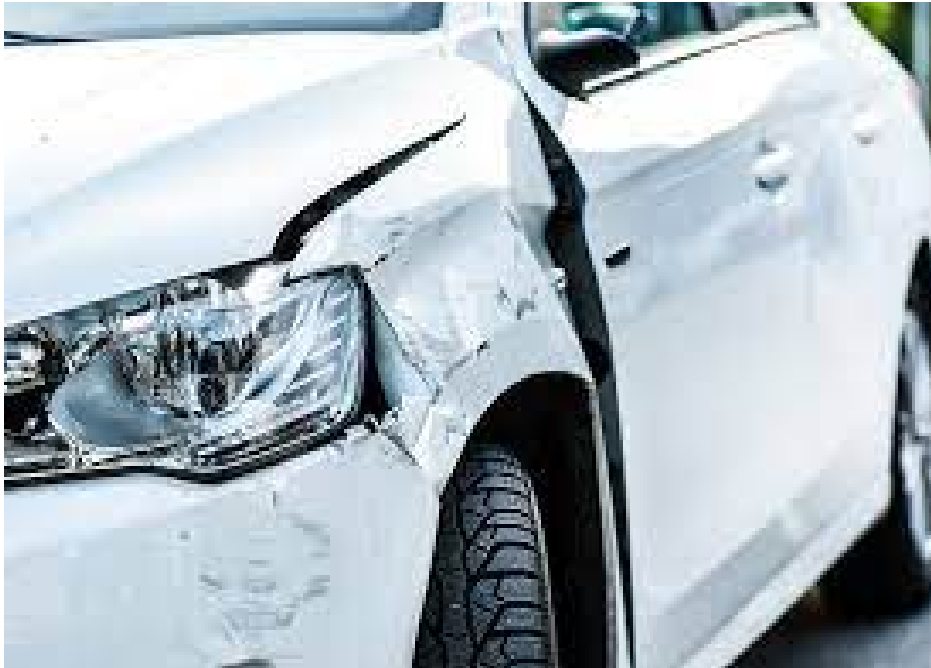
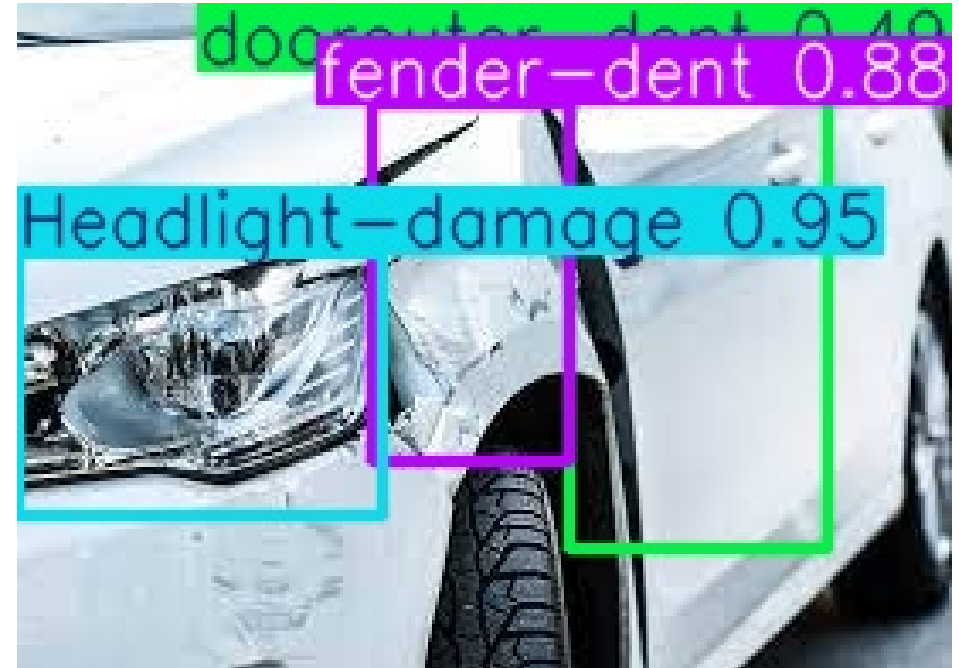
## Image 7 of 10

Class	Confidence
Headlight-damage	0.95
fender-dent	0.88
doorouter-dent	0.49

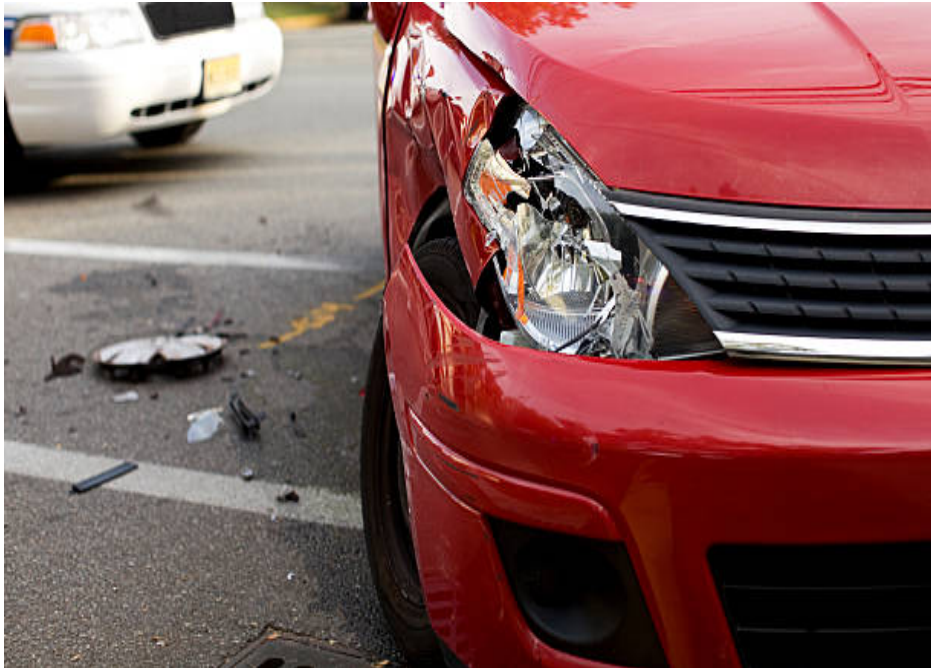
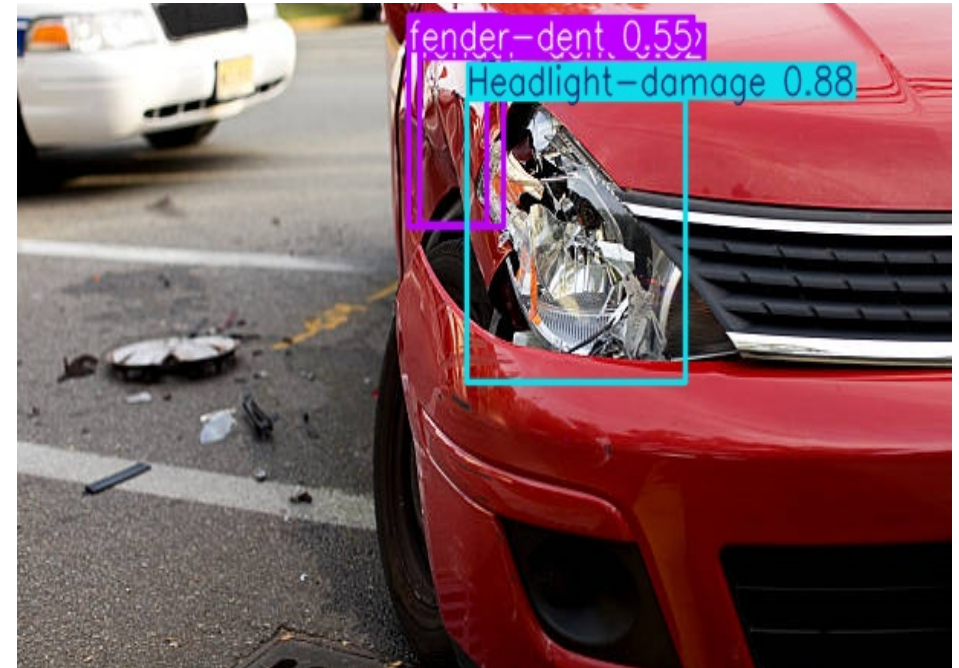
## Image 8 of 10

Class	Confidence
Headlight-damage	0.88
fender-dent	0.55
fender-dent	0.32

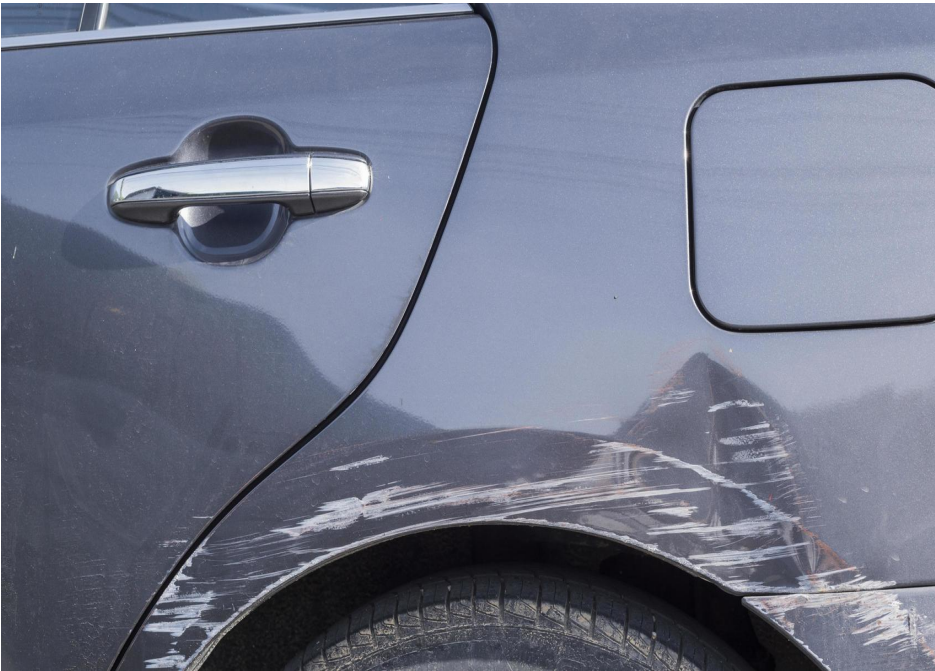
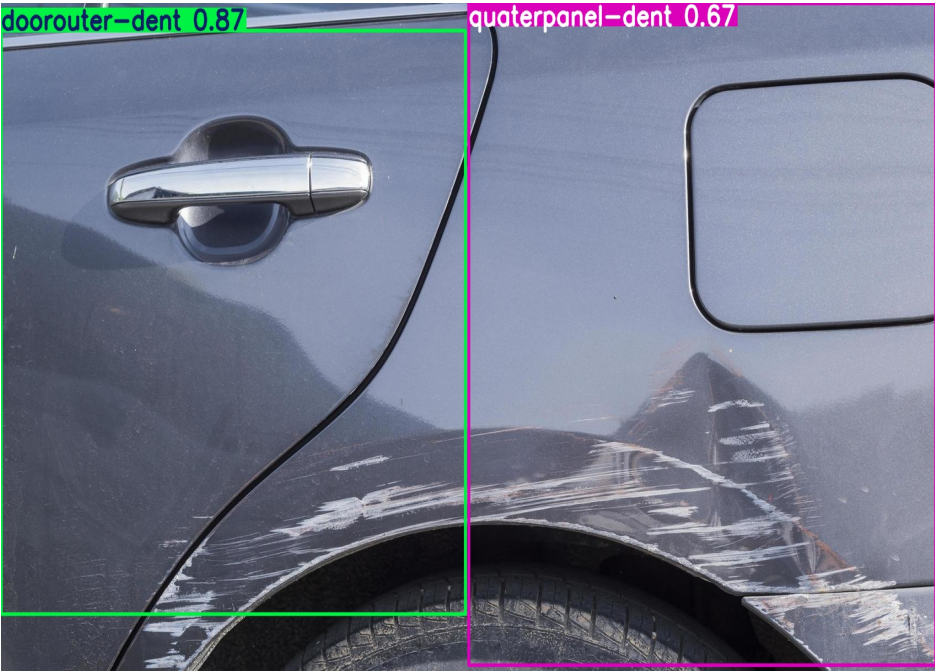
# Image 9 of 10

Class	Confidence
doorrouter-dent	0.87
quaterpanel-dent	0.67
