# Damage Detection Report

Generated on: 2025-05-18 23:00:38

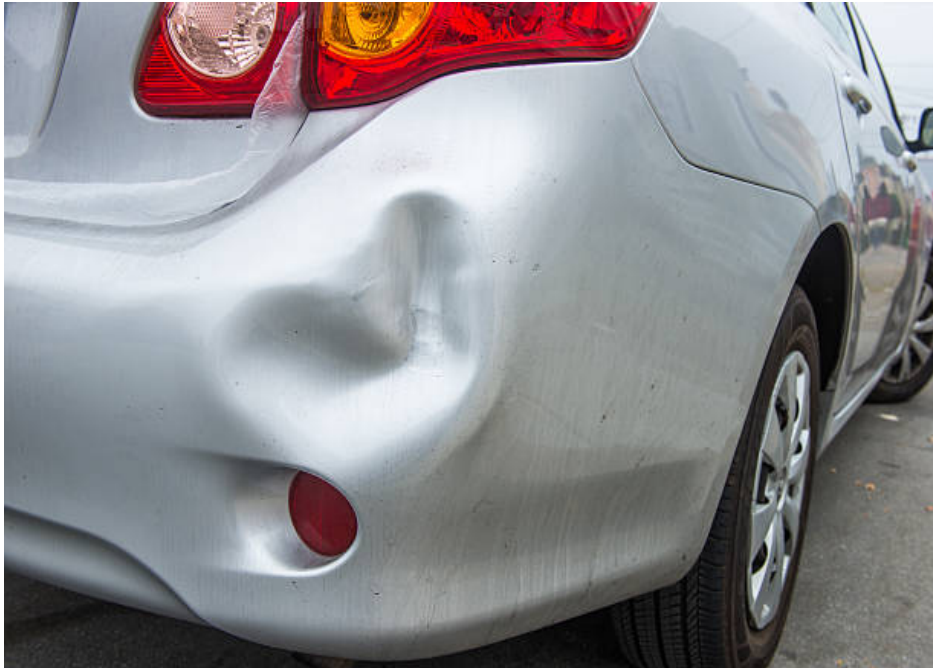
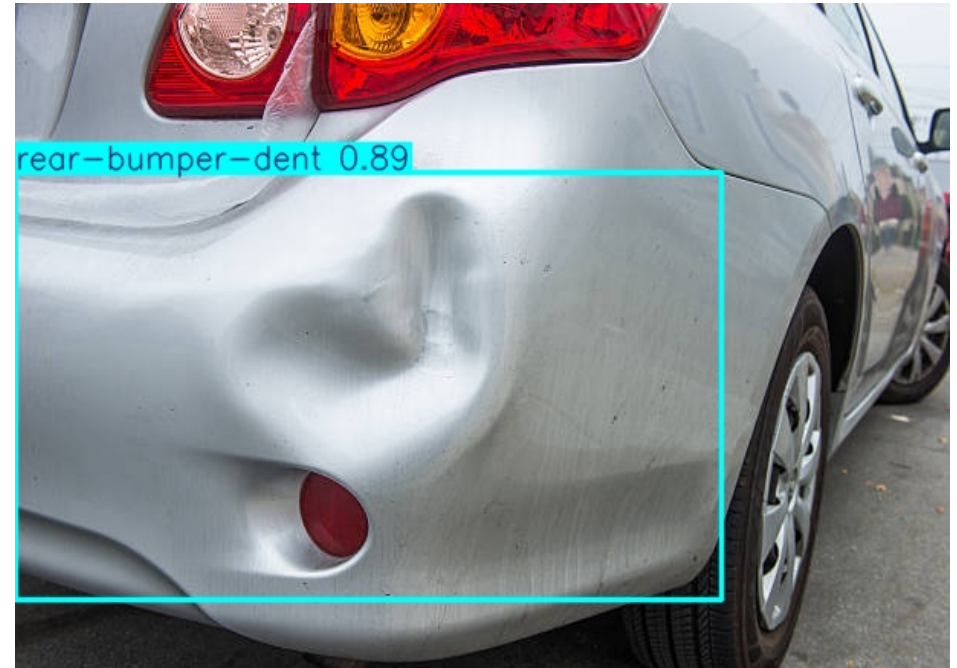
## Image 1 of 11

rear-bumper-dent

88.57%

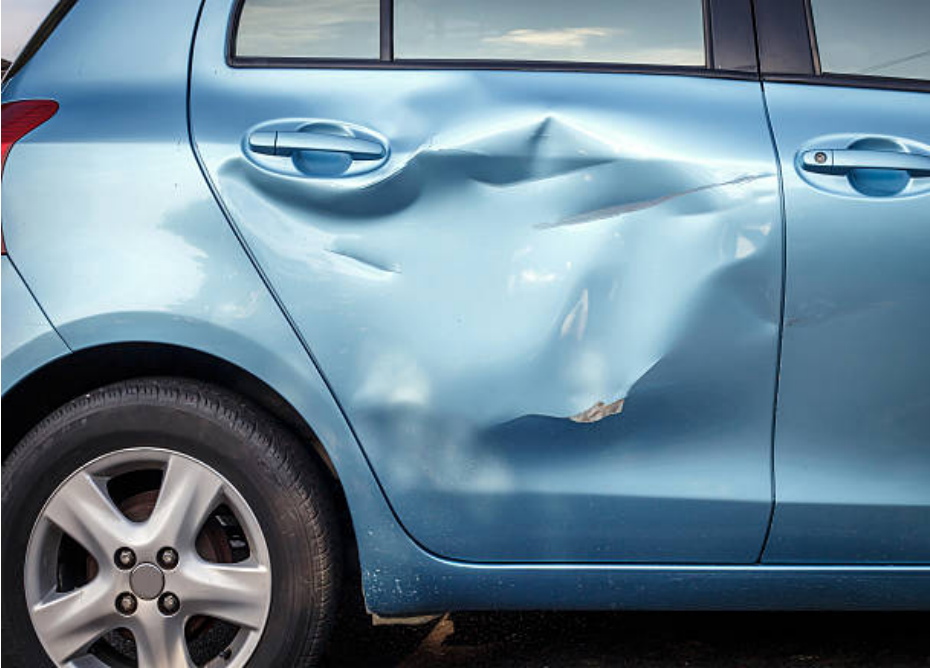
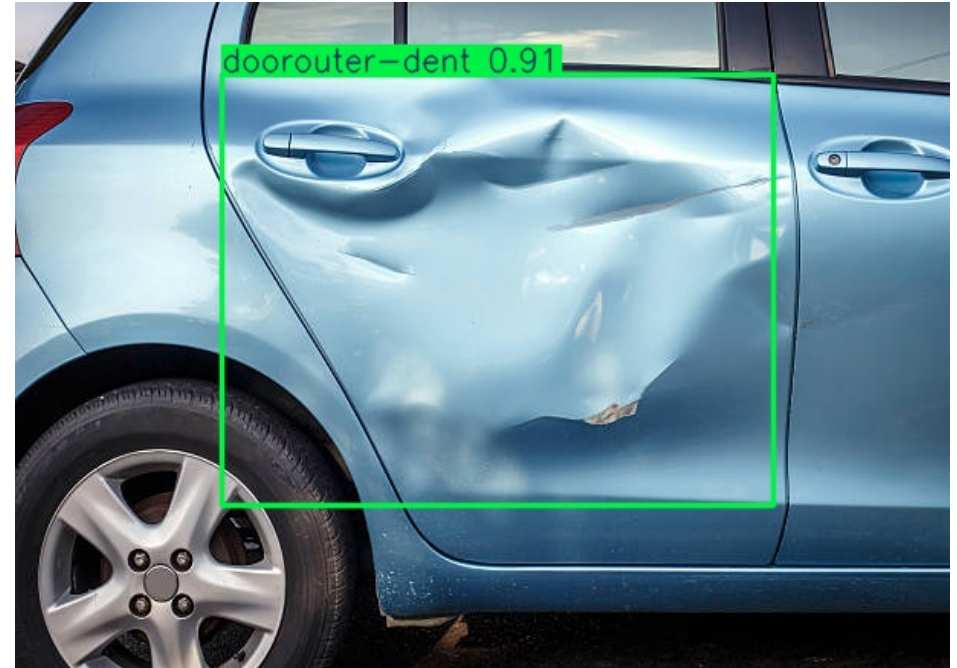
## Image 3 of 11

doorrouter-dent

90.83%

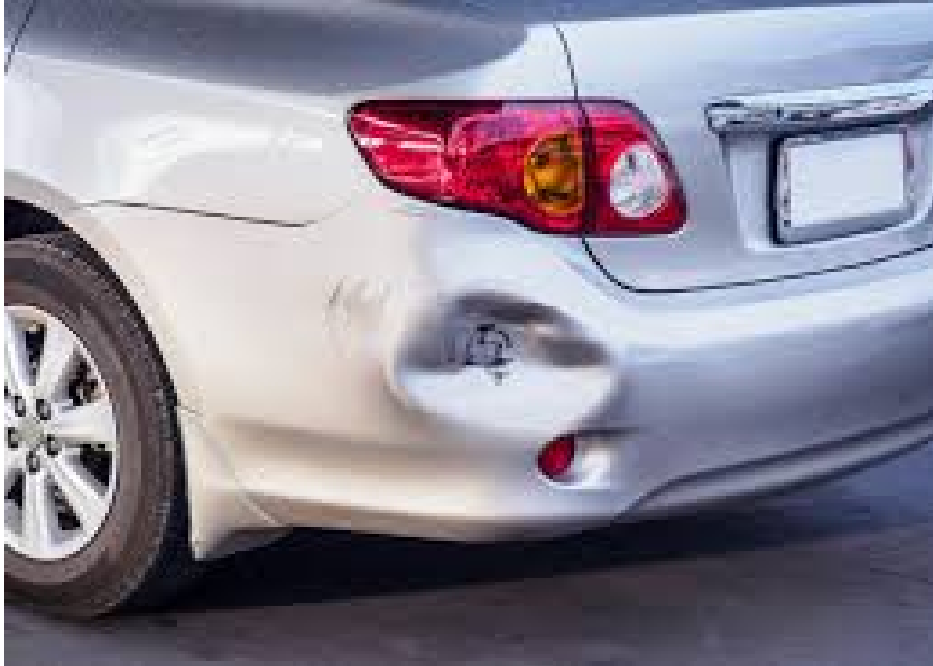
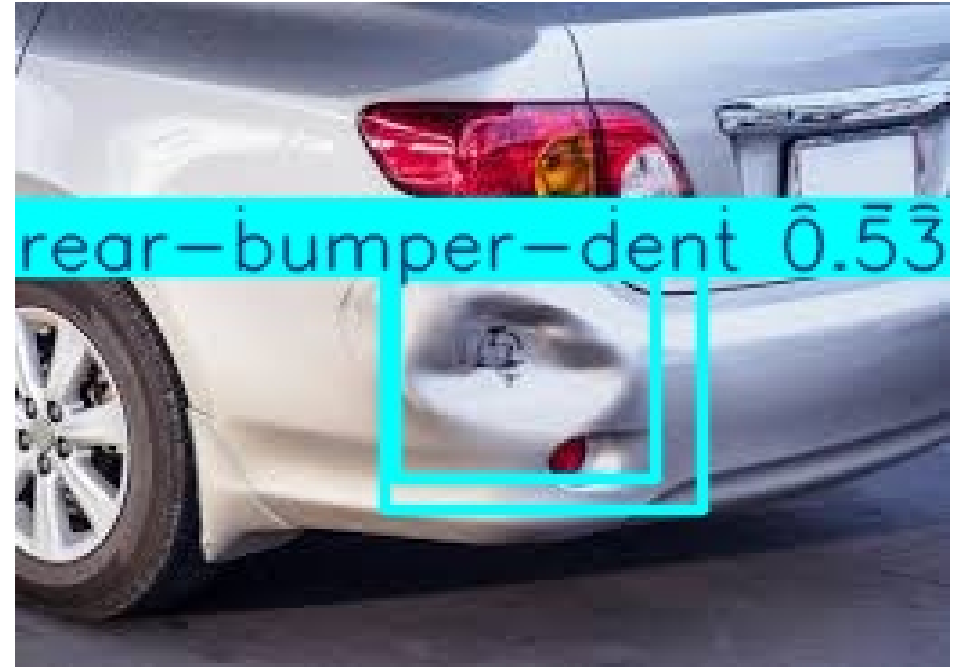
## Image 4 of 11

Class	Accuracy
rear-bumper-dent	53.44%
rear-bumper-dent	38.35%

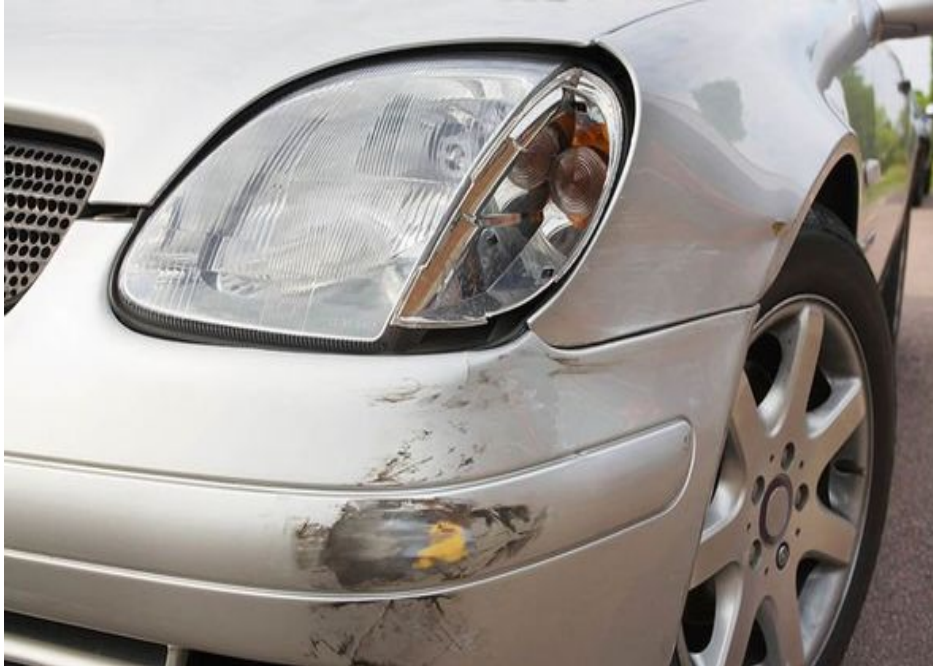
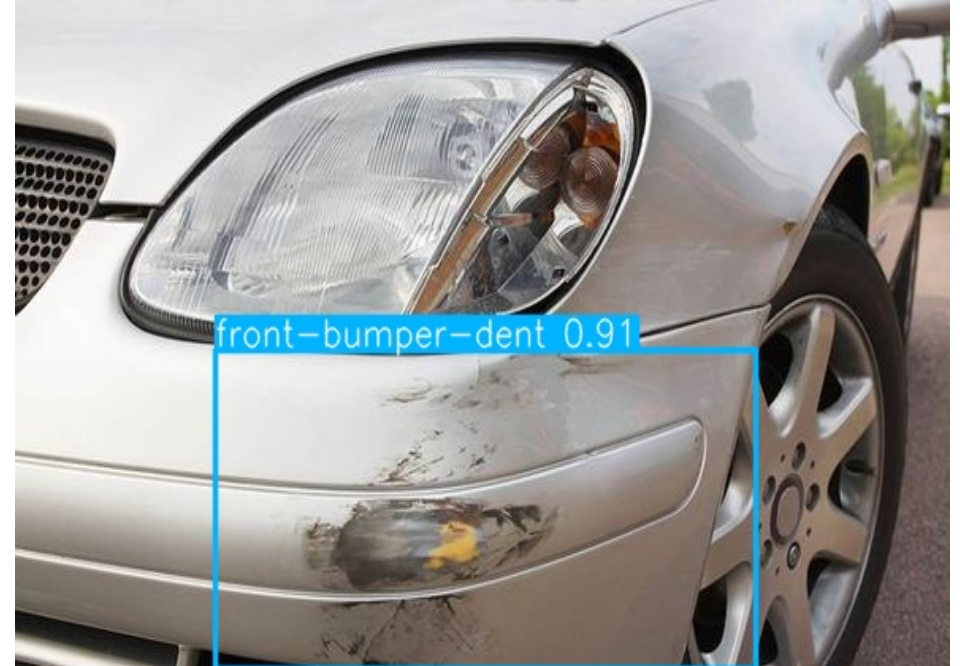
## Image 5 of 11

front-bumper-dent

90.55%

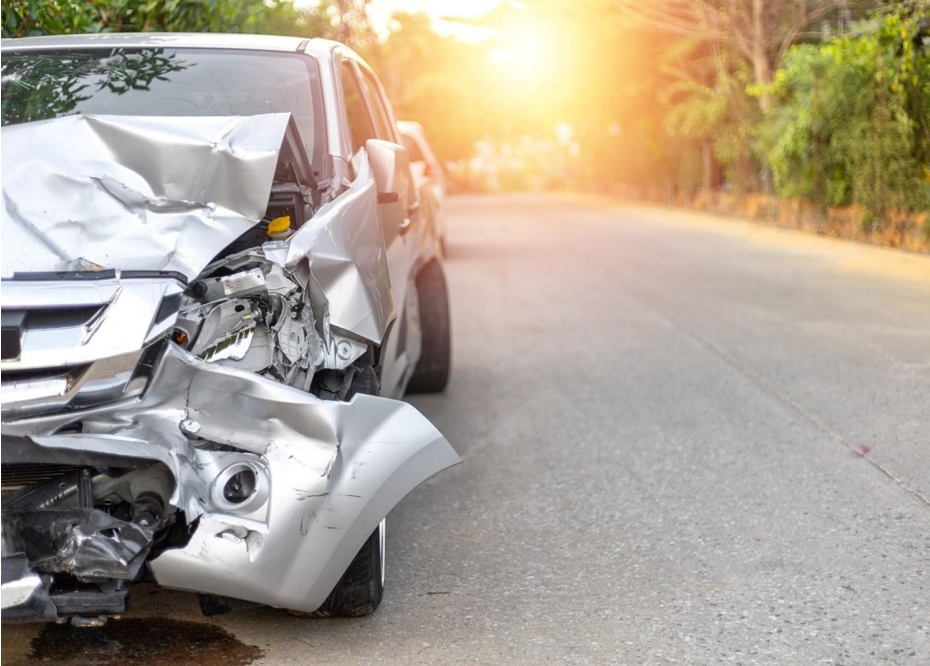
## Image 6 of 11

Class	Accuracy
bonnet-dent	81.95%
front-bumper-dent	80.60%
Headlight-damage	32.69%

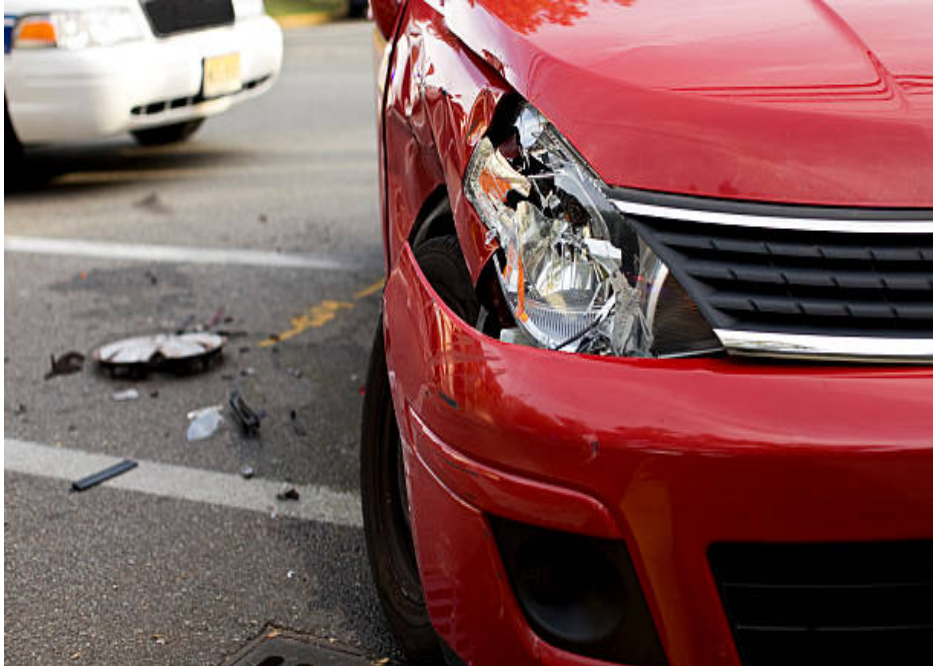
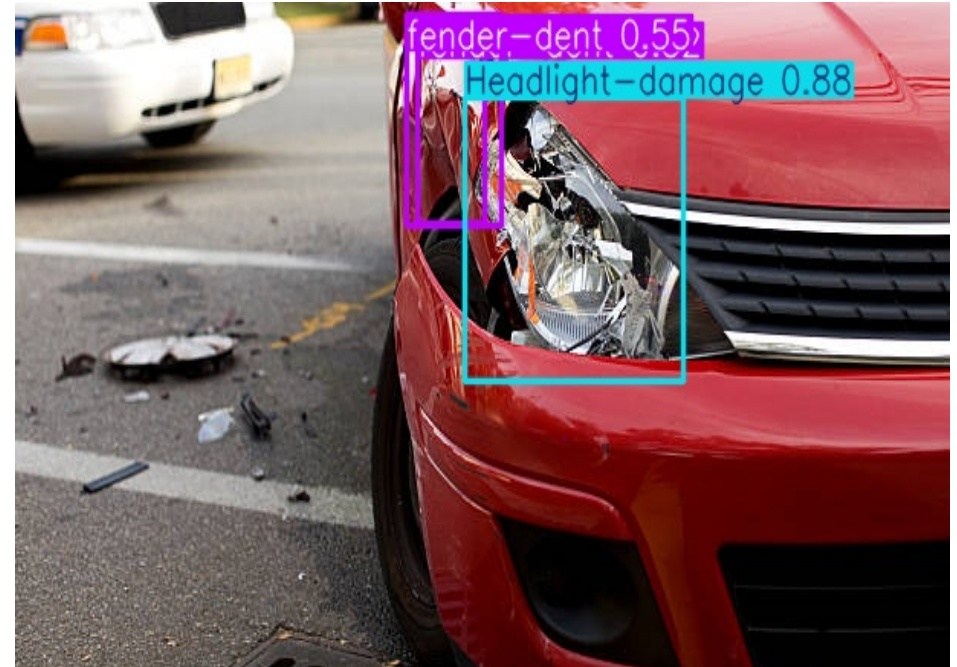
## Image 8 of 11

Class	Accuracy
Headlight-damage	87.78%
fender-dent	54.69%
fender-dent	31.77%

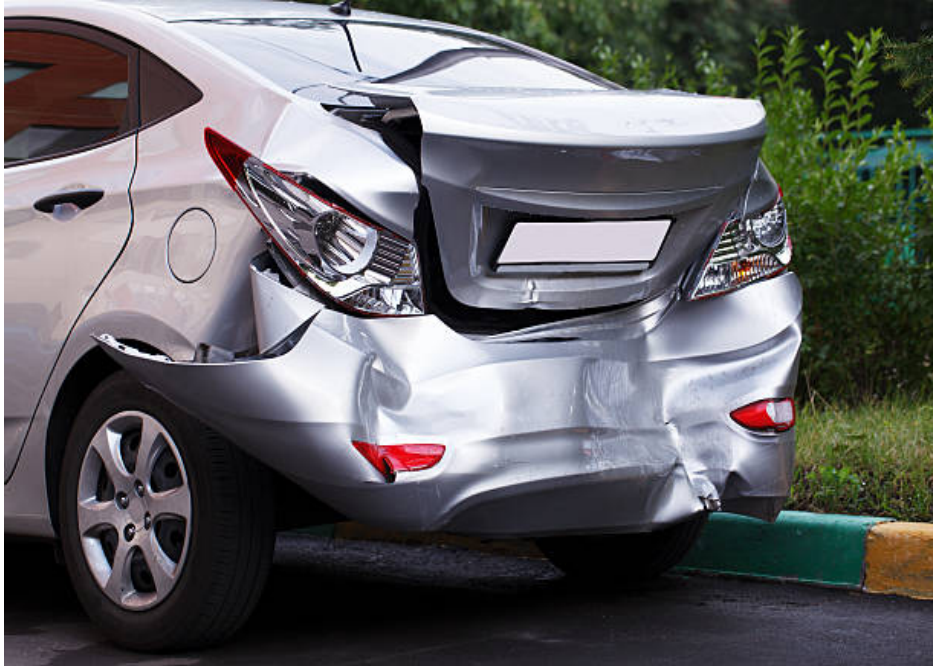
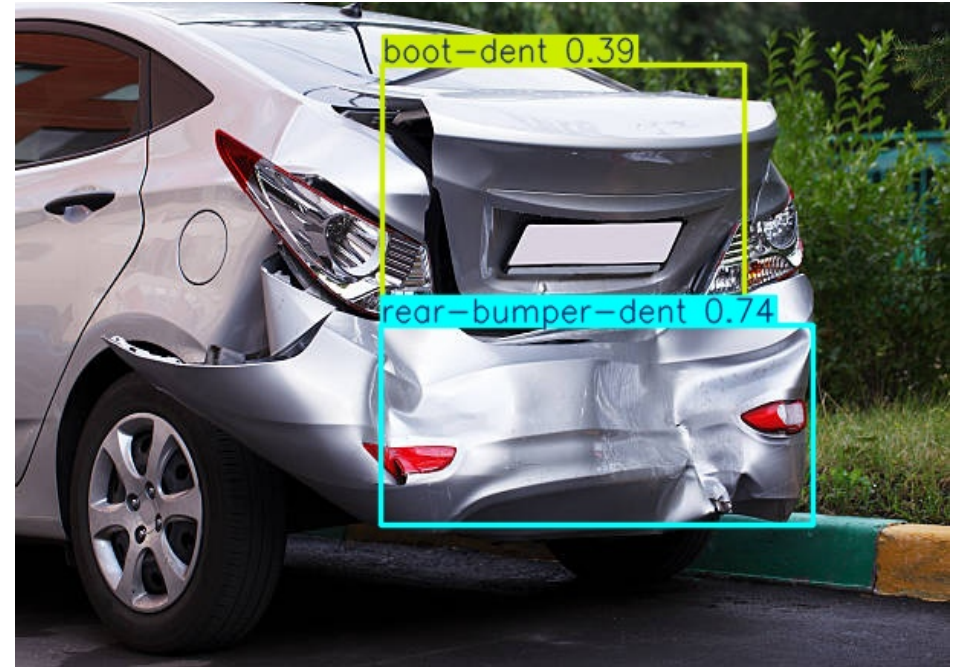
## Image 11 of 11

rear-bumper-dent  
boot-dent

74.40%  
38.50%
