# Damage Detection Report

This report presents the results of an advanced AI-driven vehicle damage detection system.

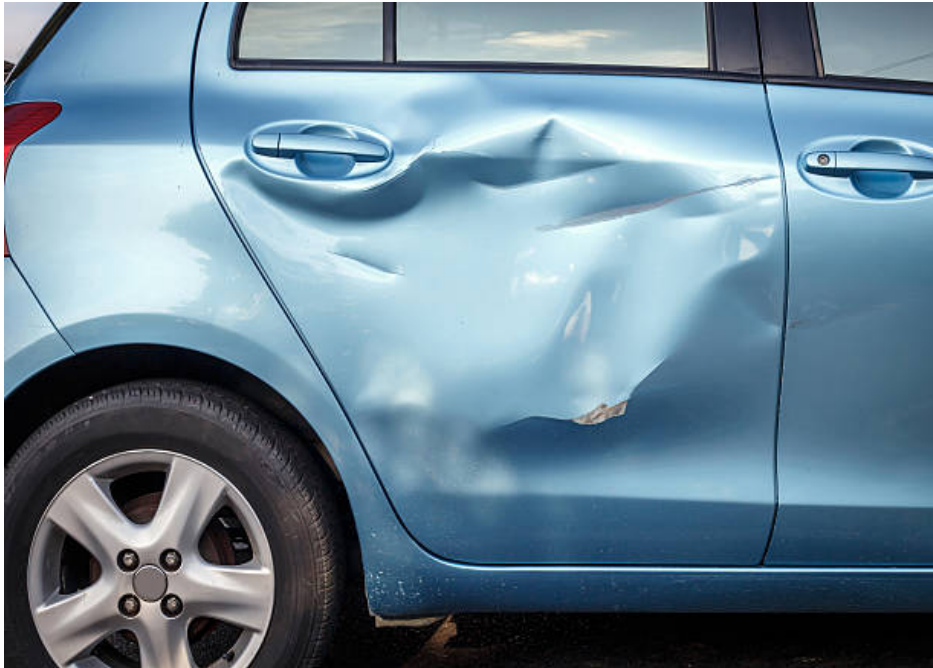
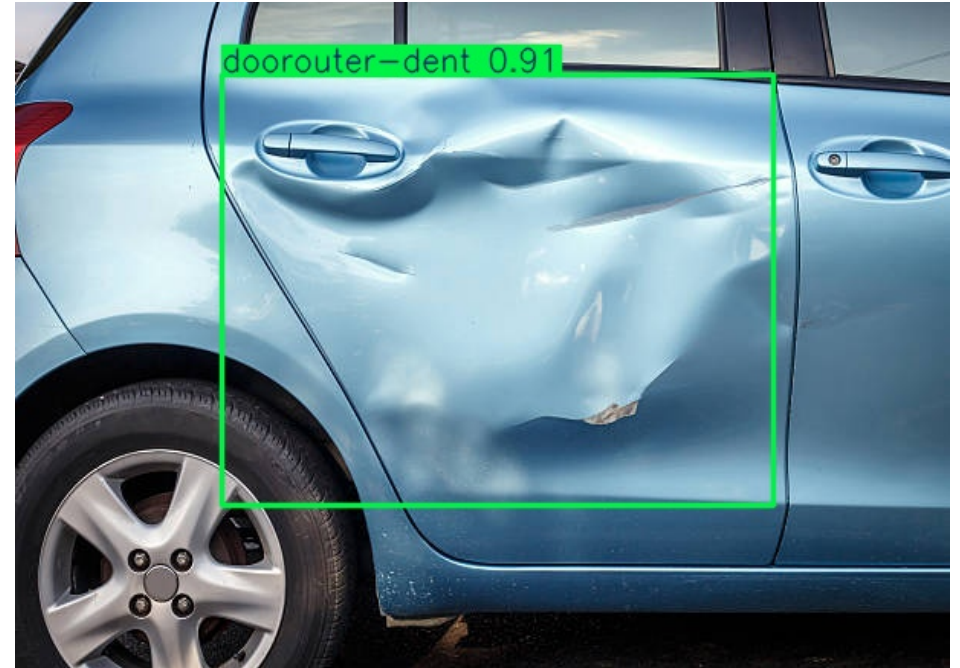
## Image 2 of 6

doorrouter-dent

0.91

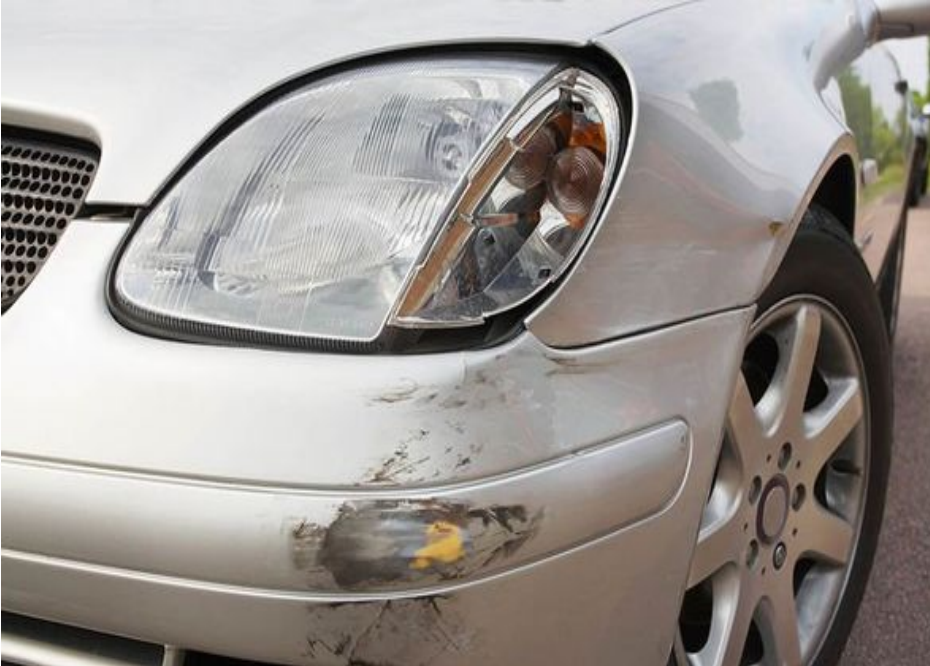
## Image 4 of 6

front-bumper-dent

0.91
