Damage Detection Report

Generated on: 2025-05-18 21:16:15

This report presents the results of an advanced AI-driven vehicle damage detection system.

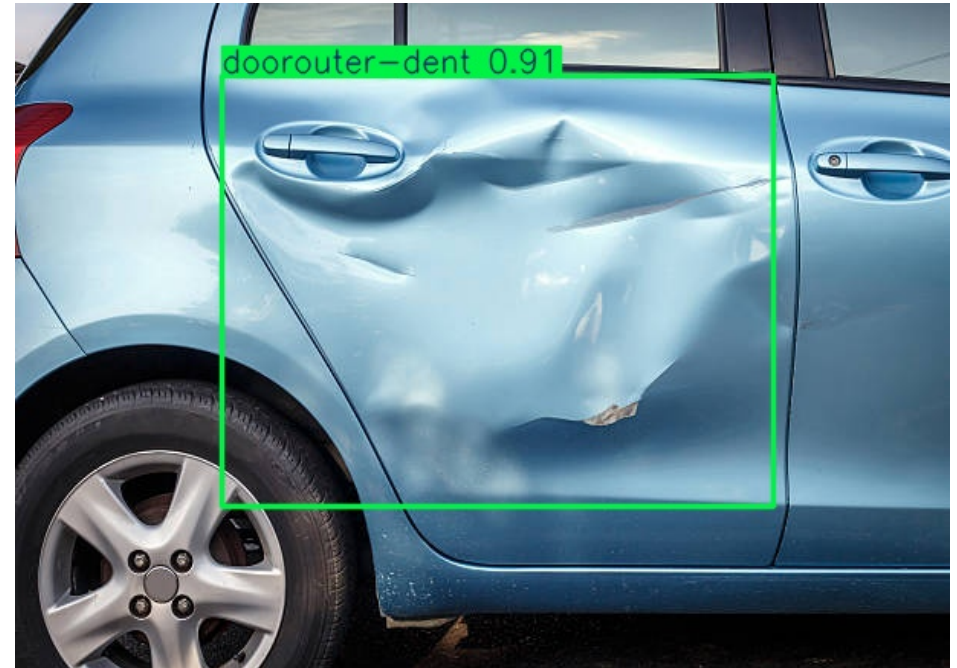
Image 3 of 6

doorrouter-dent

0.91

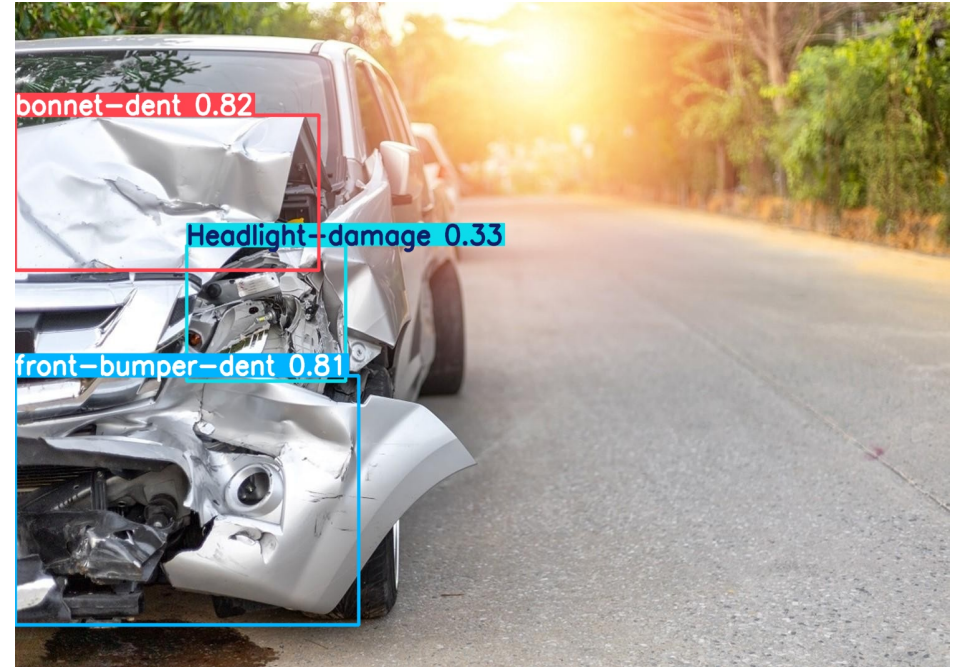
Image 6 of 6

Class	Confidence
bonnet-dent	0.82
front-bumper-dent	0.81
Headlight-damage	0.33
