DEV NUMBER: DEV25-0192	ORIGINATOR: Abdul Castillo	DATE: 13-Jun-25	RAIN BIRD		BUSINESS UNIT (SBU and PLANT) W/ PRIMARY DESIGN CONTR		SHEET:	
			DEVIATION FORM (DRAWING)		025 OTY >>> GLF		1 OF 1	
DMR# (IF APPLICABLE):			DEVIATION NEW <input type="checkbox"/>					
			TYPE: EXTENSION <input checked="" type="checkbox"/> OF DEV#: 23-0336		FORM#233813-01 REV: T			
TOP-LEVEL SKU P/N(S) AND MODEL NUMBER(S): Golf: 900, 950, 952, 11000			EFFECTIVITY DATE: 13-Jun-25		EXPIRATION DATE: 25-Sep-25		AFFECTED MFG PLANTS (WHERE USED):	
PROJECT NAME OR NO. (OPTIONAL):					005 LAM <input type="checkbox"/> 013S STL <input type="checkbox"/> 025 OTY <input checked="" type="checkbox"/> 041 NOG <input type="checkbox"/>		008 BUY <input type="checkbox"/> 019 AZU <input type="checkbox"/> 028 TUC <input type="checkbox"/> 047 TUC <input type="checkbox"/>	
					013E EEX <input type="checkbox"/> 020MX NMD <input type="checkbox"/> 026 ELG <input checked="" type="checkbox"/> CHINA <input type="checkbox"/>

DRAWING NUMBER: DRAWING REVISION: DEVIATION REVISION: DRAWING TITLE/ PART DESCRIPTION: VENDOR:						PLANT MANAGER		
215014 E E3 Bearing guide ELAG						J. Borquez/ V. Soto/ V. Martinez/ S.Sanchez		
215015 C C2 Bea

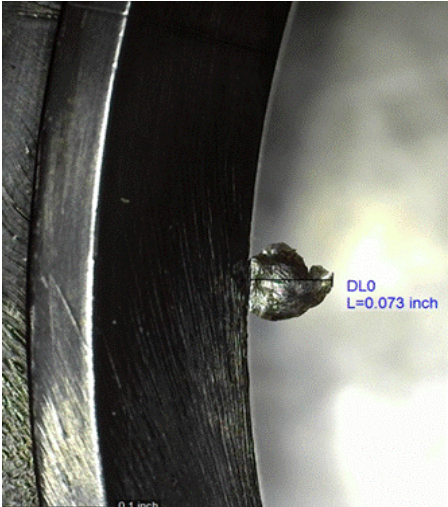
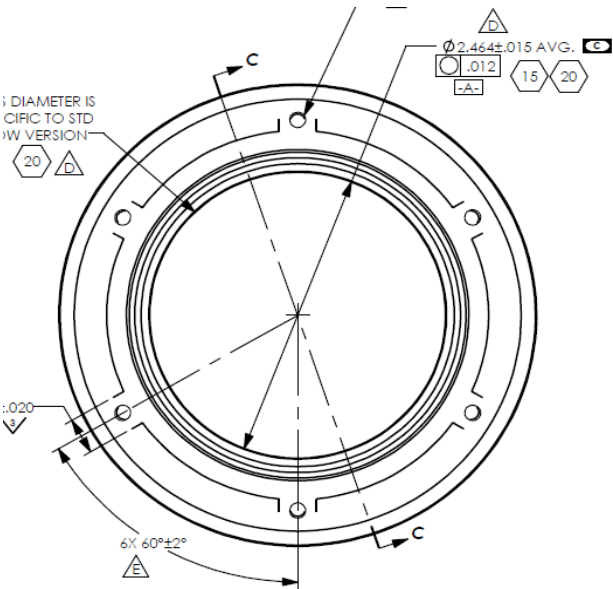
D. Bush / E. Iniguez/ C. Olvera		
DESCRIPTION OF DEVIATION (IS/WAS CONDITION AND DRAWING ZONE FOR EACH PART NO. OR ATTACH REDLINE PRINTS):						QUALITY DIRECTOR (REQUIRED FOR BACK-TO-BACK DEVIATIONS)		
IS						Blanca Salas		
WAS								
<div>15. FLASH PERMITTED IN THIS AREA .015 HIGH X .010 THK. NON CONTINUOUS FLAKES OF FLASH MAX .125 X .125 X .010 ARE PERMITTED.</div>

Molder reported flash occurring due to gate vestige getting trapped in the tool and attached to the next shot (pictured)

Samples of the impacted areas were obtained and examined. Though they don't pose a functional threat, the small flakes should be investigated because they could be gradually harming the tool.

- 1.- Run 20 weeks of coverage (155,600 pcs) 1 month Oscar Santillan
- 2.- Take mold out for reverse Eng and reapiir , 2 months Jorge Rivero
- 3.- Run QAP1001. send samples to evaluation. 1 month Jorge Rivero
- 4.-Evaluate parts 3 weeks Abdul Castillo
