A	B	C	D	E	F	G	H	I	J	K	L	M	N	O	P	Q	R	S	T	U	V	W	X	Y	Z	AA	AB	AC	AD	AE	AF	AG	AH	AI	AJ	AK	AL	AM	AN	AO	AP	AQ	AR	AS	AT	AU	AV
1	DEV NUMBER:				ORIGINATOR:										DATE:				<b>RAIN BIRD</b>										BUSINESS UNIT (SBU) W/ PRIMARY DESIGN CONTROL:										SHEET:									
2	DEV25-0003				Abdul I. Castillo										10-Jan-25														>>> GLF										1 OF 1									
3	DMR# (IF APPLICABLE):				DEVIATION NEW <input checked="" type="checkbox"/>										<b>DEVIATION FORM (DRAWING)</b>										AFFECTED MFG PLANTS (WHERE USED):																							
4					TYPE: EXTENSION <input type="checkbox"/> OF DEV#:																														FORM#233813-01 REV:N													
5	TOP-LEVEL SKU P/N(S) AND MODEL NUMBER(S):														EFFECTIVITY DATE:				EXPIRATION DATE:				005 LAM <input type="checkbox"/>		013S STL <input type="checkbox"/>		025 OTY <input checked="" type="checkbox"/>		041 NOG <input type="checkbox"/>

9	213784 Housing nozzles Comolded 552. The cavity blocks were shattered in an attempt to weld and recut them. The steel was so thin in one place that it cracked multiple times. The second shot (rubber) could pass through the crack. As an alternative, cavity blocks were soldered, modifying

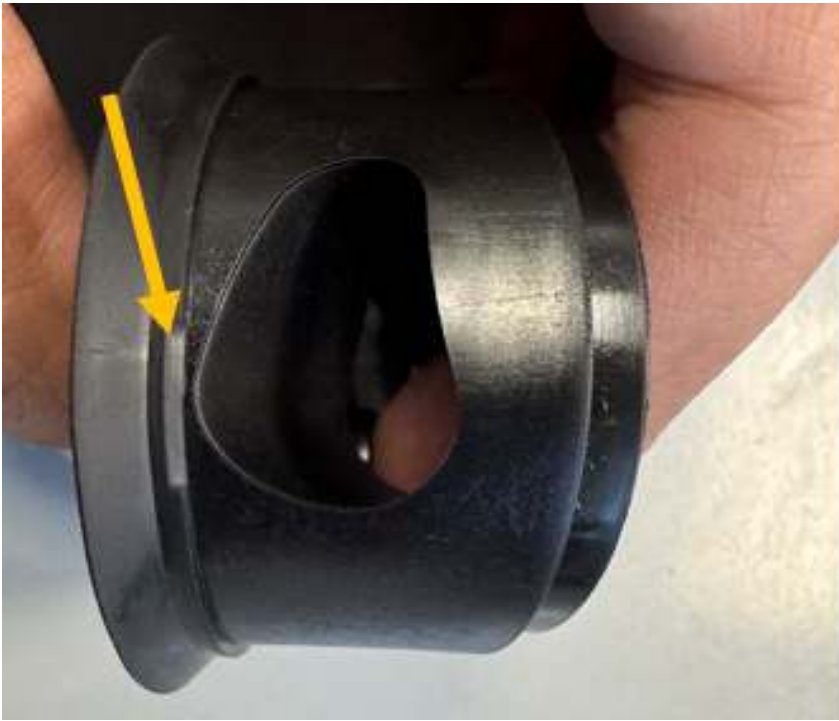
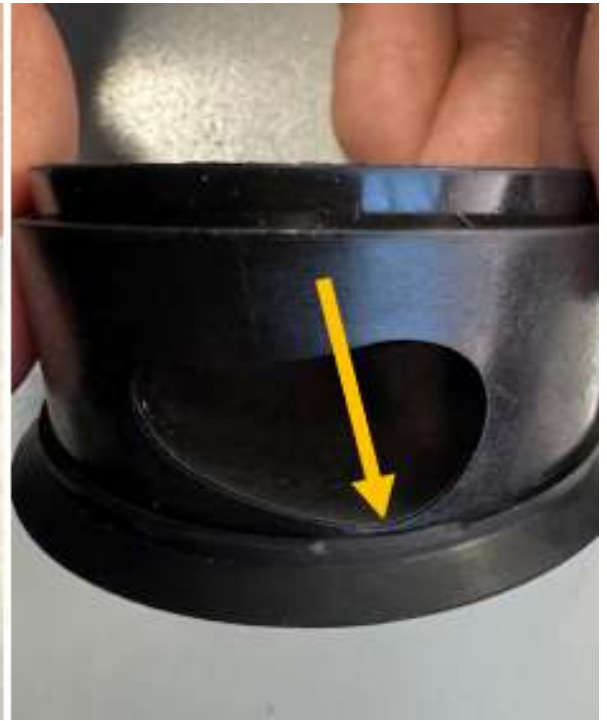
213784 Housing nozzles Comolded 552, Cavity blocks were cracked. An attempt to weld and recut it. The steel was so thin in this area that it cracked several times. the second shot (rubber) could going to flash through the crack. As an option, cavity blocks were solder-changing the surface as described in the picture.

16	3.- Built up 16 weeks of inventory. Oscar Santillán.																																															
17	4.- Validation will be required. A. Castillo																																															
17	Design intent		DRAWING REVISION:				DEVIATION REVISION:				DRAWING TITLE/ PART DESCRIPTION:										VENDOR:				PLANT MANAGER																							
18	213784		DRAWING REVISION:				D2				Housing Nozzle Comolded 552										AMA Westfall				Jorge Borquez / Soto Valeria																							
19																									SBU PRODUCT MGR. OR SBU ENG. MGR																							
20																									Altan Tolan/ Javier Guardado																							
21																									OTHER:																							
22																									D. Bush / J. Rivero/ C. Rodriguez																							
23	DESCRIPTION OF DEVIATION (IS/WAS CONDITION AND DRAWING ZONE FOR EACH PART NO. OR ATTACH REDLINE PRINTS):																										QUALITY DIRECTOR (REQUIRED FOR BACK-TO-BACK DEVIATIONS)
