## Vehicle Data

Vehicle Type	PASSENGER VEHICLE	Registration Number	675513144
Manufacturer	MERCEDES-BENZ		
Model	C CLASS SEDAN	Paint Finish	C - COMMON
VIN	WDD2040082R088866	Fuel	DIESEL
Year Model	2009	Transmission	AUTOMATIC
Km Reading	238,574 KM	Doors	4
Cab / Body Type	SEDAN	Color	SILVER

## General Condition

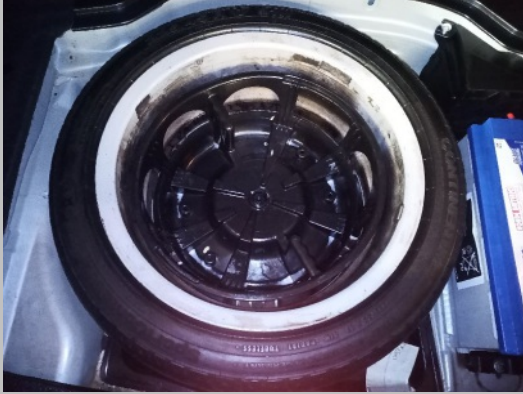
Spare wheel

Size	Load/Speed Index	Manufacture	Model	Type*	Production Date	Tread Depth (mm)
Front Left	225/45R17	91W	Continental	Contact	V	1514	1 mm
Front Right	225/45R17	91W	Continental	Contact	V	2914	0 mm
Rear Left	245/45R17	91W	Continental	Contact	V	3314	2 mm
Rear Right	245/40R17	91W	Continental	Contact	V	3314	2 mm
Spare	225/45R17	91W	Continental	Contact	V	0000	0 mm

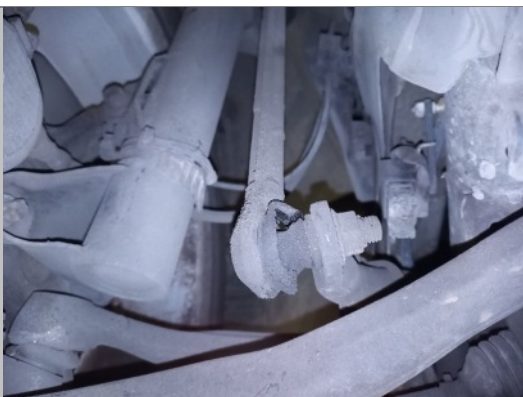
Left front stabilizer dust cov

Damage	Repair Way
Tyre Front Right Smooth	Roadworthy Relevant
Both front stabilizer dust covers torn	Roadworthy relevant
Both front lower control arms bushes cut torn	Roadworthy relevant
