Assignment

Client We Buy Cars

Vehicle Type	PASSENGER VEHICLE	Registration Number	987911674
Manufacturer	MERCEDES-BENZ		
Model	C CLASS SEDAN	Paint Finish	C - COMMON
VIN	WDD2040022R148261	Fuel	DIESEL
Year Model	2010	Transmission	AUTOMATIC
Km Reading	167,130 KM	Doors	4
Cab / Body Type	SEDAN	Color	WHITE

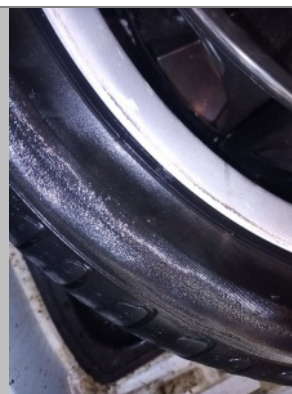
Sparewheel sidewall damage

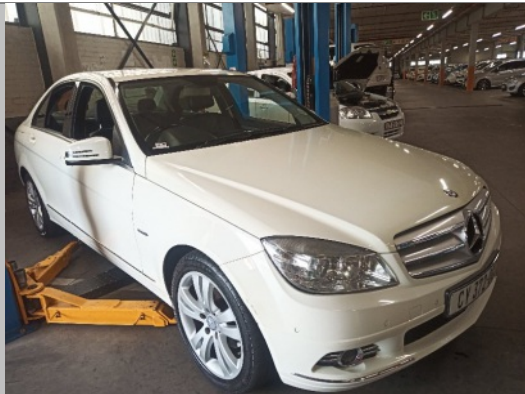
Repair/Spray work noted

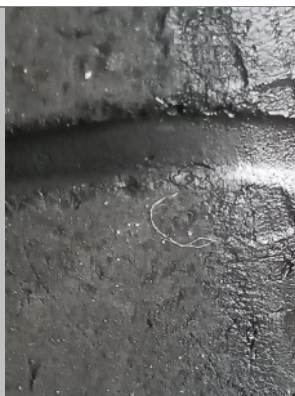
Size	Load/Speed Index	Manufacture	Model	Type*	Production Date	Tread Depth (mm)
Front Left	225/45R17	91W	CONTINENTAL	SPORT	V	1417	0 mm
Front Right	225/45R17	91W	CONTINENTAL	SPORT	V	1417	0 mm
Rear Left	225/45R17	94W	MAXTREK	MAXIMUS	V	////	5 mm
Rear Right	225/45R17	91W	PIRELLI	CINTURATO	V	0920	5 mm
Spare	225/45R17	91W	PIRELLI	CINTURATO	V	////	5 mm

Damage	Repair Way
Front Bumper Damaged	Roadworthy Relevant
Windscreen Cracked	Roadworthy Relevant
Both front tyres smooth	Roadworthy Relevant

Both front tyres smooth
