NAKUJA PROJECT
DESIGN.MAKE.LAUNCH

N-3 Launch report

27th February 2024

Nakuja Project

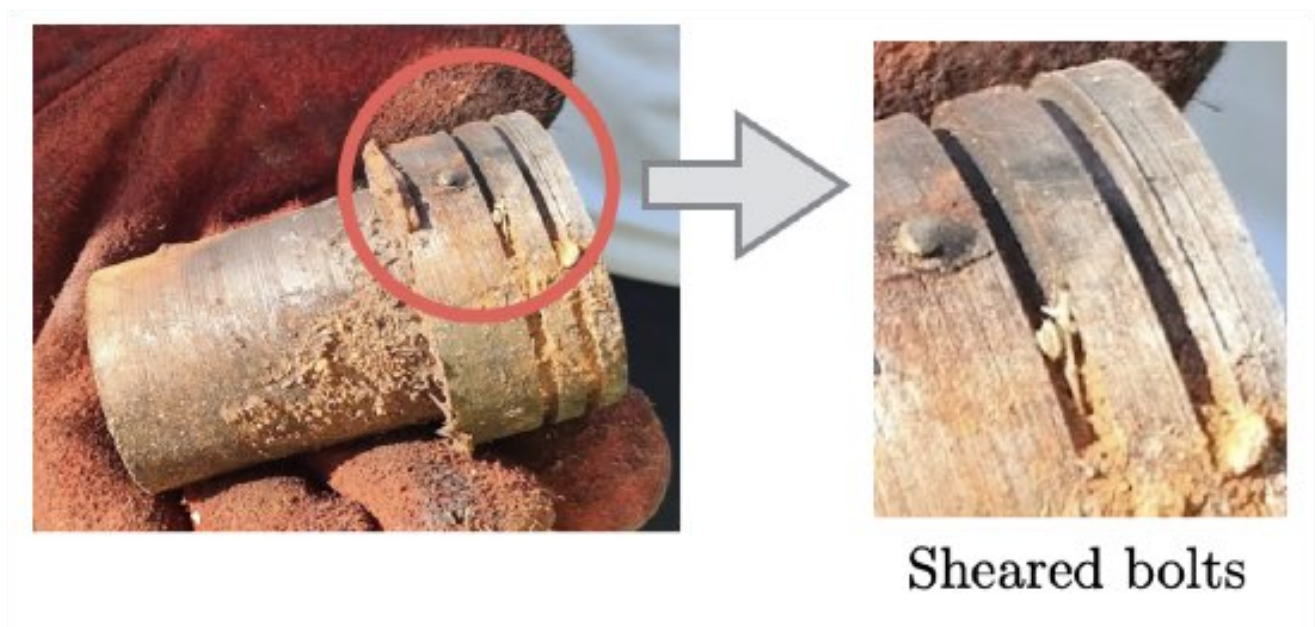
Figure 7. Sheared bolts

The observed apogees were way lower than the simulated apogees, at around 1,600 m. The reason for the discrepancy is the significant low performance of the solid rocket motor, which was caused by the pressure release due to the ejection of the nozzle and bulkhead from the solid rocket motor casing during the initial stage of combustion. The details will be discussed in the section on solid rocket motors.

The failure of the launch was mainly due to the issue of the solid rocket motor. From the recovered rocket motor, it was found out all eight bolts used to fasten the nozzle to the casing were cut by the shear force, as shown in Figure 7. It was an unexpected failure as the design was confirmed to have sufficient strength against the shear. Moreover, it was even strange because the casing was intact against the tensile force, which was supposed to have less strength compared to the shear force. After the investigation, the team found out that the bolts were changed to the new bolts just before the launch, as shown in Figure 8. Initially, the bolts were made of steel, whereas the new bolts were made of silicon bronze. After the launch, the team did a calculation again and confirmed the new bolts could not withhold the generated force.

Based on the findings, the team replaced the bolts with steel bolts and conducted a static test, where they successfully confirmed that the revised motor worked.

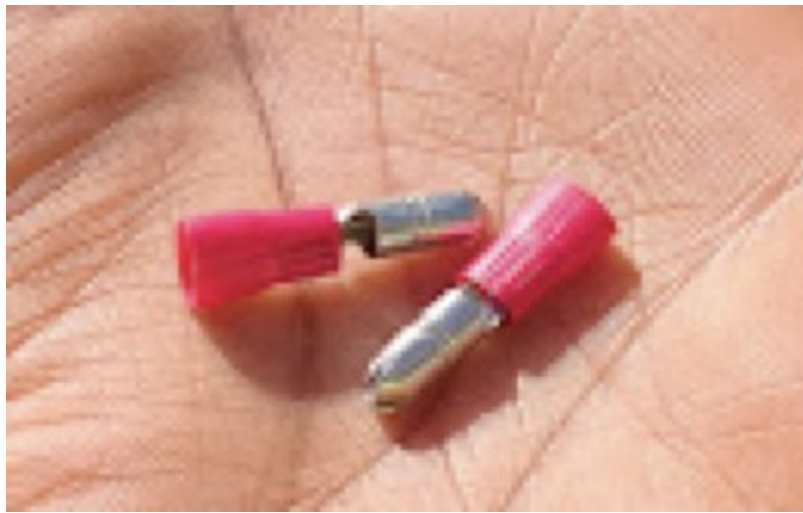
Figure 9. Terminal crimp that malfunctioned

In the second launch test (Kaburu rocket), the team had an issue igniting the solid rocket motor. Through the measurement of the resistance using a digital multimeter, the team identified the problem was caused by the poor crimping at the end of the nichrome wire, which caused the loose connection, as shown in Figure 9. The lesson learned is to always check the continuity of the ignitor during the fabrication.

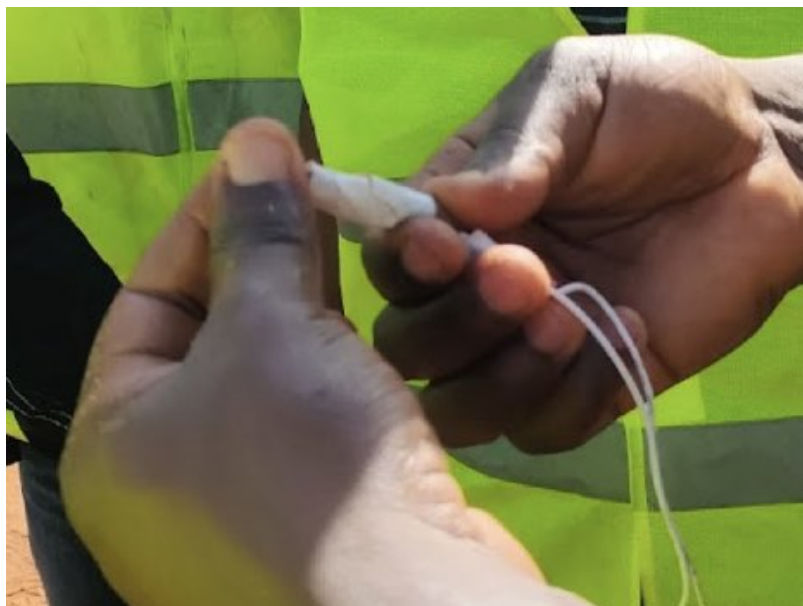
Figure 10. Modified ignitor

To replace the terminal crimp, the team extracted the ignitor pre-inserted into the rocket motor. After removing the ignitor from the rocket motor, the team faced difficulty installing the spare ignitor into the rocket motor because the ignitor was not designed to be installed smoothly on-site, forcing the team to smash it to be smaller, as shown in Figure 10. Considering the potential misfiring of the rocket motor in a future launch, the ignitor must be redesigned to be reloadable on-site. Concretely, the ignitor needs to be made much thinner to go inside the grain holes.

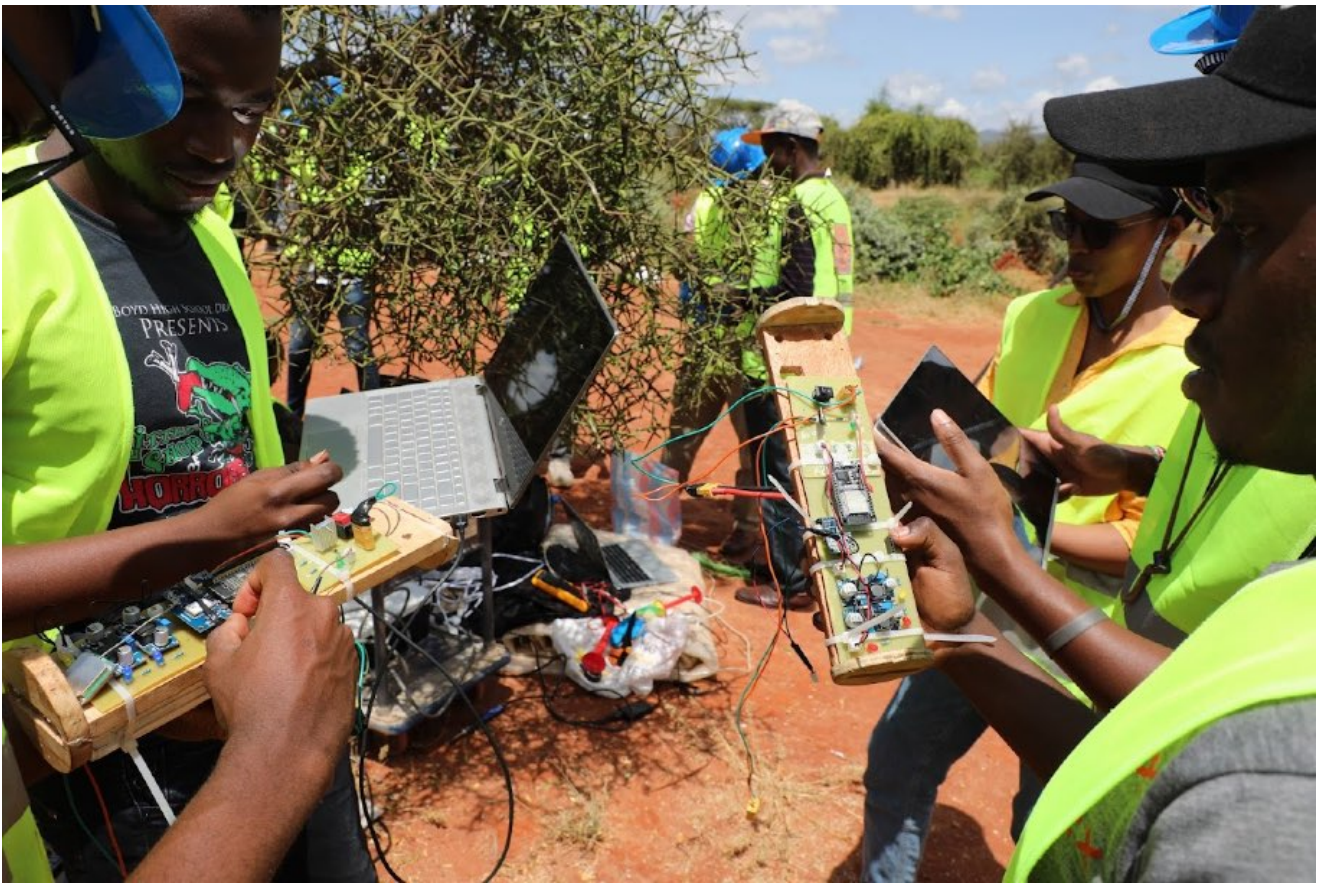
Figure 12. Preparation of avionics before the launch

Preparing the flight computer and ejection board was another time-consuming task on the site, which delayed the scheduled launch. For instance, the team had a wrong soldering on the ejection board, which led to the accidental firing of the ejection mechanism for the Tembo rocket. Based on the accident, the team needed to disassemble the rocket again and start the installation again. The reinstallation process revealed that the team didn't carry enough amount for the backup; the team needs to bring more in the next launch.

Several short circuits were seen here and there, which caused the team to lose two Raspberry Pi Zeros for video capture. It made the team learn the importance of quality control, where they secured enough time to check the successful function of each fabricated PCB.

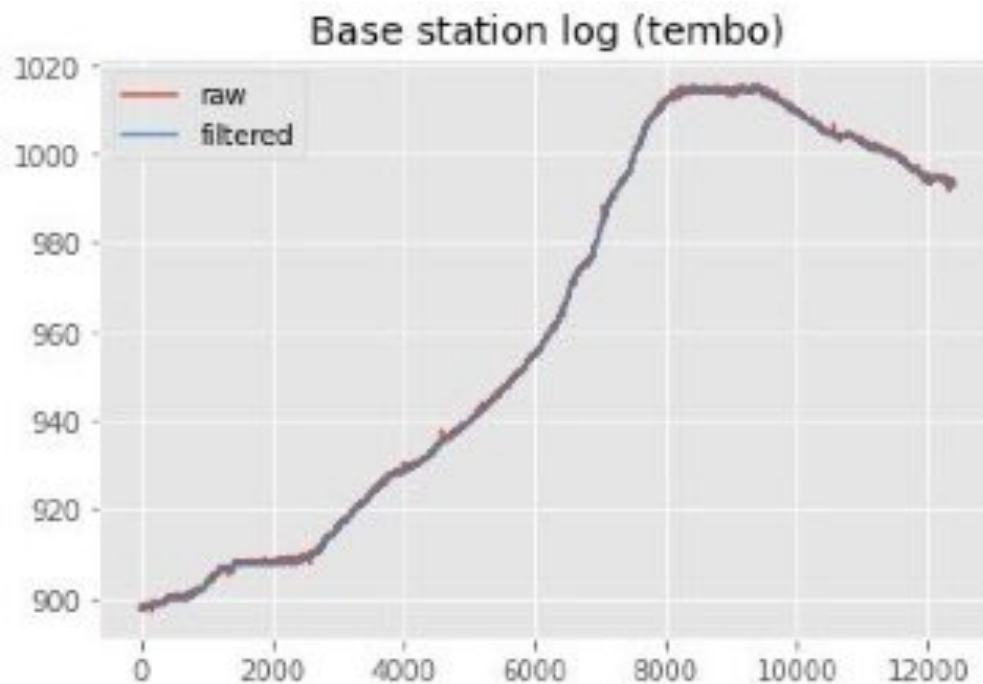
Figure 13. Data stored in the base station (Kabura rocket)

The sensor data received at the base station is shown in Figure 13. The flash memory was damaged because of the hard landing, which made it impossible to recover the data from the onboard flight computer. The graph seems reasonable, but there are two issues. First, the data acquisition is stopped at a certain point, where the data transmission is terminated. The team will conduct the test to confirm if the rise in temperature would affect it in that manner.

Secondly, there is an offset between the actual altitude of the launch site (around 1,200 m) and the measured altitude (around 900 m). The team suspects the issue was caused by the operating heat during the launch, which is being investigated.

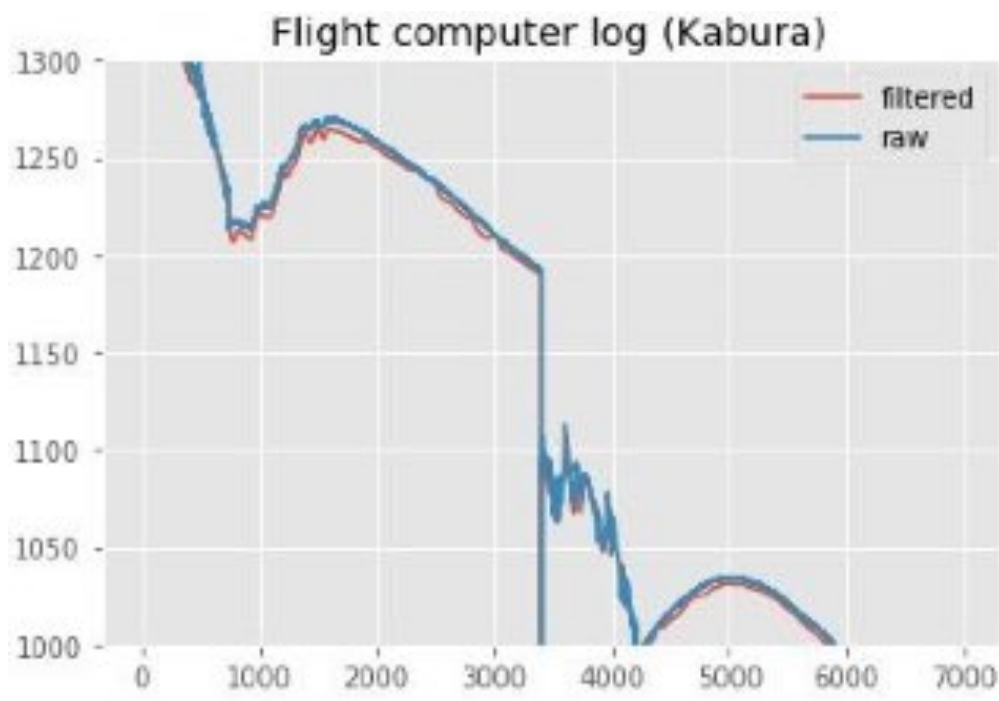
Figure 14. Data acquired from flight computer (Tembo rocket)

Because of the hard landing, the team could recover only the sensor data stored on the flash memory from the Kabura rocket. The data recovered from the Kabura rocket indicated strange and complex behavior, as shown in Figure 14. The reason is being identified by the flight computer team.

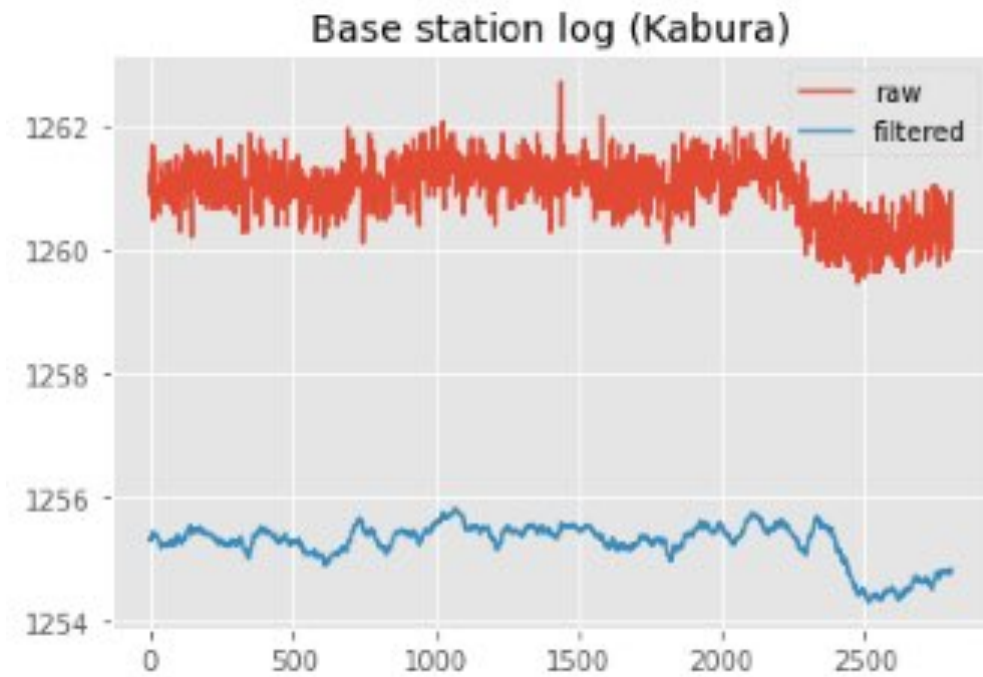
Figure 15. Data acquired from base station (Kabura rocket)

Regarding the base station log, neither Kabura nor Kifaru had meaningful data. As shown in Figure 15, the sensor data Kabura received at the base station was almost stable with a random noise. Figure 16 shows the base station data acquired from Kifaru, which recorded a monotonous decrease trend, which is not an expected behavior. To identify the cause of the

malfunction, the team needs to conduct several tests at the laboratory by emulating the condition of the launch site.

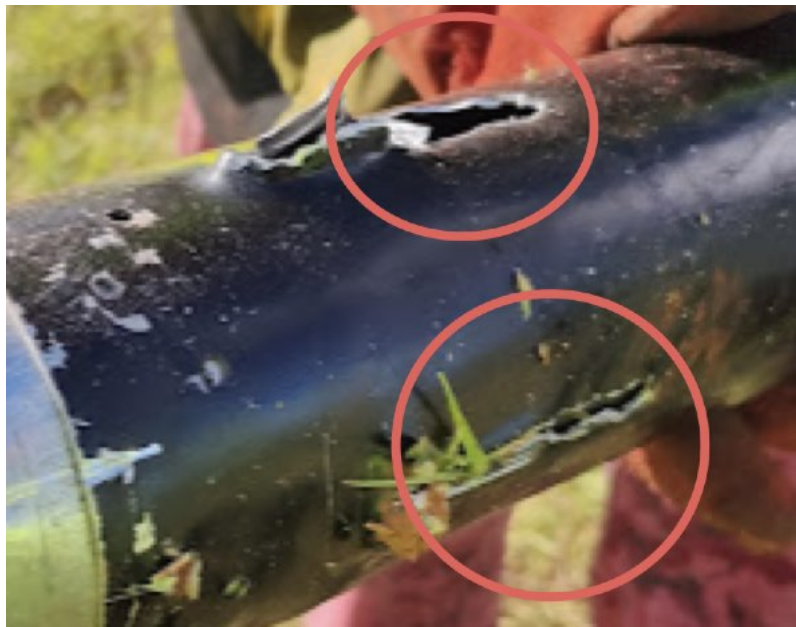
Figure 17. Teared rocket body

From the recovered airframe, as shown in Figure 17, the team found tears on the rocket body, where the solid rocket motor was joined with a few bolts. It signifies that the rocket body could not maintain its structural consistency against the generated thrust. It let the team realize the necessity of integration testing during the static test to confirm the strength of the joint mechanism of the solid rocket motor and body tube. The team conducted a post-calculation and found that the 8 bolts were required to resist the crushing force, as opposed to the four bolts used in the launch.

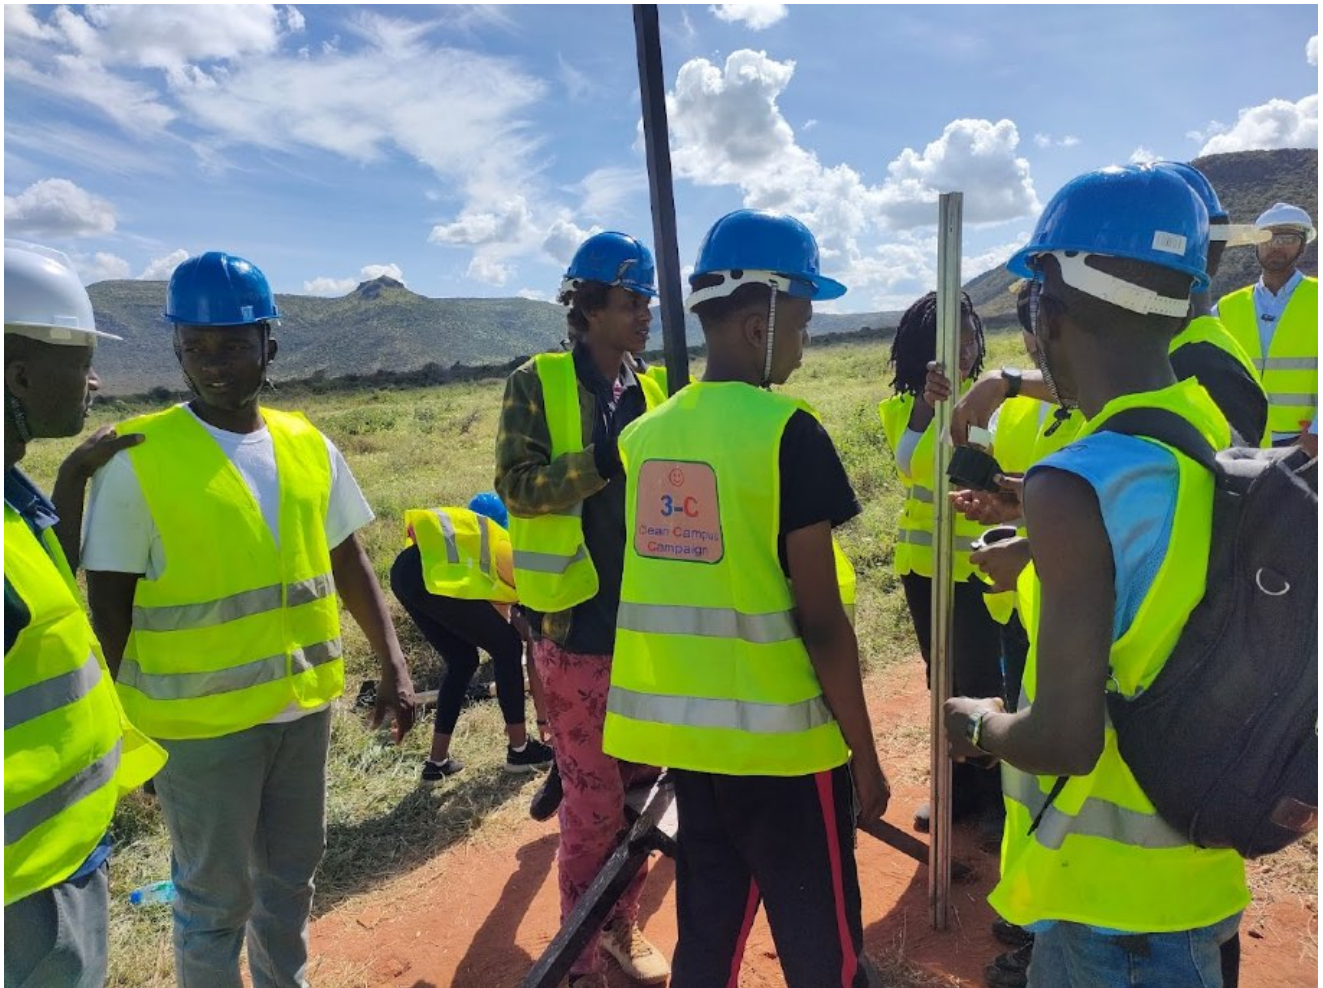
Figure 19. The team fixes launch rail after the 1st launch

The launchpad was intact after the launch, except for the damaged launch rail during the first flight. The team initially adhered launch rugs to the rocket airframe, increasing the friction between the rocket and the launch pad. Based on the advice from Major Were, the team decided not to adhere the launch rugs on the airframe using epoxy. In the 2nd and 3rd launches, the rails were not damaged, so the effectiveness of the new method was proven.

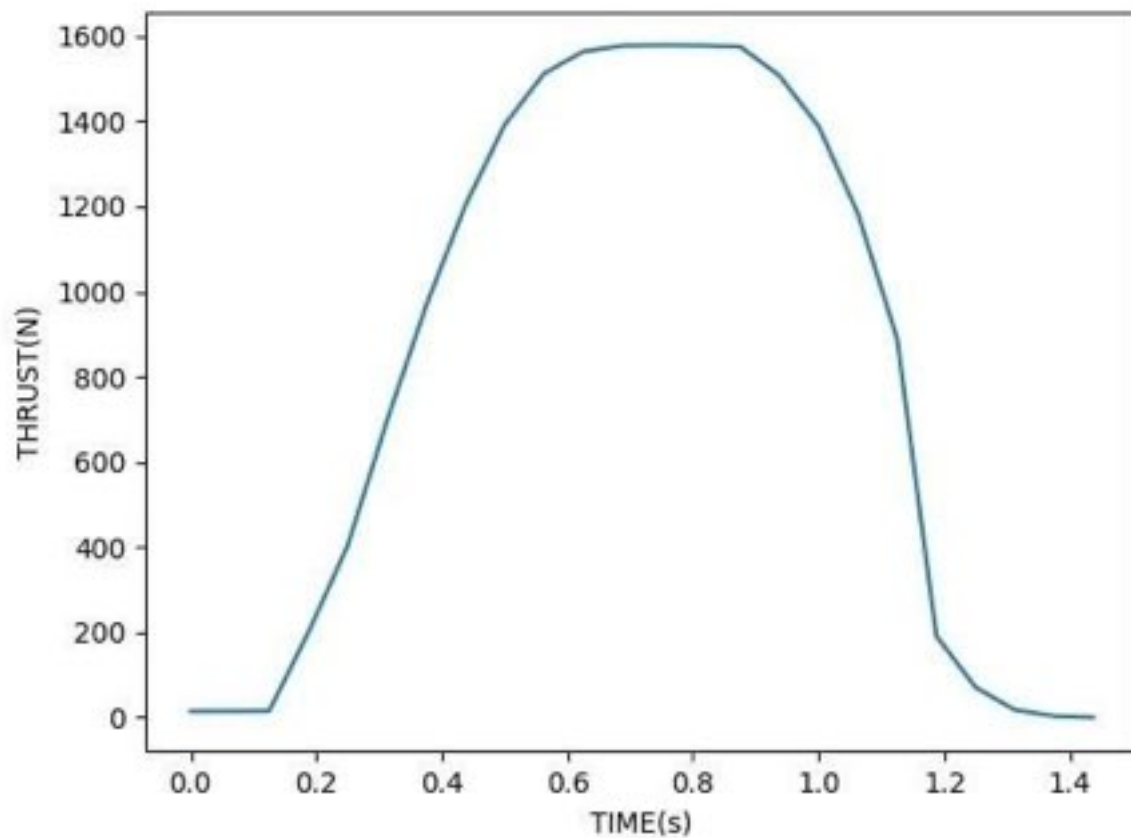
Figure 21. Thrust curve of the new solid rocket motor

The total impulse of the motor is calculated as 1220.74 [N•s], which is categorized as a J-class motor. This means there is still room for improving the solid rocket motor's performance since the designed motor's theoretical performance is 2,104 [N•s], categorized as a K-class motor.
