Installation / Location	PS-3
Subject	Corrosion Monitoring Activities
Contract Number	LC241047A0
Assigned Axxess Representatives	Stuart Dunthorne
Date of Issue	18-07-2025

Activities Summary

Work activities were completed today, with Coupon and ER Probe locations being serviced on PS3-D Upper Deck and Main Decks. We also returned to PS3-B to install a new ER Probe at 1 location where there was a handrail obstruction. Further details as follows.

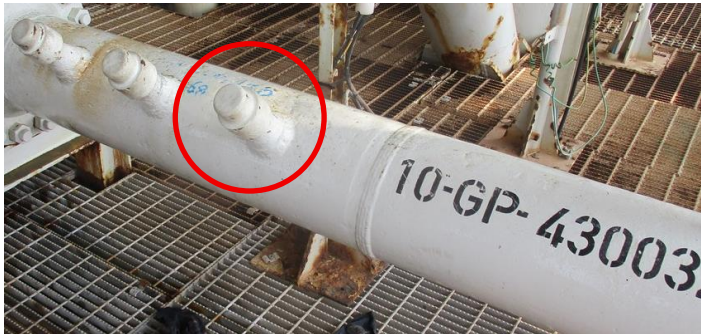
Comments Although the location was serviced, the Access Fitting sealing face is in poor condition, with widespread pitting. This can become problematic during the retrieval process if a good seal between the Service Valve and sealing face is not maintained. It is recommended that the Access Fitting be replaced during shutdown, or the existing fitting be repaired/refaced during normal operations.

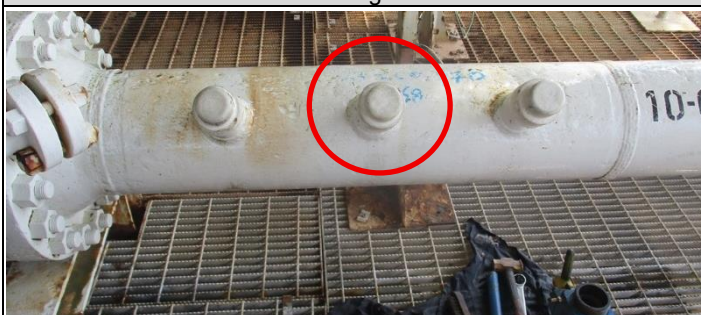
Access Fitting Picture

Although the location was serviced, the Access Fitting sealing face is in poor condition, with widespread pitting. This can become problematic during the retrieval process if a good seal between the Service Valve and sealing face is not maintained. It is recommended that the Access Fitting be replaced during shutdown, or the existing fitting be repaired/refaced during normal operations.

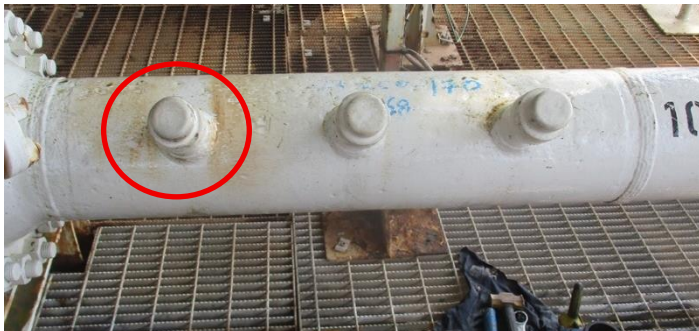
Comments Although the location was serviced, the Access Fitting sealing face is in poor condition, with widespread pitting. This can become problematic during the retrieval process if a good seal between the Service Valve and sealing face is not maintained. It is recommended that the Access Fitting be replaced during shutdown, or the existing fitting be repaired/refaced during normal operations.

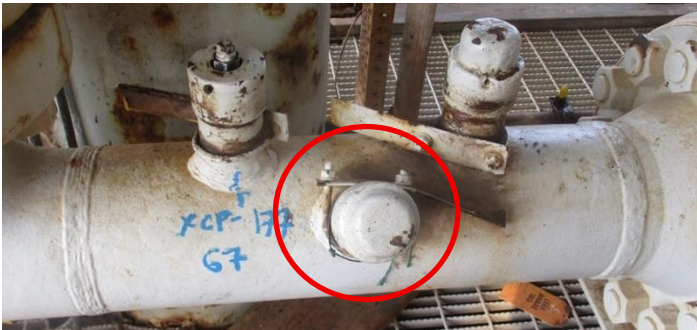
Comments Although the location was serviced, the Access Fitting sealing face is in poor condition, with widespread pitting. This can become problematic during the retrieval process if a good seal between the Service Valve and sealing face is not maintained. It is recommended that the Access Fitting be replaced during shutdown, or the existing fitting be repaired/refaced during normal operations.

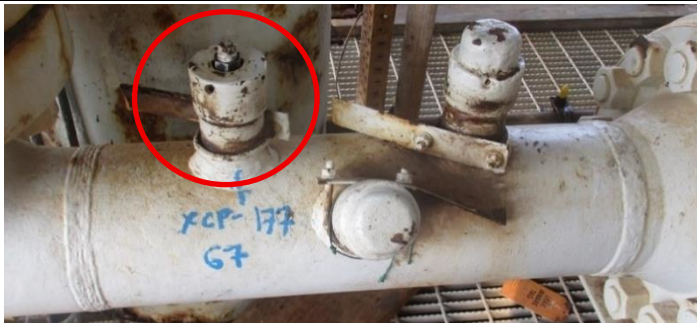
18/07/2025 10:53				
Comments Exact specification of probe was not available, so slightly different specification was installed. Removed probe was 8.5" T10. The Checkmate handheld device was set up with the new specification of element. This location has also suffered pitting on the sealing face so it should be repaired as soon as possible.

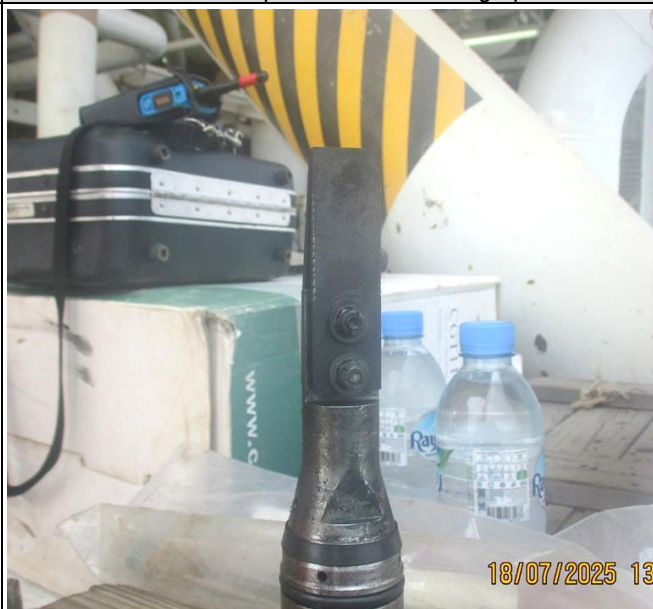
Comments Although the coupons were successfully retrieved, resistance could be felt during operation of the tool, indicating that something was jamming/catching the installed coupons. Upon closer inspection of the retrieved coupons, mechanical damage could clearly be seen on the edges of the coupons. This would indicate an obstruction within the Access Fitting, most likely weld impingement from the fabrication process. It is recommended that this fabrication defect be repaired during the next available shutdown. This task could probably be completed with just basic hand tools

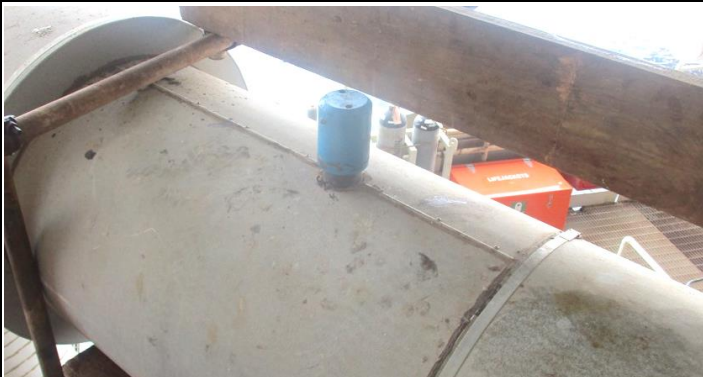
18/07/2025 14:33			
Comments This location has suffered some pitting on the sealing face so it should be repaired/refaced as soon as possible. The retrieved coupon holder was only 2.12" long so a longer 11.5" holder was installed. An even longer holder could potentially be installed, but this would mean moving up to the 37" Retrieval Tool. Using the 37" tool would however be much more difficult, as the tool would need to be moved up onto the high scaffolding tower.

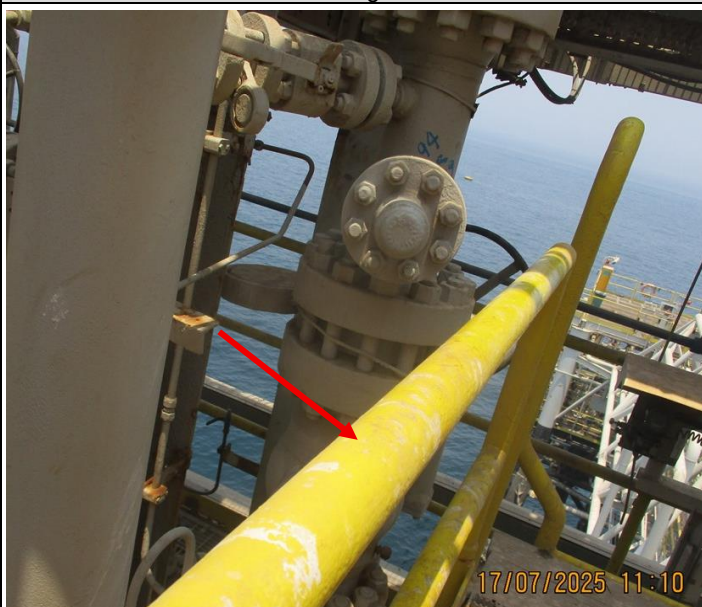
Access Fitting Picture

The Access Fitting at this location is obstructed by a handrail. The handrail was successfully removed by the mechanical team, but it took quite some time and proved very challenging. It is recommended that a permanent modification be made to the handrail so future servicing is easier.
