Annual performance report for: Derriford Incinerator Facility

Permit Number: EPR/GP3236AX

Year: 2022

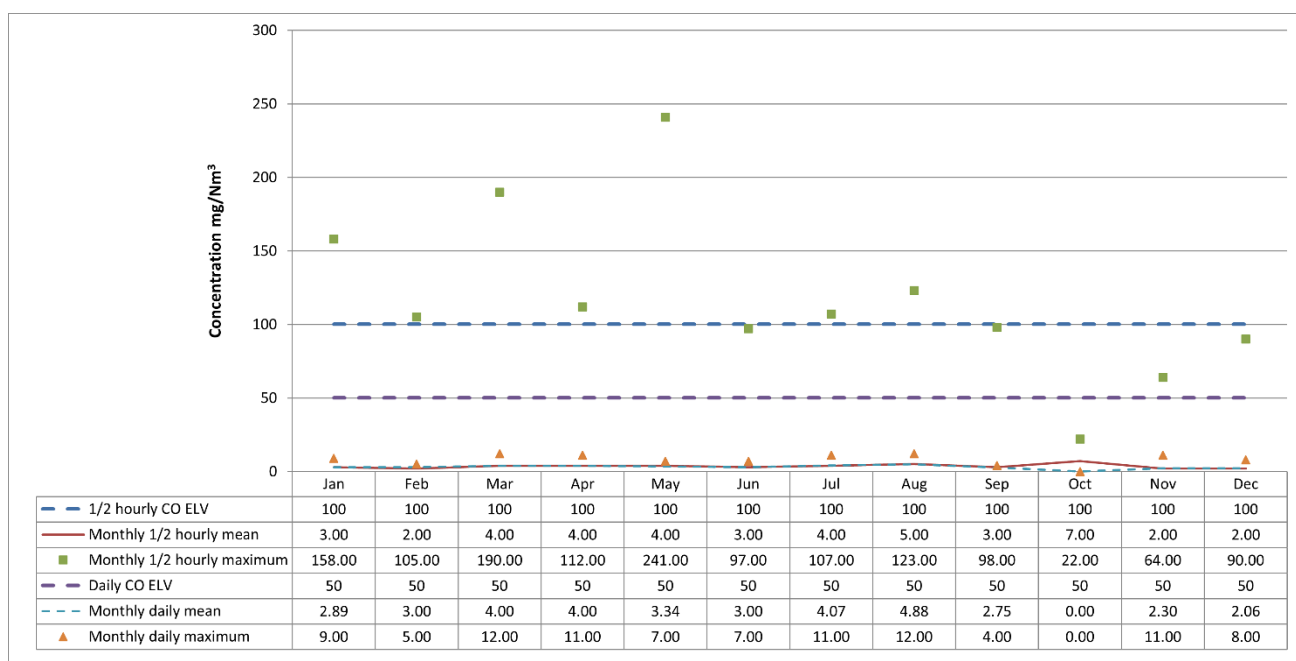
Line 1 – Carbon monoxide (CO)

Date	Summary of notification or non-compliance	Reason	Measures taken to prevent reoccurrence
15/01/2022	CO exceedance 1	The shift foreman (JR) reported a CO exceedance. This was caused by an unidentified item of waste within the contents of a bin which caused high levels of CO; waste feeding and rotation were stopped to allow the CO levels to deplete.	CO. Potentially high-risk waste streams are already diluted to reduce the harmful effect of emissions on the environment. Despite having copies of all consignees pre acceptance waste declarations.
18/01/2022	SO2 exceedance 2	The shift foreman (EB) reported a SO2 exceedance. This was caused by an identified item of waste within the contents of a bin which caused high levels of SO2; waste feeding and rotation were stopped, and the lime	SO2. Potentially high-risk waste streams are already diluted to reduce the harmful effect of emissions on the environment. Despite having copies of all consignees pre acceptance waste

speed increased to combat the high levels of SO2.	declarations.
01/02/2022	CO exceedance 3	The shift foreman (EB) reported a CO exceedance. This was caused by an unidentified item of waste within the contents of a bin which caused high levels of CO; waste feeding and rotation were stopped to allow the CO levels to deplete.	CO. Potentially high-risk waste streams are already diluted to reduce the harmful effect of emissions on the environment. Despite having copies of all consignees pre acceptance waste declarations.
16/03/2022	SO2 exceedance 4	The shift foreman (GB) reported a SO2 exceedance. This was caused by an unidentified item of waste within the contents of a bin which caused high levels of SO2; waste feeding and rotation were stopped to allow the SO2 levels to deplete	SO2. Potentially high-risk waste streams are already diluted to reduce the harmful effect of emissions on the environment. Despite having copies of all consignees pre acceptance waste declarations.

02/05/2022	CO exceedance 9	The shift foreman (EB) reported a CO exceedance. This was caused by an unidentified item of waste within the contents of a bin which caused high levels of CO; waste feeding and rotation were stopped to allow the CO levels to deplete.	CO. Potentially high-risk waste streams are already diluted to reduce the harmful effect of emissions on the environment. Despite having copies of all consignees pre acceptance waste declarations.
04/05/2022	CO exceedance 10	The shift foreman (JR) reported a CO exceedance. This was caused by an unidentified item of waste within the	CO. Potentially high-risk waste streams are already diluted to reduce the harmful effect of emissions on the environment.

contents of a bin which caused high levels of CO; waste feeding and rotation were stopped to allow the CO levels to deplete.	Despite having copies of all consignees pre acceptance waste declarations.
16/05/2022	CO exceedance 11	The shift foreman (BE) reported a CO exceedance. This was caused by an unidentified item of waste within the contents of a bin which caused high levels of CO; waste feeding and rotation were stopped to allow the CO levels to deplete.	CO. Potentially high-risk waste streams are already diluted to reduce the harmful effect of emissions on the environment. Despite having copies of all consignees pre acceptance waste declarations.
16/05/2022	CO exceedance 12	The shift foreman (BE) reported a CO exceedance. This was caused by an unidentified item of waste within the contents of a bin which caused high levels of CO; waste feeding and rotation were stopped to allow the CO levels to deplete.	CO. Potentially high-risk waste streams are already diluted to reduce the harmful effect of emissions on the environment. Despite having copies of all consignees pre acceptance waste declarations.

08/07/2022	CO exceedance 13	The shift foreman (EB) reported a CO exceedance. This was caused by an unidentified item of waste within the contents of a bin which caused high levels of CO; waste feeding and rotation were stopped to allow the CO levels to deplete.	CO. Potentially high-risk waste streams are already diluted to reduce the harmful effect of emissions on the environment. Despite having copies of all consignees pre acceptance waste declarations.
28/07/2022	CO exceedance 14	The shift foreman reported a CO exceedance. This was caused by an unidentified item of waste within the contents of a bin which caused high levels of CO; waste feeding and rotation were stopped to allow the CO levels to deplete.	CO. Potentially high-risk waste streams are already diluted to reduce the harmful effect of emissions on the environment. Despite having copies of all consignees pre acceptance waste declarations.

12/08/2022	CO exceedance 15	The shift foreman (BE) reported a CO exceedance. This was caused by an unidentified item of waste within the contents of a bin which caused high levels of CO; waste feeding and rotation were stopped to allow the CO levels to deplete.	CO. Potentially high-risk waste streams are already diluted to reduce the harmful effect of emissions on the environment. Despite having copies of all consignees pre acceptance waste declarations.
16/08/2022	SO2 exceedance 16	The shift foreman (GB) reported a SO2 exceedance. This was caused by an unidentified item of waste within the contents of a bin which caused high levels of SO2; waste feeding and rotation were stopped to allow the SO2 levels to deplete.	SO2. Potentially high-risk waste streams are already diluted to reduce the harmful effect of emissions on the environment. Despite having copies of all consignees pre acceptance waste declarations.

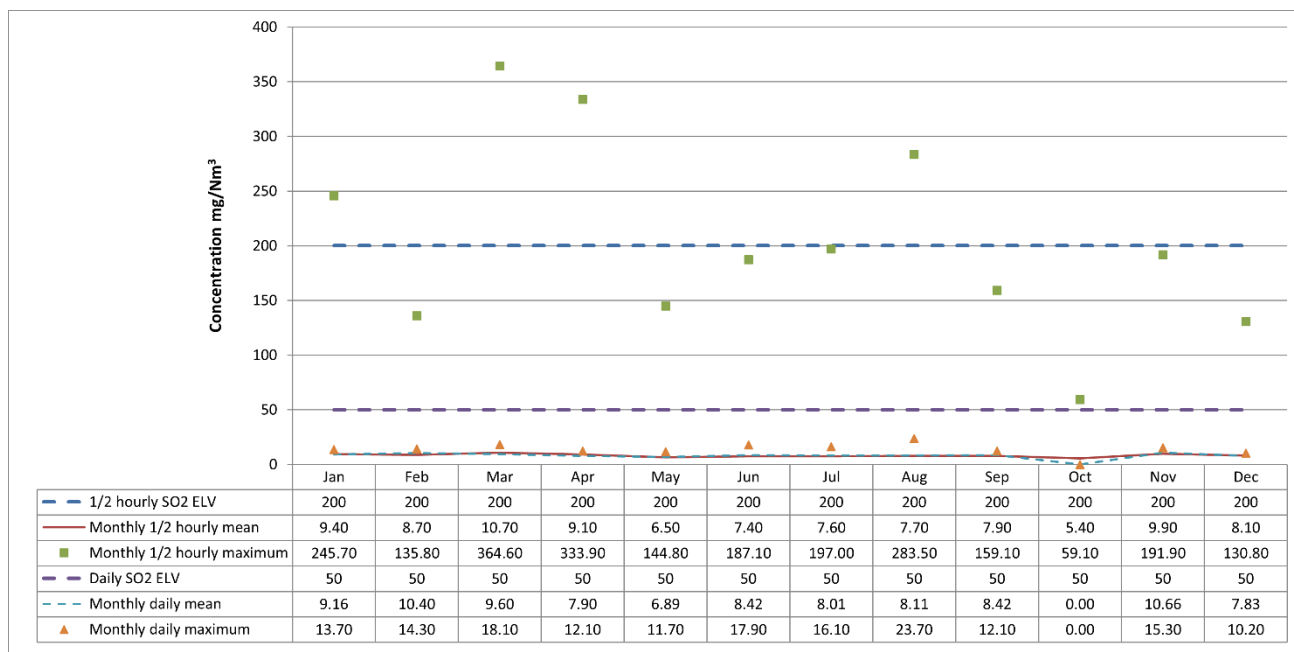
Line 1 – Sulphur dioxide (So2)

16/03/2022	SO2 exceedance 5	The shift foreman (EB) reported a SO2 exceedance. This was caused by an unidentified item of waste within the contents of a bin which caused high levels of SO2; waste feeding and rotation were stopped to allow the SO2 levels to deplete	SO2. Potentially high-risk waste streams are already diluted to reduce the harmful effect of emissions on the environment. Despite having copies of all consignees pre acceptance waste declarations.
27/03/2022	CO exceedance 6	The shift foreman (EB) reported a CO exceedance. This was caused by an unidentified item of waste within the contents of a bin which caused high levels of CO; waste feeding and rotation were stopped to allow the CO levels to deplete	CO. Potentially high-risk waste streams are already diluted to reduce the harmful effect of emissions on the environment. Despite having copies of all consignees pre acceptance waste declarations.

13/04/2022	SO2 exceedance 7	The shift foreman (GB) reported a SO2 exceedance. This was caused by an unidentified item of waste within the contents of a bin which caused high levels of SO2; waste feeding and rotation were stopped to allow the SO2 levels to deplete.	SO2. Potentially high-risk waste streams are already diluted to reduce the harmful effect of emissions on the environment. Despite having copies of all consignees pre acceptance waste declarations.
19/04/2022	CO exceedance 8	The shift foreman (EB) reported a CO exceedance. This was caused by an unidentified item of waste within the contents of a bin which caused high levels of CO; waste feeding and rotation were stopped to allow the CO levels to deplete.	CO. Potentially high-risk waste streams are already diluted to reduce the harmful effect of emissions on the environment. Despite having copies of all consignees pre acceptance waste declarations.
