## STM32MP151x/3x/7x device errata

This document applies to the part numbers of STM32MP151x/3x/7x devices and the device variants as stated in this page.

It gives a summary and a description of the device errata, with respect to the device datasheet and reference manual RM0441 for STM32MP151x, RM0442 for STM32MP153x, and RM0436 for STM32MP157x.

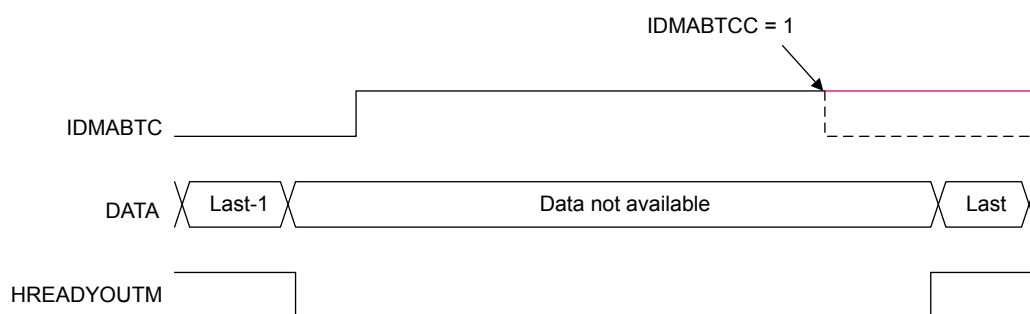
**Figure 4. SDMMC AHB transfer vs IDMABTC flag status**

If the internal/external memory is not ready to transmit/receive the last word before the IDMABTCC is set, the IDMABTC flag is not cleared whereas it should be (see Figure 4). As a result, the software may consider it several times.

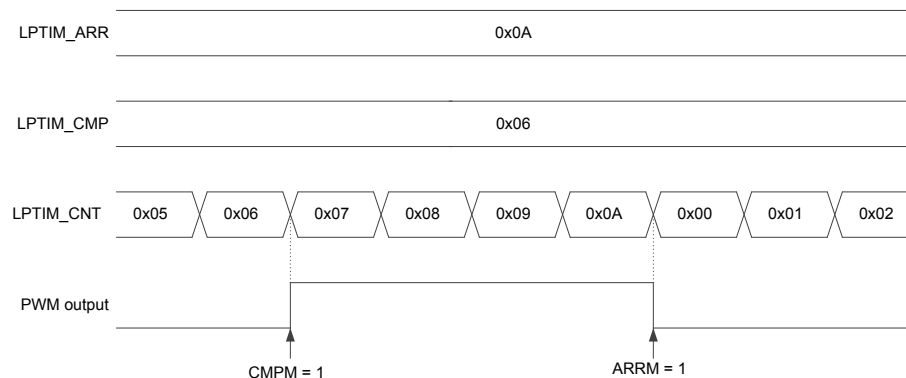
**Figure 5. Example of PWM output mode**

The following waveform gives the example of PWM output mode and the effect of the delay:

Set the compare value to the desired value minus 1. For instance in order to generate a compare match when LPTIM\_CNT = 0x08, set the compare value to 0x07.
