# **NATIONAL TRANSPORTATION SAFETY BOARD**

## **PIPELINE ACCIDENT SUMMARY REPORT**

**NATURAL GAS PIPELINE RUPTURE AND FIRE  
DURING DREDGING OF TIGER PASS, LOUISIANA  
OCTOBER 23, 1996**

**NTSB/PAR-98/01/SUM  
PB98-916501  
Notation 6809A  
Adopted: September 28, 1998**

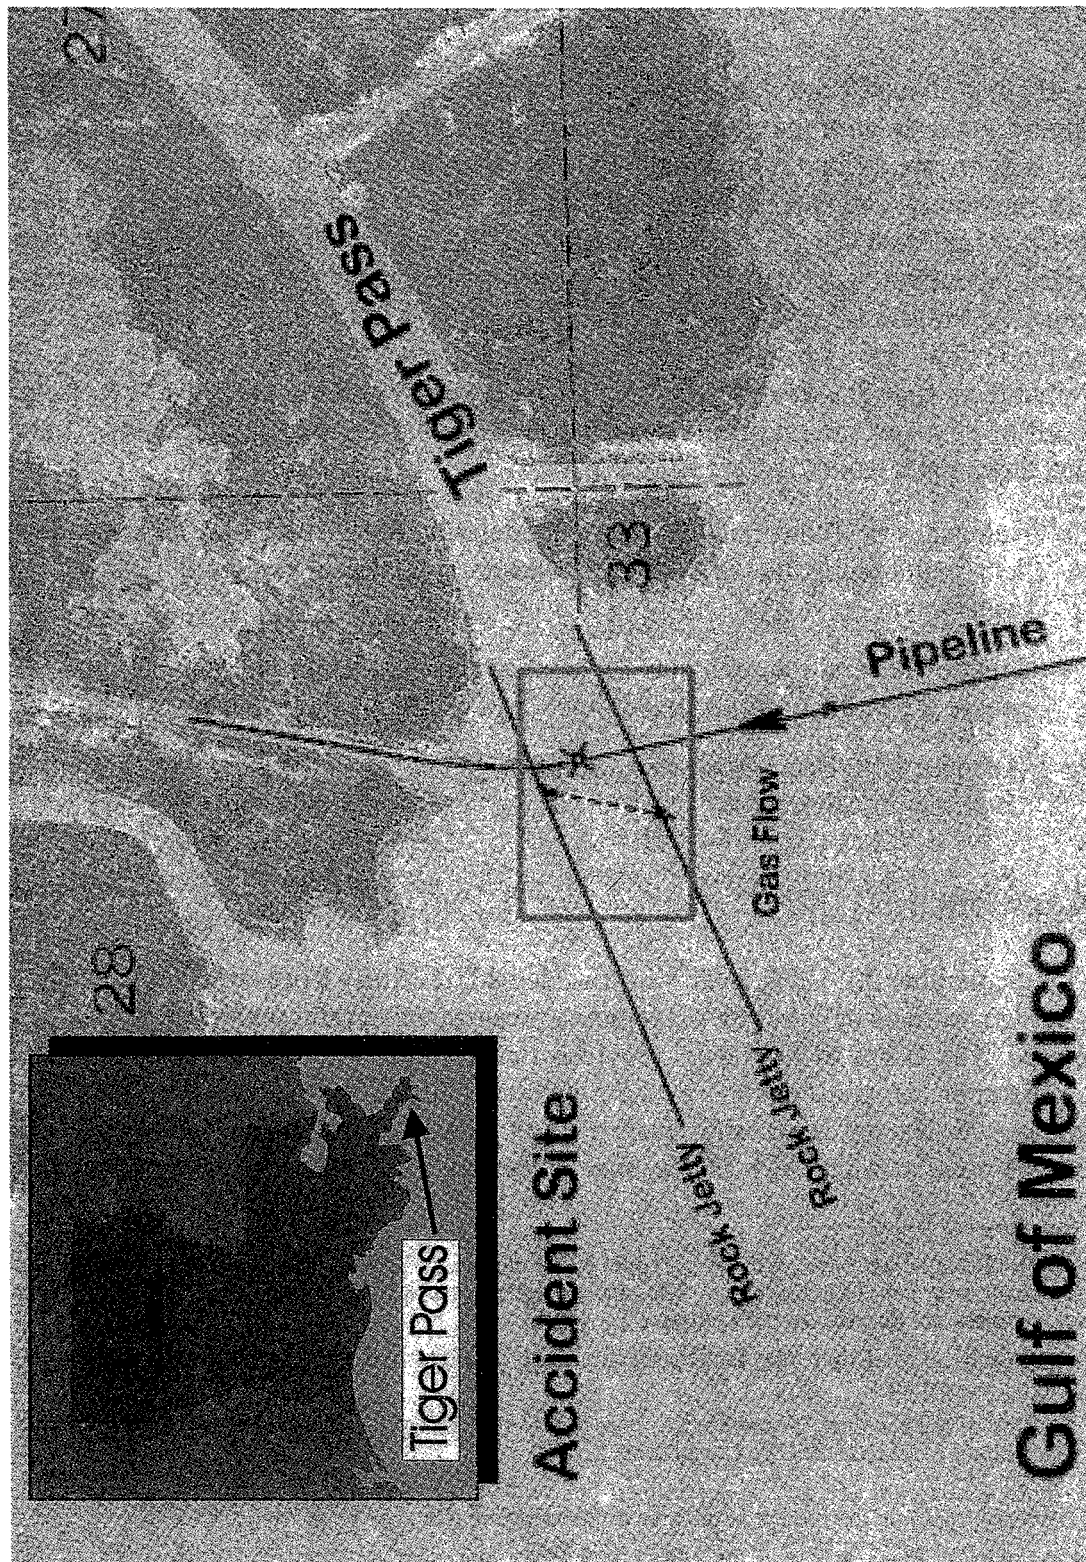
Figure 1. Overview of accident site. Dotted line marks location of pipeline as identified by pipeline operator. (Rectangular area shown in greater detail in figure 2.)

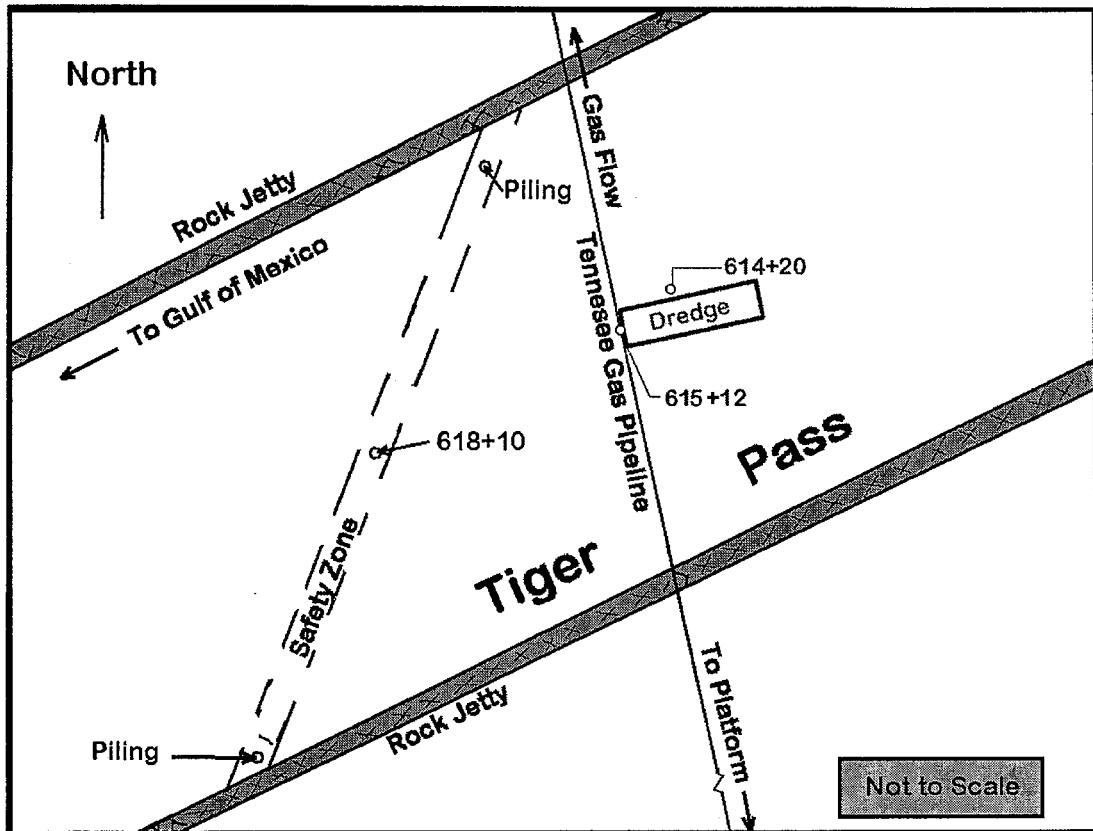
About 2 p.m., on October 19, a Tennessee Gas inspector boarded the dredge and, using information and a sketch provided by her supervisor, established a 100-foot safety zone in the area of the two pilings. (See figure 2.) In order to avoid damage to the pipeline, dredging in that area was to be done with the suction pumps only, without using the cutting head. Bean's daily quality control reports showed that the pipeline location identified by Tennessee Gas personnel did not match the location shown on the Corps of Engineers drawings.

Figure 2. Detailed view of accident area. Corps of Engineers drawings showed location of pipeline at 614+20; pipeline owner identified location as 618+10; actual location was 615+12.

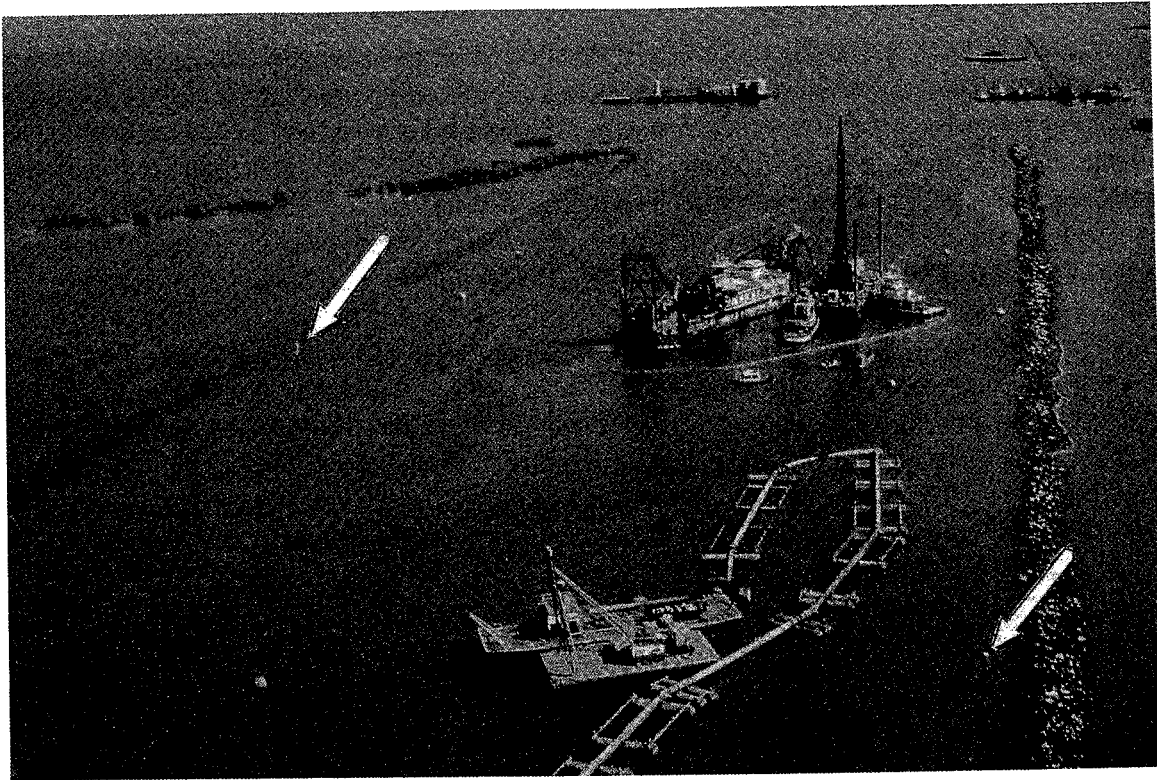
On October 23, at 4:50 a.m., after stopping the dredging to clean the cutting head and reset the swing anchors, the crew dropped a stern spud into the river at about station 615+12 and directly into the Tennessee Gas pipeline, rupturing the pipeline and releasing pressurized natural gas. (See figure 3.)

Figure 3. Aerial view of the stern of dredge *Dave Blackburn* (large white vessel near the center) and the pilings (marked by arrows) that were believed to locate the pipeline. The rectangular framework on the stern of the dredge is directly over the ruptured pipeline.
