# Preliminary assessment of the damage of the Feb. 6 Turkey earthquake on Chinese and Turkish buildings

Xinzheng Lu

Tsinghua University, Beijing China, [luxz@tsinghua.edu.cn](mailto:luxz@tsinghua.edu.cn)

Feb. 8. 2023, 11:30 (UTC +8)

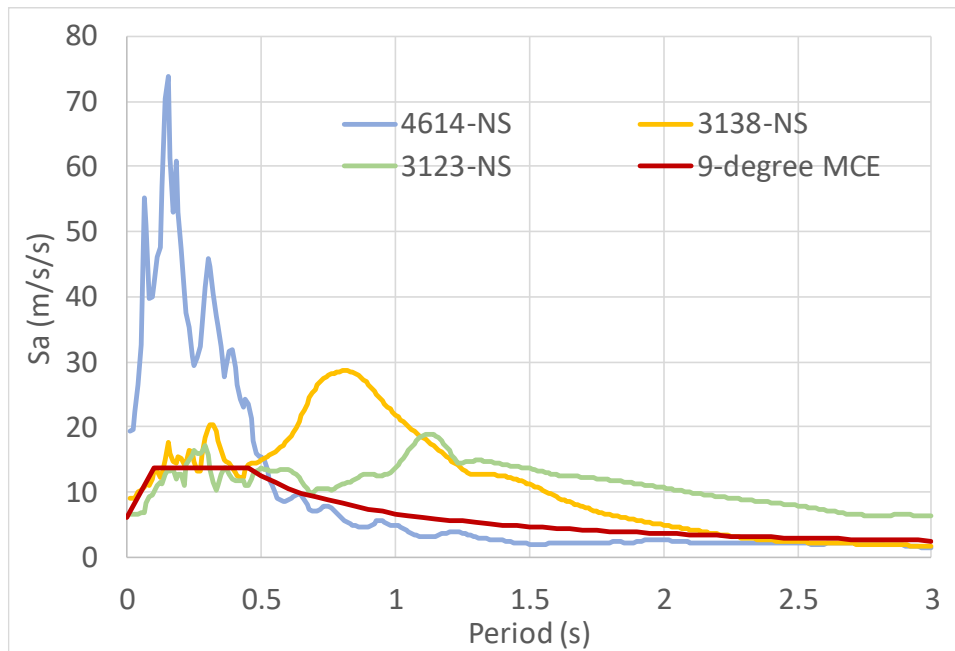
Figure 1 Response Spectrum of Typical Stations for the First M7.8 Earthquake

As can be seen from Figure 1, the M7.8 earthquake provided full-frequency coverage from short-period (station 4614), medium-period (station 3138), to long-period (station 3123). It is particularly worth mentioning that the red line in Figure 1 is the design response spectrum of the 9-degree maximal considered earthquake (MCE) in the Chinese design code. Readers familiar with Chinese earthquake engineering are aware that 9-degree MCE is the highest level for seismic design in China, with only a few areas or projects meeting this standard. However, the actual earthquake intensity of the M7.8 earthquake far exceeded this highest level. It can be seen that this earthquake is powerful.

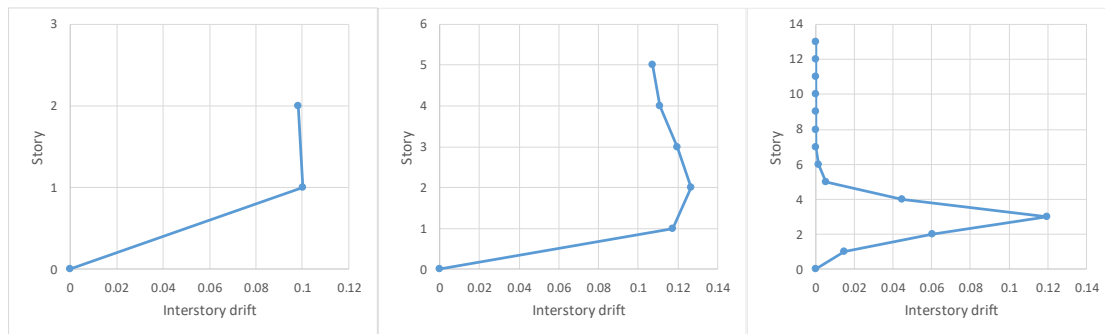
Let's first look at the damage to individual buildings. We analyzed the responses of three Turkish multi- and high-rise reinforced concrete frame models (2 stories, 5 stories, and 13 stories) subjected to the ground motion recorded at station 3123, and the results were as expected. All three frames collapsed very quickly (Figure 3). Therefore, Turkish buildings seem to be very difficult to resist the strong ground motions near the epicenter of this earthquake.

Figure 3 The response of the Turkish multi- and high-rise frames subjected to the ground motion recorded at station 3123

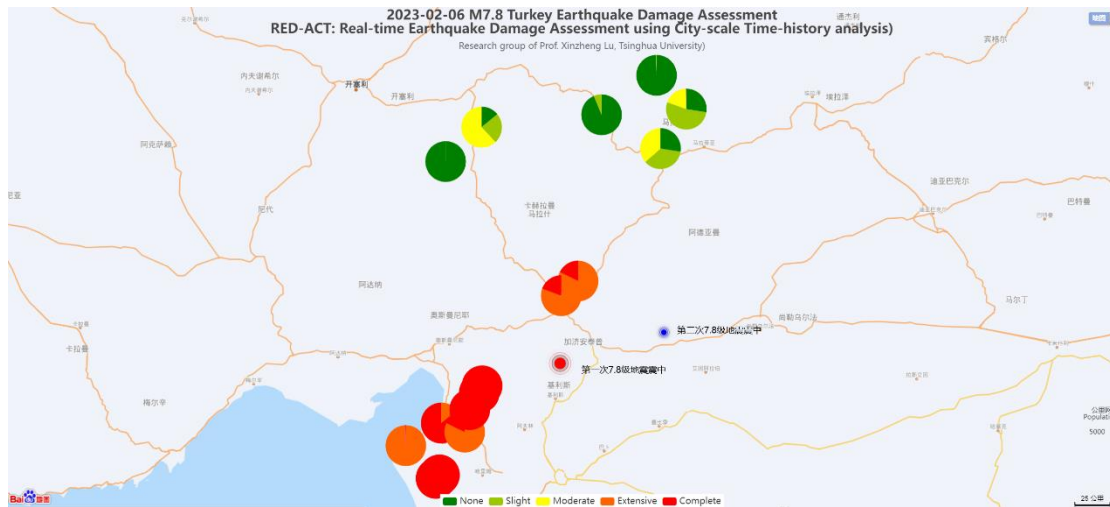
Figure 4 Distribution of regional building damage subjected to the first M7.8 earthquake

It can be seen from Figures 4 and 5 that the earthquake damage on the south side of the map is very serious, and most buildings approach the state of collapse or severe damage (red or orange).

Note that Figure 4 is only the damage caused by the first M7.8 earthquake. The buildings near the epicenter of the second M7.8 earthquake (the blue dot) will definitely suffer serious damage after the second M7.8 earthquake!

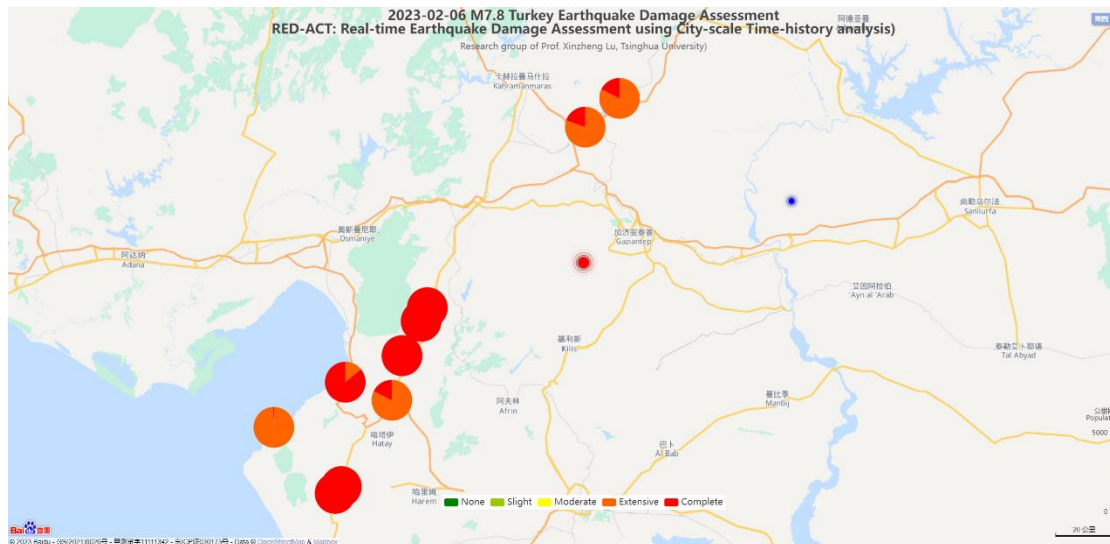
Figure 5. Distribution of regional building damage subjected to the first M7.8 earthquake (zoom-in)

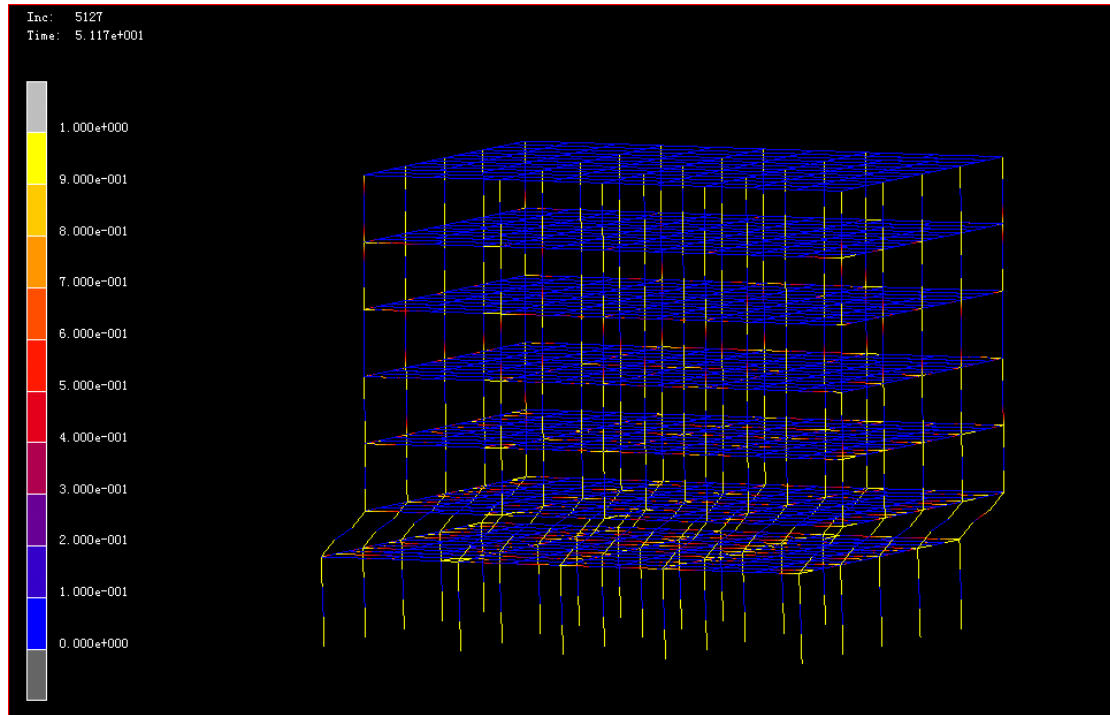
We input the ground motion records of station 3123 into the reinforced concrete frame, and the collapse process of the structure is shown in Figure 7.

Figure.7 The collapse mode of the Chinese 7-story reinforced concrete frame subjected to the ground motion records of station 3123 (displacement amplification factor = 1)

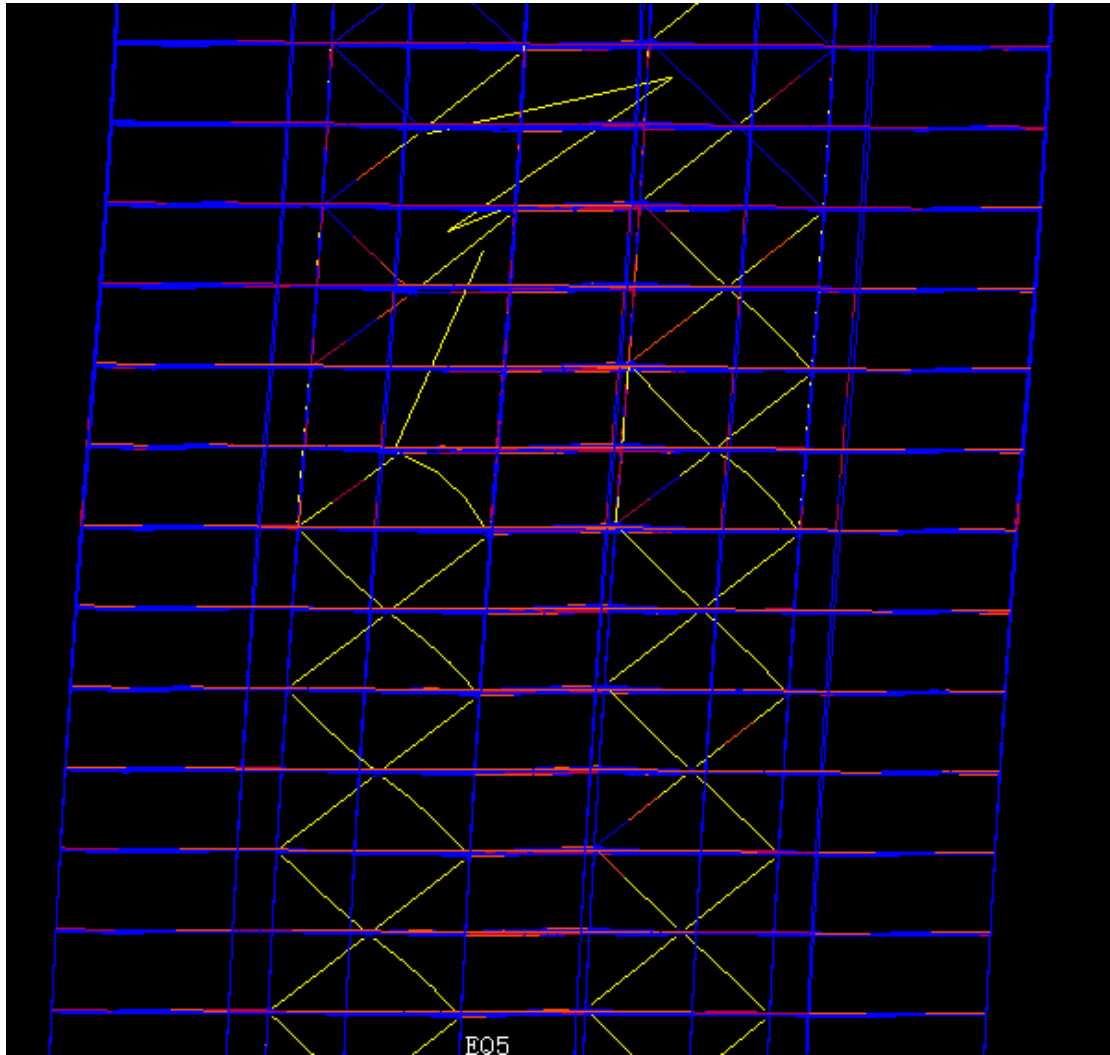
Figure 9 The damage mode of the Chinese 37-story steel braced-frame structure subjected to the ground motion records of station 3123

The steel braced-frame structure vibrates violently under the earthquake. The braces in the medium stories (ordinary rectangular steel tube braces, not BRB) buckled and failed, and finally, the overall structure was unstable and collapsed.

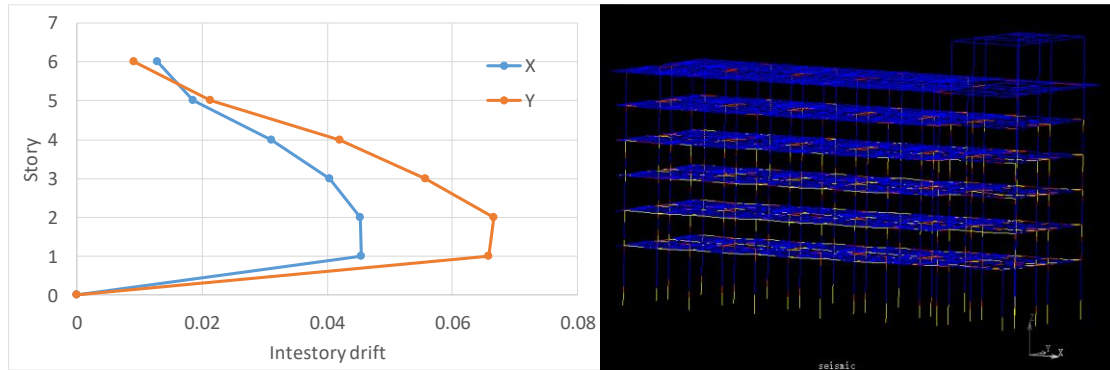
We input the ground motion records of station 3123 into the frame and obtained the structural damage status and inter-story drift envelope, as shown in Figure 11. The inter-story drift has also far exceeded the limit value of the Chinese seismic design code (code requirement: 2%, the calculated result: 6.7%).

Figure 11 Damage state and inter-story drift envelope of Chinese 6-story steel frame
