Global Rapid Post-Disaster Damage Estimation (GRADE) Report

February 6, 2023 Kahramanmaraş Earthquakes

Türkiye Report

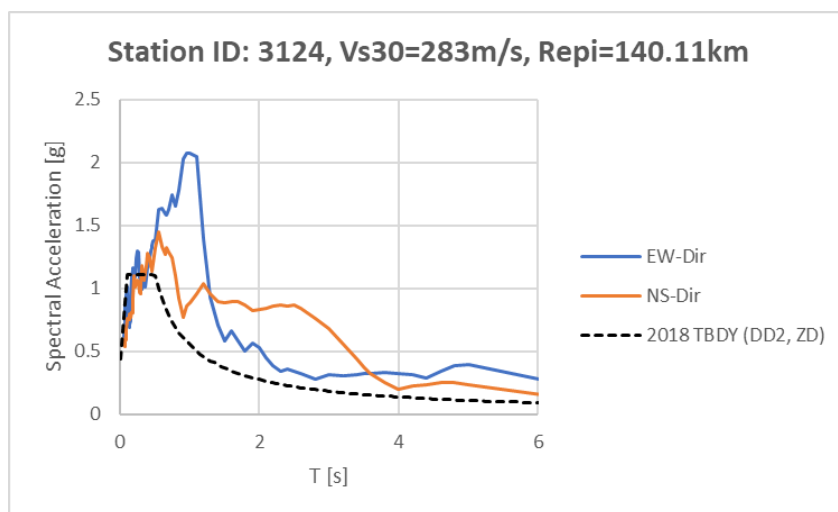
- **At some locations in the affected area, such as Antakya, recorded ground motions associated with the earthquakes were very high.** These high levels of ground motion may have contributed, alongside other critical factors, to the extensive damage observed in the affected areas (Annex A1.7 provides further information). Liquefaction¹⁵ was also observed in some areas.

Figure 7: Plots comparing the EW and NS components of spectral acceleration at a station in Antakya to the horizontal elastic response spectrum according to the seismic design code in Türkiye (2019). Recording relates to the magnitude 7.7 earthquake occurring on 06/02/23 at 01:17 UTC. More recordings are provided for multiple locations in Annex 0.

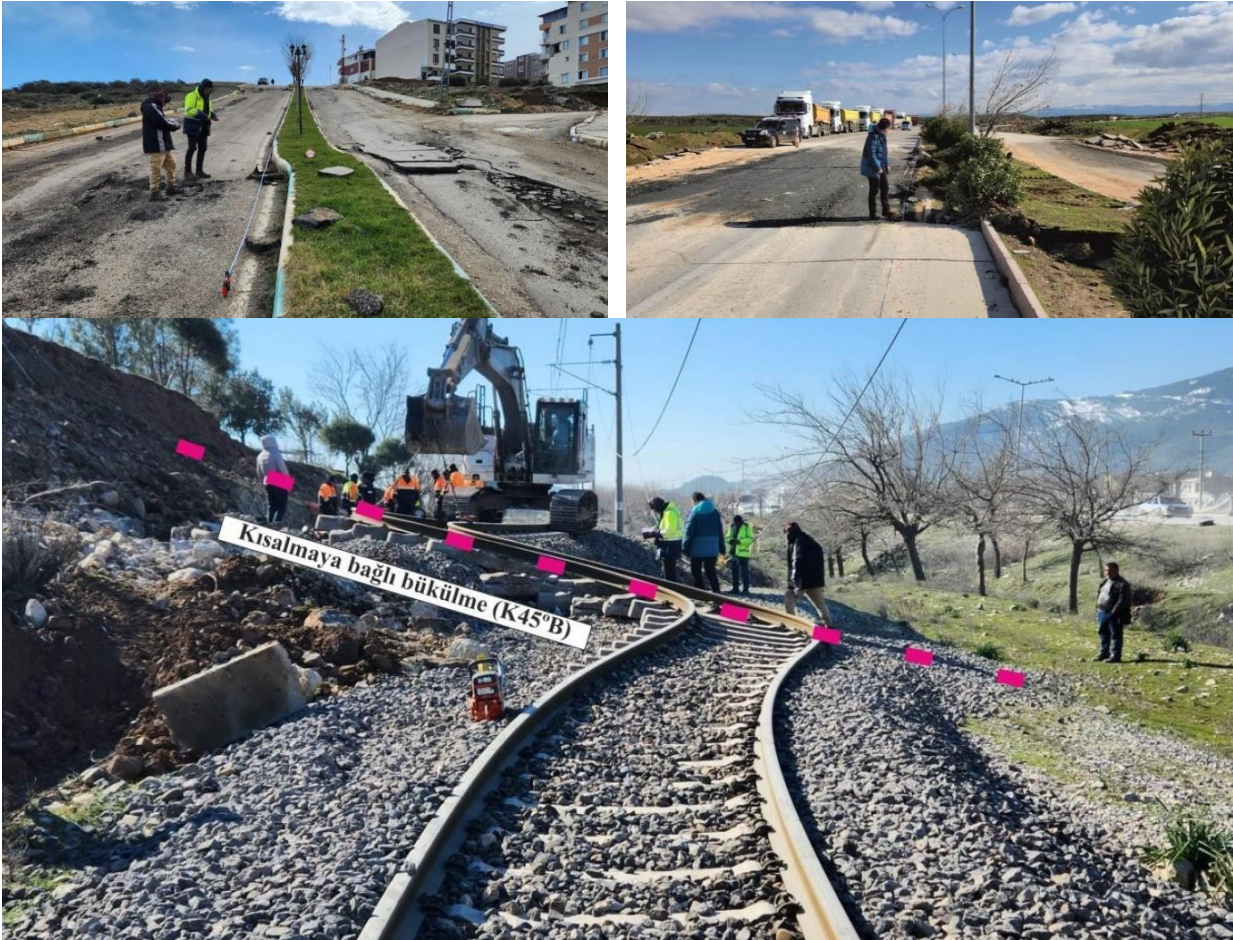
Figure 10: Examples of visible surface ruptures along roads and railways captured during field investigations in southeastern Türkiye. Source: MTA (2023).

According to the examinations and findings of the MTA team, several displacements and fault ruptures expanding up to 4.5 m were visible on roads, railways, fields and in stone walls.
