Global Rapid Post-Disaster Damage Estimation (GRADE) Report

February 6, 2023 Kahramanmaraş Earthquakes

Türkiye Report

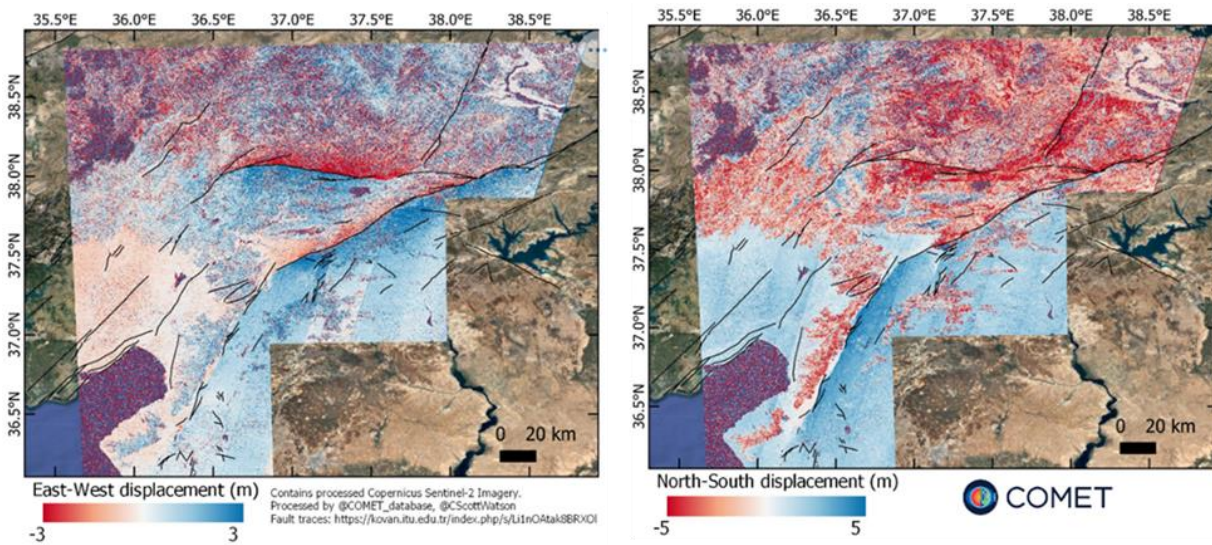
Figure 9: Surface displacement in (1) east-west and (2) north-south direction derived from pixel tracking using Sentinel-2 pre- and post-event imagery. Source: Watson (2023).

Maps that were produced using pixel offset or tracking are useful to measure surface slip, localize earthquake surface ruptures and to estimate the distribution of damages to better understand earthquake disasters. In Figure 9, two large surface displacements can be observed. The longer surface displacement rupture along the East Anatolian Fault in northeastern direction from the tip of the Mediterranean Sea was caused by the first of the two major earthquakes. It is about 300 km long. The second smaller surface displacement rupture is about 125 km long and was created by the second earthquake that occurred about nine hours later. According to Prof. Tim Wright, COMET team lead, the length of these two cracks indicates the large amount of energy that was released during the twin earthquake events; stronger earthquakes form larger and longer faults. The analysis of the COMET researchers shows horizontal displacements of up to 5 m (Pultarova, 2023).
