2025 February Deployment and Emergency Recovery of unit_1024 1024-20250224

Summary

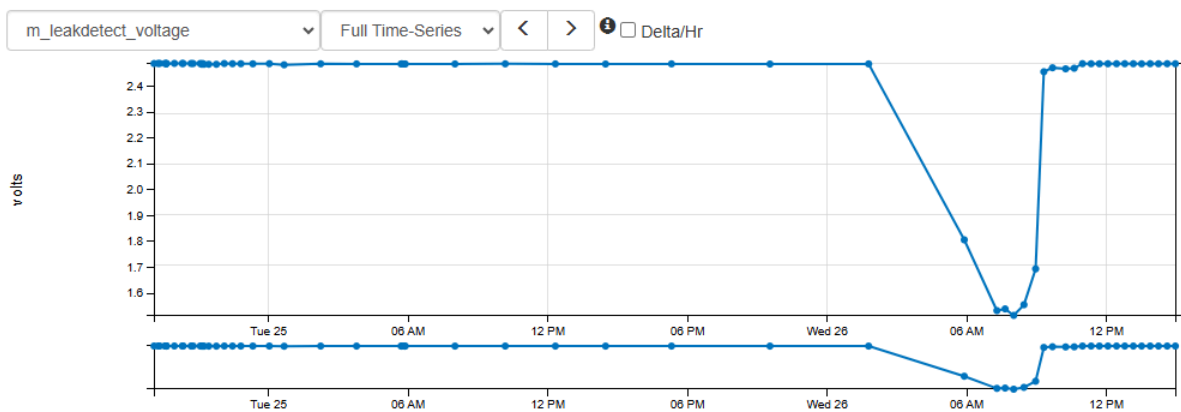
At 9:54 p.m. PST on February 26 (5:54 a.m. UTC on February 27), unit_1024 aborted its mission for a leak in the aft section. The abort occurred at 155.78 m, as the glider was climbing after a 600 m dive. Prior to the abort, the glider had performed four dives to 600 m. At the time of the abort, the aft leakdetect sensor returned a value of 1.81 V, well below the steady value of 2.485 V the sensor had maintained prior to the leak (Figure 2). Pilots retrieved a log file, but the cause of the leak remained unclear. Pilots repeatedly checked the leakdetect voltage to determine whether the abort was caused by an errant reading, but because the voltage continued to drop to a low value of 1.5 V, we concluded that the leak was real. We allowed the glider to drift at the surface overnight, although the leakdetect voltage returned to 2.487 V approximately 5 hours later. The glider was recovered on the afternoon of February 26 from the *F/V Outer Limits*. Prior to the leak, the glider traveled a total of 29.74 km while performing 29 dives to a maximum depth of 600 m.

Figure 2. Aft leakdetect readings from unit_1024, showing the drop in voltage when the leak occurred.

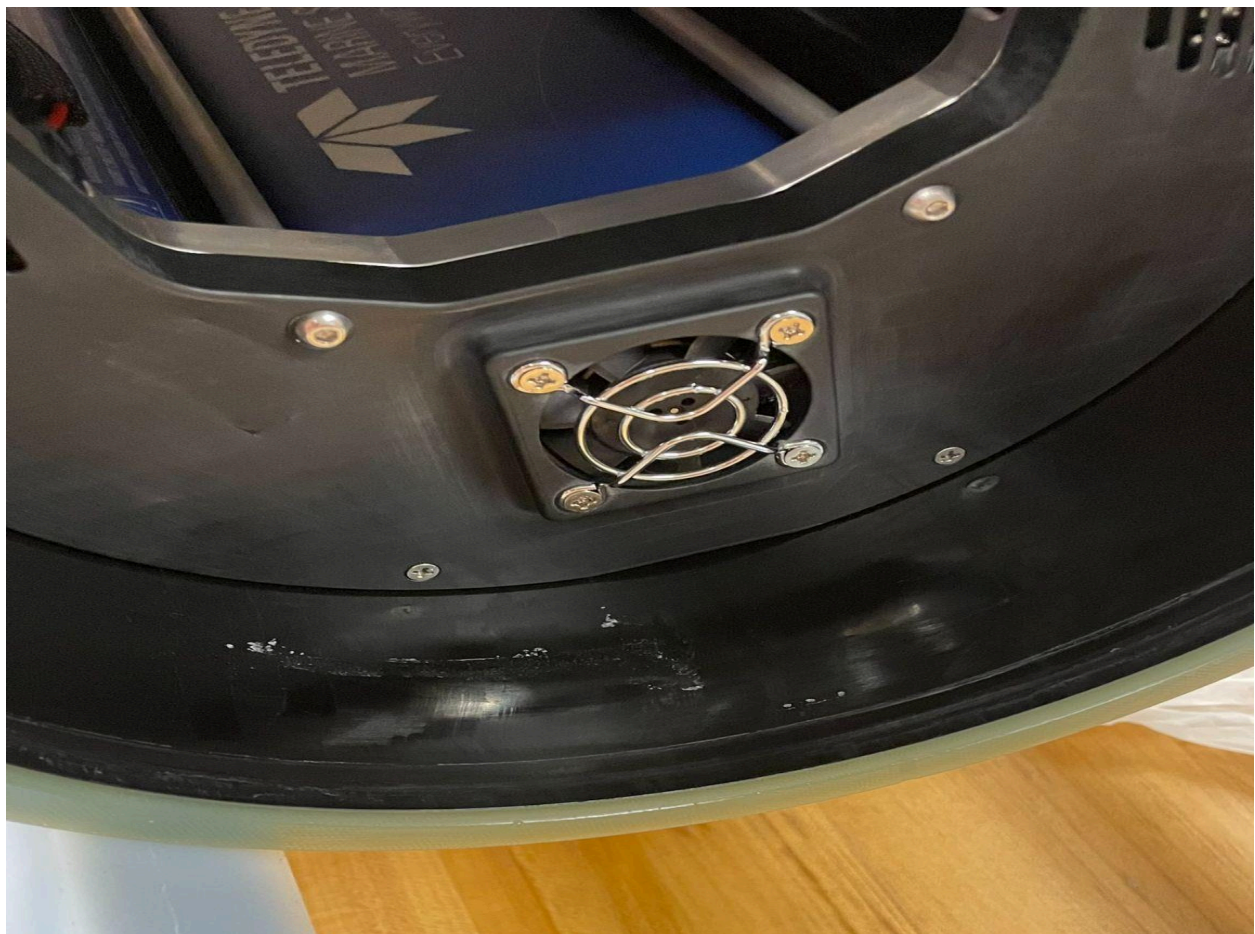
On February 27, ESD and Teledyne staff carefully opened and inspected unit_1024 to determine the source of the leak. The glider was opened methodically and slowly to allow for water between glider sections and on top of o-rings to be carefully removed. There was no evidence of water inside the glider at the junction between the aft section and the science bay, suggesting the leak occurred near the tail. There was evidence of dried salt, but no water, behind the aft battery in the hull (Figure 3), on the back edge of the battery itself (Figure 4), and on a metal plate behind the main board (Figure 5). There was also a trail of dried salt from one of the through-holes for an MCBH connector in the aft cap down to the bottom of the aft cap (Figure 6), suggesting that the MCBH connector may have been the source of the leak. The internal desiccant pack, when weighed, was 6 g heavier than it was prior to deployment, indicating that the desiccant pack had absorbed the water in the glider. The tail will be shipped back to Teledyne for further diagnostics.

Figure 3. Dried salt behind aft battery

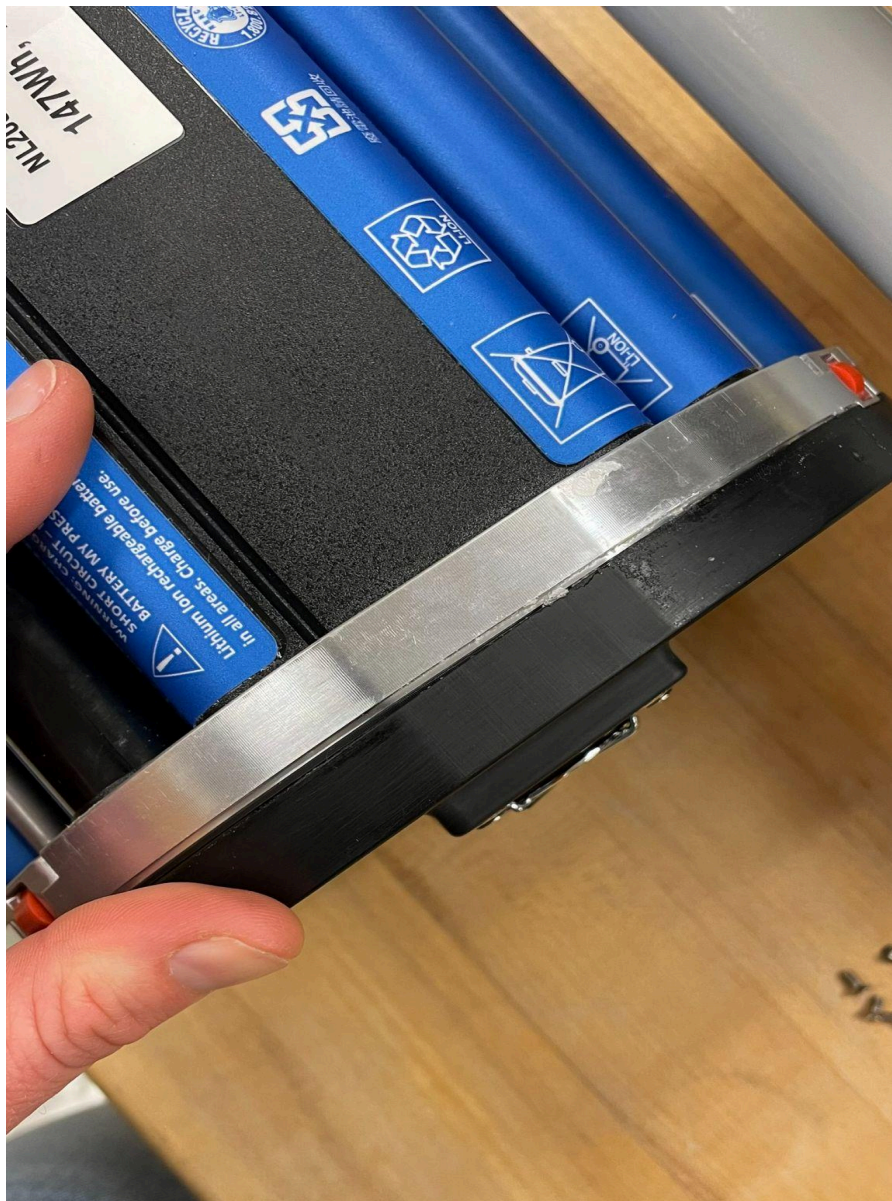
Figure 4. Dried salt on aft battery.

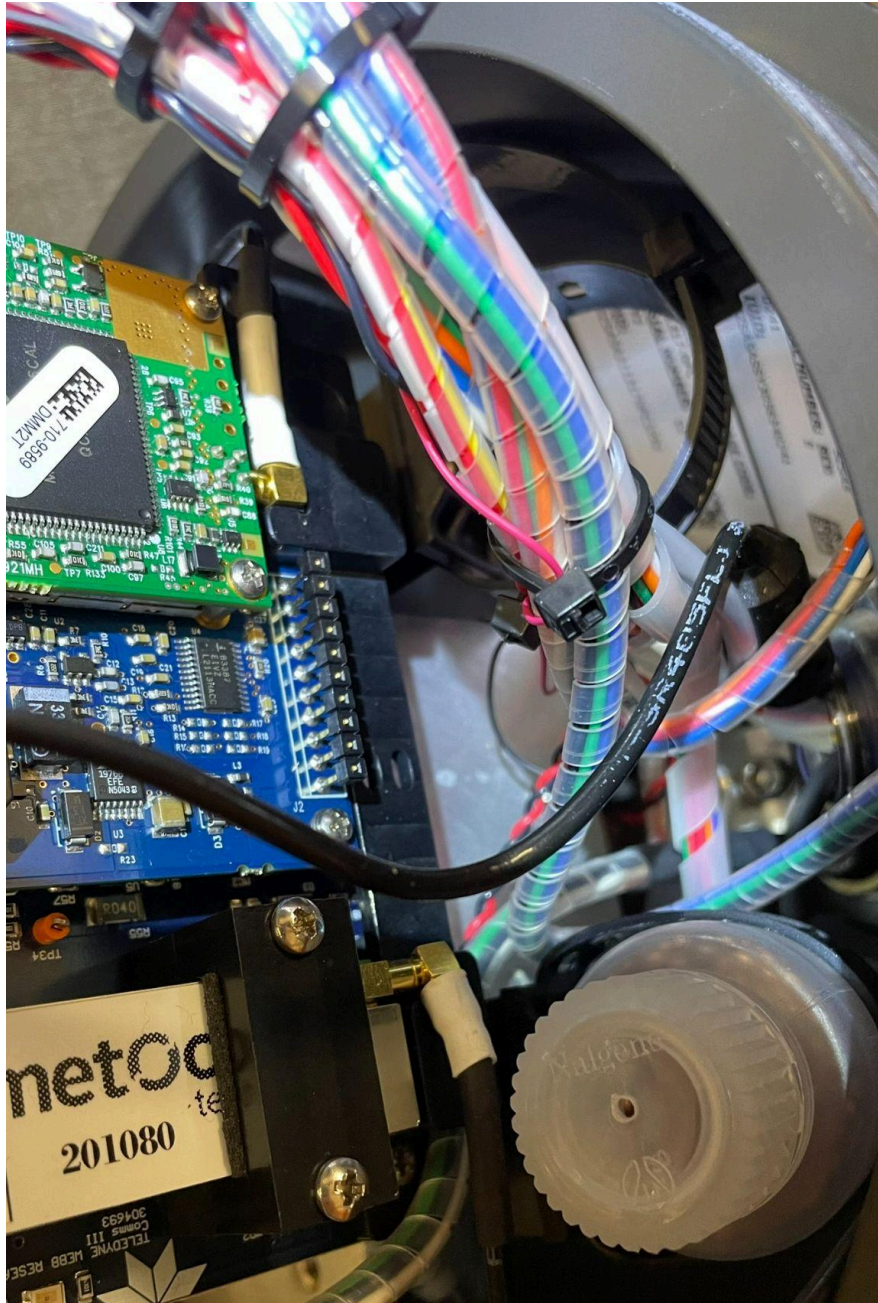
Figure 5. Dried salt on metal plate behind main board.

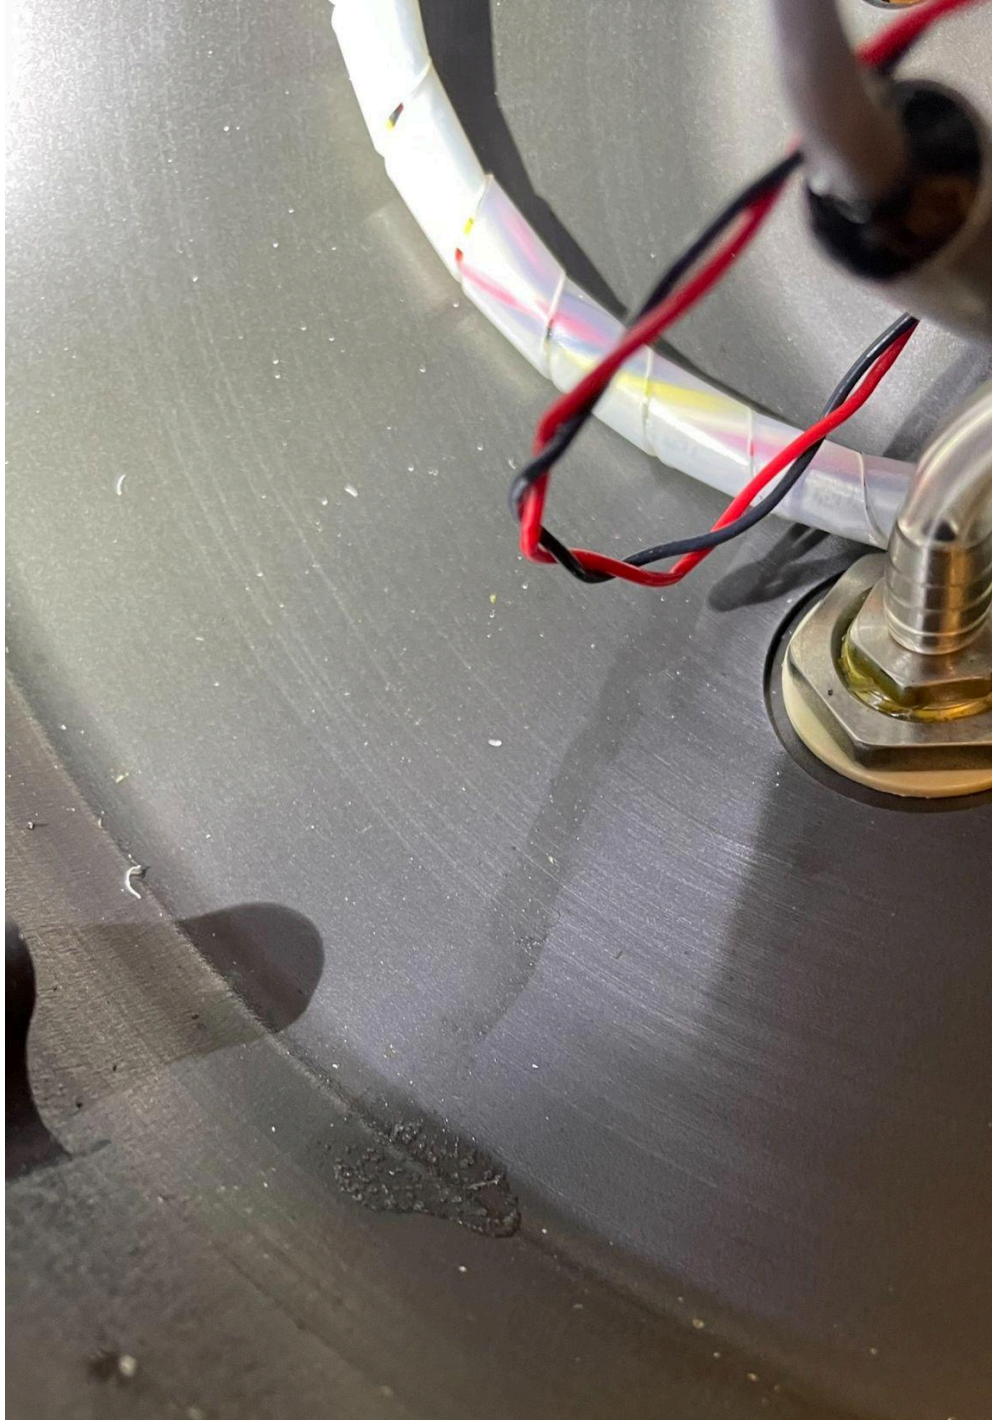
Figure 6. Dried salt from MCBH connector.
