Applicability

This document applies to the part numbers of devices and the device variants as stated in this page.

It gives a summary and a description of the device errata, with respect to the device datasheet and reference manual RM0351.

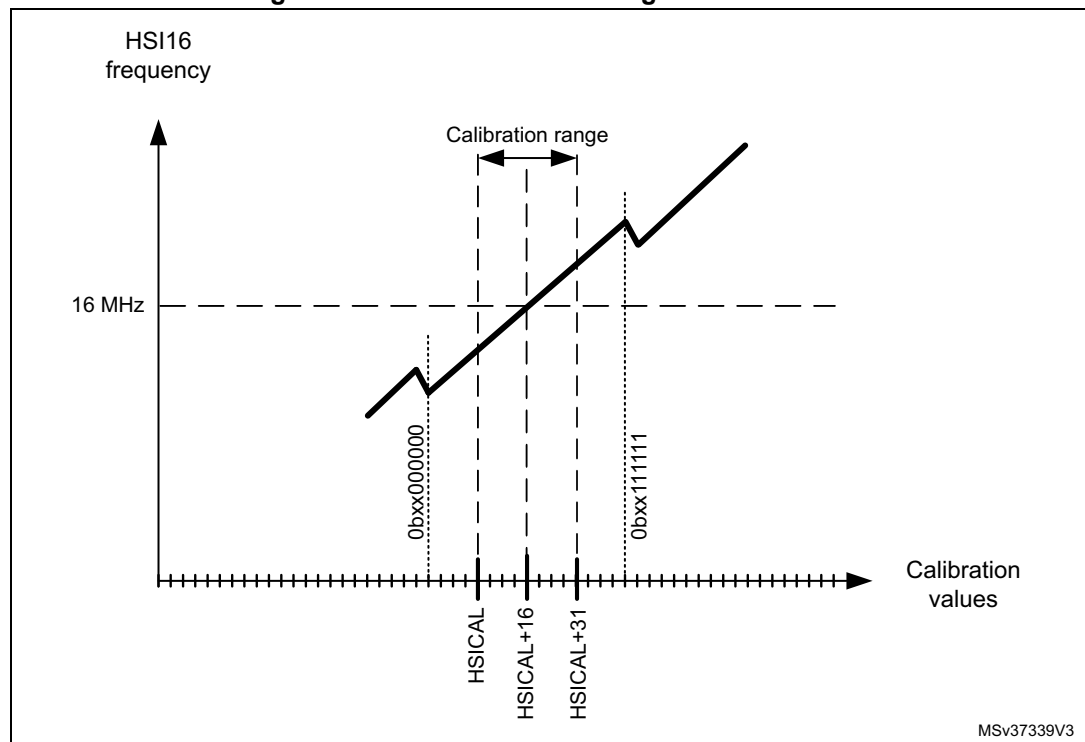
Figure 1. HSI oscillator trimming characteristics

Consequently, the user trim correction must not jump over the codes multiple of 64, which can limit the user correction either in positive or in negative direction.

None.

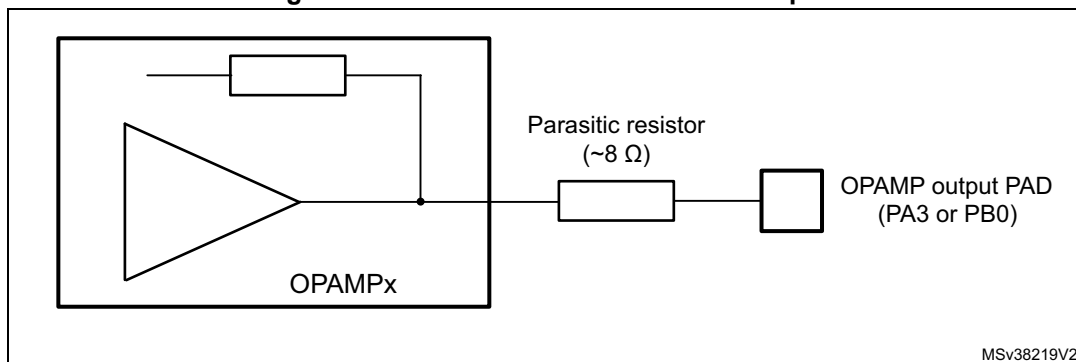
Figure 4. Parasitic resistor on OPAMP output

2.11.1 OPAMP characteristics can be degraded depending on the current sunk on OPAMP output

Resistor value between OPAMP outputs and I/O (PA3 or PB0) is greater than expected: 8 Ω typical, as shown in [Figure 4](#). As a consequence the OPAMP characteristics can be impacted depending on the current sunk on the output.

None.
