Bridge Inspection Summary - 2025

City of Riverton - Department of Public Works - Inspection window: 2025-09-08 to 2025-09-12

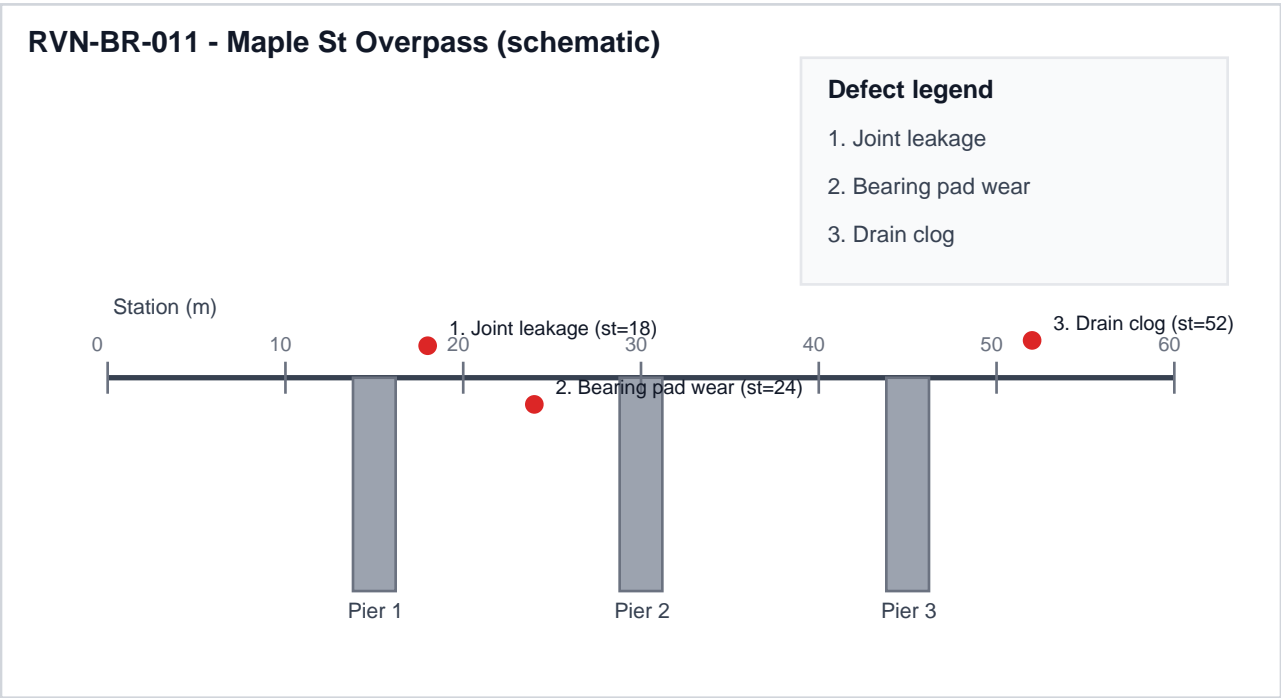
Vector schematic: defect locations

Schematic view (not to scale). Defects are plotted as vector points with station coordinates.

ID	Asset	Station (m)	Vertical offset (mm)	Description
1	RVN-BR-011	18	120	Joint leakage
2	RVN-BR-011	24	-100	Bearing pad wear
3	RVN-BR-011	52	140	Drain clog

Offsets are relative to the deck centerline in the schematic (positive = above).
