A note on the M_w 6.3 earthquake in Iceland on 29 May 2008 at 15:45 UTC

Abstract This preliminary study aims to investigate a M_w 6.3 earthquake that occurred in South Iceland on Thursday 29 May 2008 at 15:45 UTC. The epicentre was in the Olfus District between the towns of Selfoss and Hveragerdi. This study examines the data recorded and the damage observed immediately after the event. Horizontal accelerations of up to 80% g were recorded in the epicentral region and there is visual evidence that the vertical acceleration exceeded 1 g. The PGA data is compared to a ground motion estimation model developed for the South Iceland earthquakes in June 2000. In general the basic properties of this event are found to be similar to the characteristics of the South Iceland earthquakes in June 2000. The duration of strong-motion is short and the intensity attenuates rapidly with increasing distance. The earthquake action resisted by buildings in the near fault area is inspected through evaluation of elastic as well as inelastic response spectra. The vast majority of structures seemed to withstand the strong-motion fairly competently and without significant visual damage due firstly to the

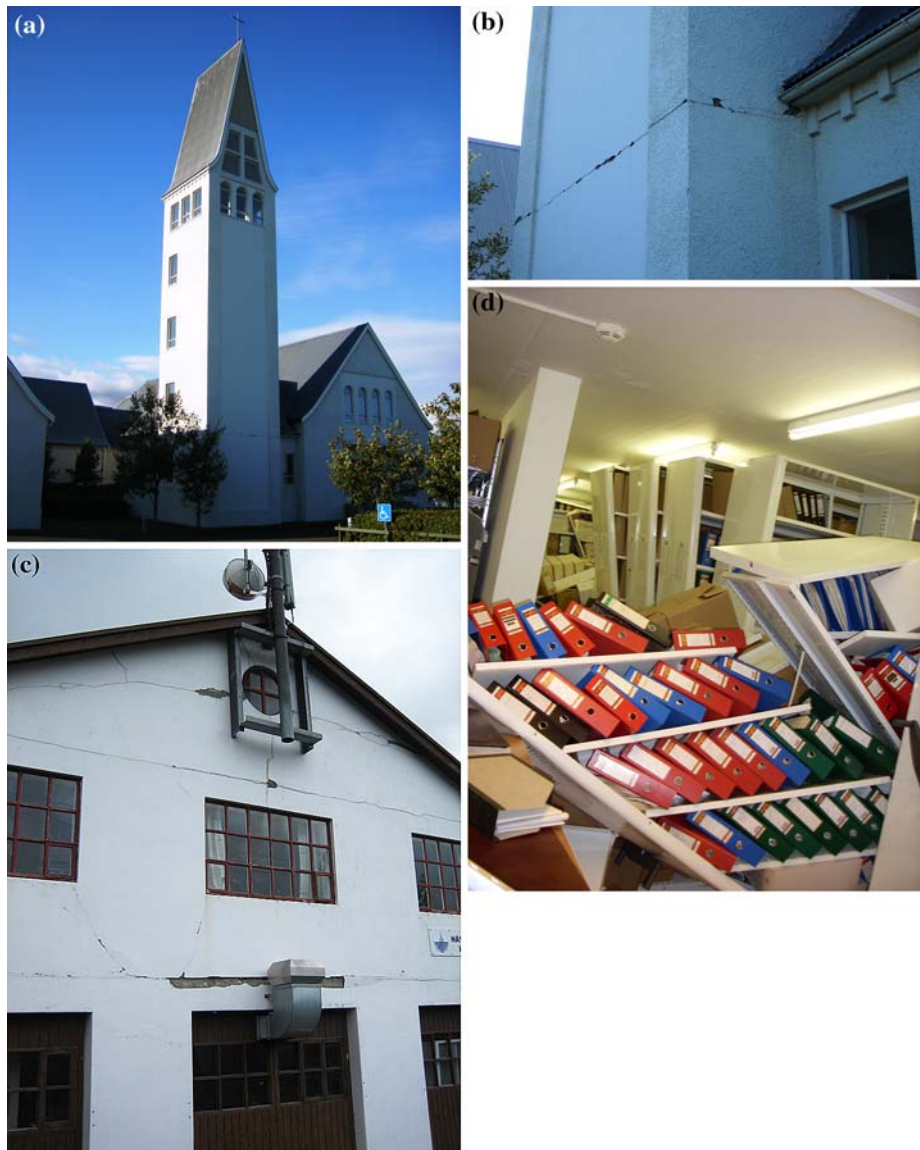
villages were strongly affected by the 2008 event, which are Hveragerdi, Selfoss and Eyraðbakki (see Fig. 2). The exposure of the built area is therefore greater, even though the earthquake magnitude was smaller (see Fig. 1). Over 2000 buildings were damaged to some extent, but only about 25 were uninhabitable after the earthquake. Twenty four buildings have since been declared unfit for repair and will be demolished. The buildings most severely damaged are most commonly older concrete or masonry buildings with little or no reinforcement. An example of such a building is shown in Fig. 4c. Several buildings sustained some tilting or cracking related to differential soil-foundation settlements. The church tower in the town of Selfoss was damaged, as shown in Fig. 4a. As seen in Fig. 4b the tower is linked to a lower building and therefore there is a change in stiffness. Furthermore, the natural frequency of the tower is about 0.4 s, which corresponds to a peak in the response spectra recorded in the Town Hall some 300 m away (see Fig. 6).

An additional 2000 incidences of damage to building interiors have been reported. The damage varies significantly in its severity, but may have stronger psychological effects on people than minor visual structural damage. It is also a fact that people in Iceland are more likely to be injured by falling interior objects such as loose bookshelves or closets than by

collapsing buildings. Figure 4d shows the effects of the earthquake on secondary systems located inside a building, as seen after the earthquake.

Fig. 4 Examples of earthquake damage to buildings and their interior. (a) The church of Selfoss and the approximately 20m high tower. (b) Fracture in the Selfoss church tower. (c) Extensively fractured masonry building in the town of Hveragerdi. (d) Archives in the town of Selfoss
