METALLOGRAPHIC FEATURES OF HYDROGEN EMBRITTLEMENT OF WELDED JOINTS OF PLATINUM

L. P. Karpov¹Translated from *Metallovedenie i Termicheskaya Obrabotka Metallov*, No. 6, pp. 37 – 38, June, 1996.

In the production of platinum articles some parts are stamped from sheets of platinum of grade 99.93 and welded by the argon arc method. When these parts were tested in a hydrogen medium gas leakage occurred along the welded joints.

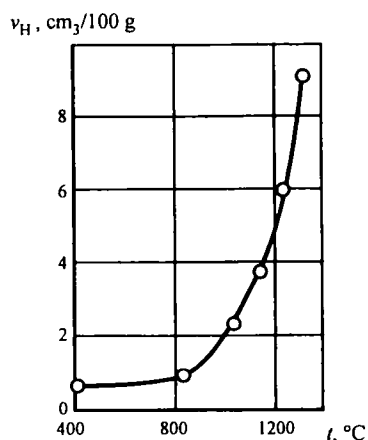
Fig. 1. Solubility of hydrogen in platinum as a function of the temperature.

point of platinum is 1773°C). In accordance with [5, p. 843] we plotted the dependence of the solubility of hydrogen in platinum as a function of the temperature (Fig. 1). It can be seen that above 800°C the solubility increases rapidly.

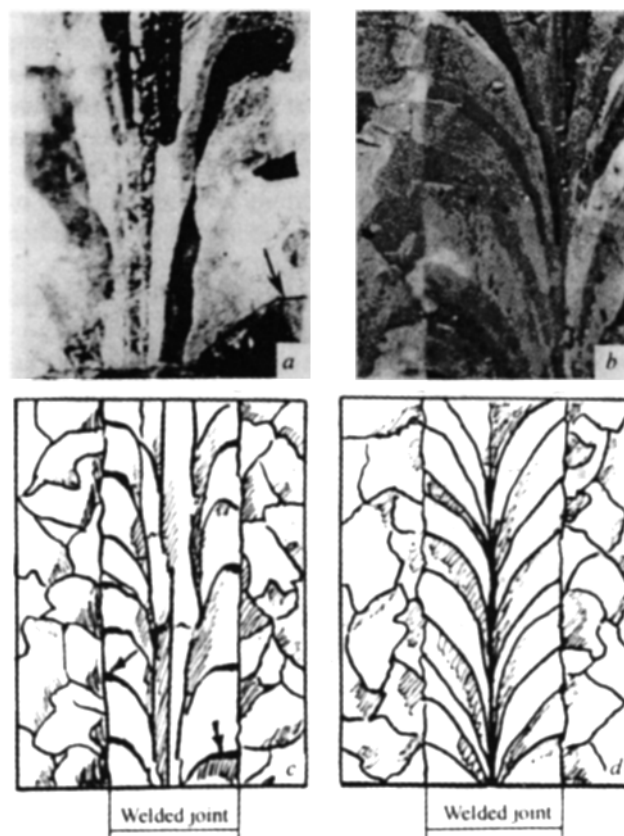
Fig. 2. Microstructure of welded joints in platinum articles disrupted (a, c) with cracks (shown by arrows) and undisrupted (b, c): a) $\times 28$; b) $\times 22$; c, d) diagrams.

A metallographic analysis showed that the macrostructures of welded joints of fit articles (nondisrupted) and rejected articles (due to a sealing failure) differ substantially (Fig. 2).

The structure of welded joints in rejected articles exhibits longitudinal crystals parallel to the welded joint with cracks between crystals in the weld root (Fig. 2a, c). In the structure of nondisrupted articles no longitudinal crystals or cracks were encountered (Fig. 2b, d). This morphology of the structure of welded joints seems to correspond to the intensity of heat removal and the degree of overheating of the molten metal.

In disrupted articles the structure of the weld contains coarser grains ($250\text{ }\mu\text{m}$) than that in nondisrupted articles ($177-250\text{ }\mu\text{m}$).

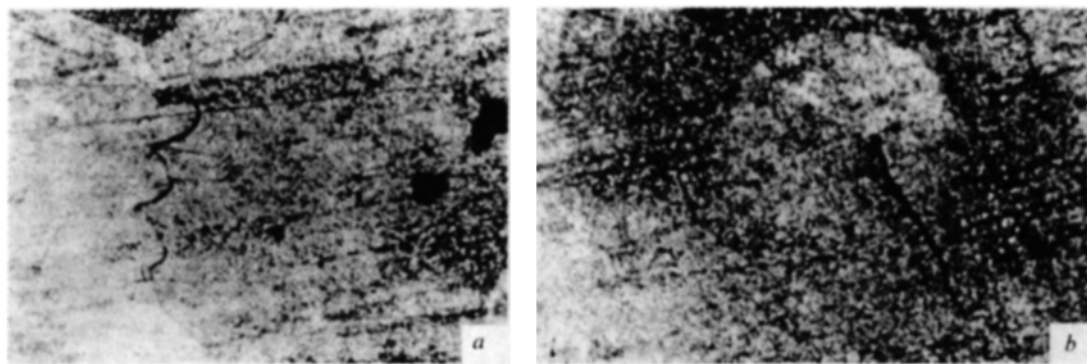
Fig. 3. Porosity and swelling of grain boundaries in a welded joint in a platinum article disrupted in a test by the mechanism of hydrogen embrittlement (a) and a crack from a hydrogen collector in a welded joint of disrupted platinum article surrounded by a weakly etched zone of plastic deformation (b). $\times 170$.

Figure 3a presents the porosity of the weld in a disrupted article and the swelling of grain boundaries. Such swelling of grain boundaries caused by hydrogen embrittlement had been observed earlier in disrupted disk springs [3]. Swelling of grain boundaries in platinum can be explained, for example, by the data presented in [5, p. 842], in which it is stated that "it seems quite probable that only absorption along boundaries occurs in platinum."

We detect an original metallographic feature of hydrogen embrittlement in the microstructure of nondisrupted articles, namely, a crack from a hydrogen collector located at the cen-

ter of a disk-shaped (round) weakly etched zone (Fig. 3b). It seems that the nature of this disk is as follows. Accumulation of hydrogen in the collector creates a high pressure, and the metal around the collector is cold-hardened, forming a spherical zone. Overstress breaks the metal with formation of a crack issuing from the collector and emerging on the surface of the part, where hydrogen penetrates too. The cold-hardened zone on the microsection looks like a disk due to the weak etching.

Thus, we can infer that hydrogen embrittlement of welded joints of platinum with formation of cracks is caused by an elevated porosity, swelling of grain boundaries, and cracks emerging from collectors surrounded by a round weakly etched zone of plastic deformation.
