# Analysis of Sheet Steel Fracture during Deep Drawing

J.L. McDougall, M.E. Stevenson, and K. McKeever

Low-carbon steel sheet used for the fabrication of automotive brake components was tearing during deep drawing. The associated mill certificates revealed that the coil met the specified chemical composition and mechanical properties. Metallographic evaluation revealed a severe variation with respect to grain size through the thickness of the steel sheet, as well as a slight segregation of pearlite. Insufficient temperature during hot rolling in combination with a high coiling temperature resulted in the observed microstructural gradient. The anisotropic mechanical properties were amplified by the slight carbon segregation.

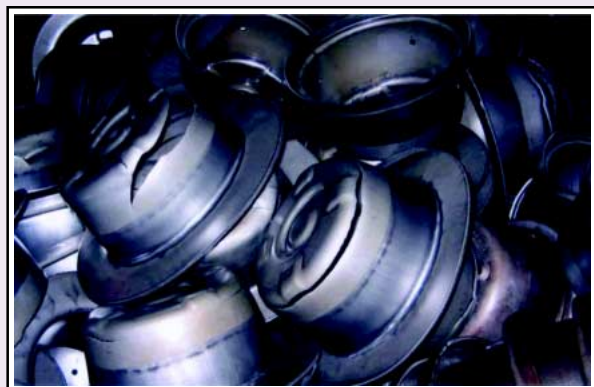
The fractured bladder cups were examined first. A photograph of a bin of fractured bladder cups was submitted (Fig. 1). Visual examination revealed a large fracture in the drawn (cup) region of the specimen, which had been sectioned in half prior to submittal. Extensive plastic deformation (necking) was observed in the region of fracture, indicating a ductile overload failure (Fig. 2).

Fig. 1 Photograph provided by the client that depicts the tearing of the bladder cups

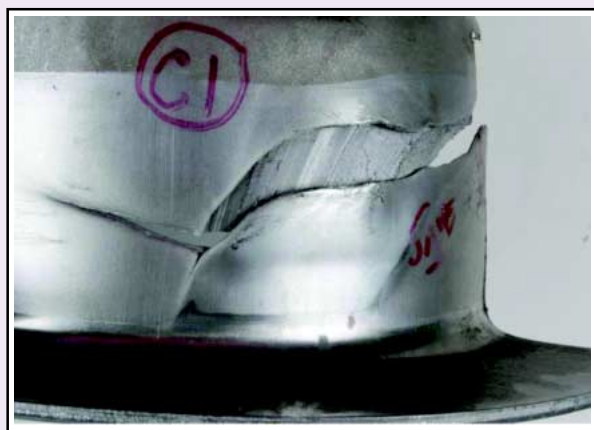
Fig. 2 Close-up photograph of the fractured bladder cup half

Visual examination of the submitted bladder cups revealed that failure was manifested in the form of ductile overload fracture. A high degree of plastic deformation (necking) was associated with the fractures. Metallographic evaluation of the fractured bladder cup, as well as blank material known to fracture during drawing, revealed a significant microstructural gradient in the form of grain size variation. The grains adjacent to the surface were significantly larger than those associated with the midthickness of the material. The increased grain size resulted during hot rolling of the material. Insufficient temperature during finishing results in irregular coarsening of the ferrite grains. This characteristic was likely amplified in combination with high coiling temperatures. The observed carbon segregation contributed to the anisotropic mechanical properties of the material.

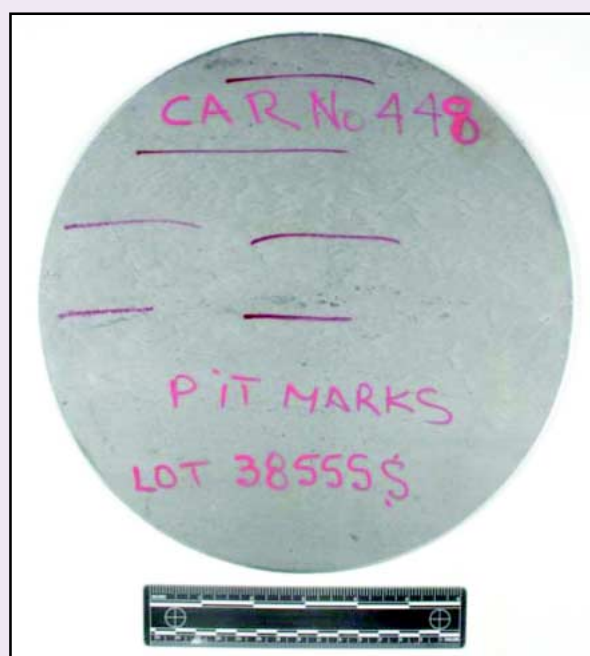
pitting. Visual examination revealed surface discontinuities associated with an isolated region, denoted by the red lines in Fig. 3. A close-up photograph of the apparent pitting is presented in Fig. 4. Metallographic evaluation of the apparent pitting was also conducted.

Fig. 3 Photograph of the apparent pitting observed on the circular blank

As part of the failure investigation, recommendations were sought regarding the remainder of the material that had been partially prepared for drawing. It was recommended that it be returned to the supplier based on both the grain size gradient as well as the observed surface discontinuities, neither of which could be feasibly rectified by the component manufacturer.

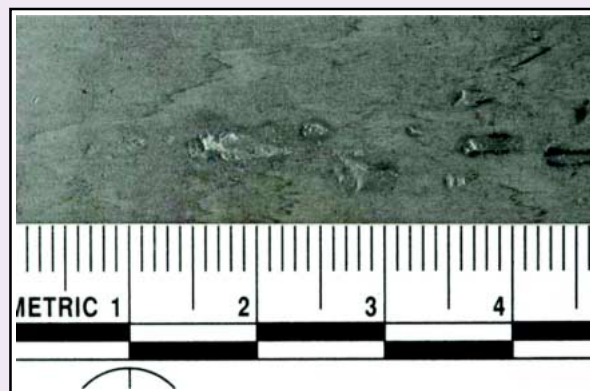
Fig. 4 Close-up photograph of the apparent pitting observed on the circular blank

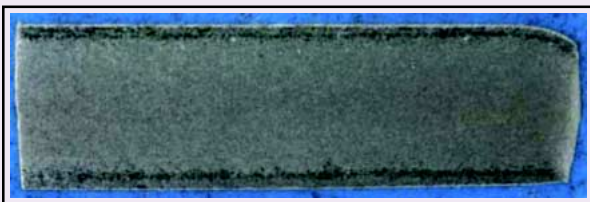
**Fig. 5** Photograph of the microstructural gradient observed on the mounted cross section through the fractured bladder

gradient through the thickness of the material was evident (Fig. 5). Composite micrographs of increasing magnification are presented in Fig. 6 and 7. From these micrographs, the nature of the microstructural gradient is evident. The grain size varies significantly across the specimen thickness, and larger grains are associated with both surfaces.

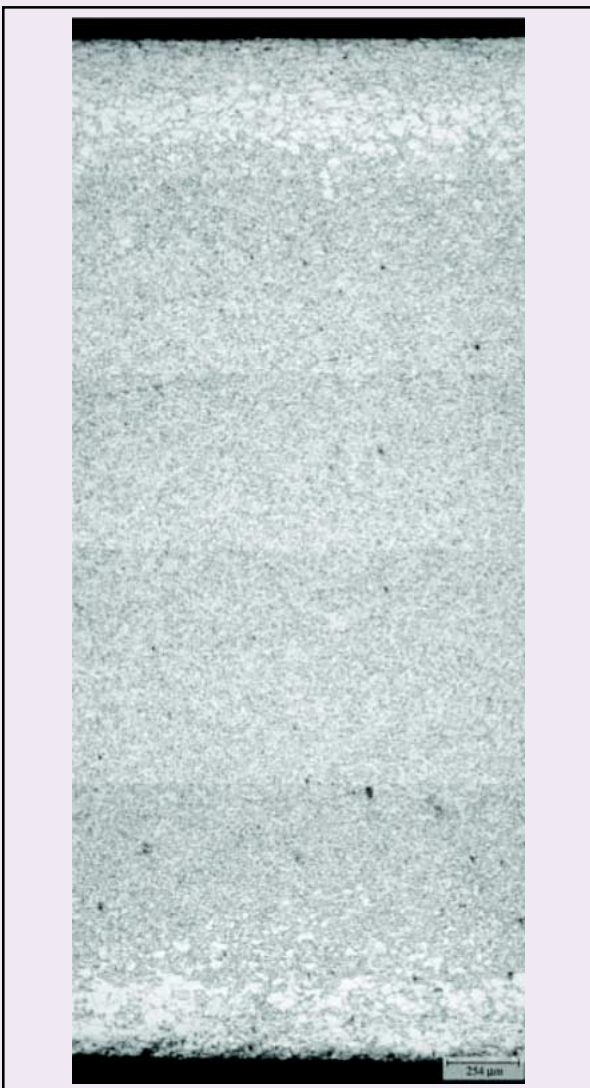
**Fig. 6** Composite micrograph of a cross section through the fractured bladder cup half section. A severe microstructural gradient with respect to grain size variation is evident. The sample was acquired in the flat rim of the bladder cup. Microhardness measurements revealed an approximate hardness of 86 HRB near the surface and 92 HRB near the midthickness.

The variation in grain size resulted from an insufficient hot rolling temperature during fabrication of the steel sheet at the mill. Low finishing temperature results in irregular coarsening of the ferrite grains, particularly at the surfaces of the steel. The variation in grain size becomes more pronounced, as in this case when high coiling temperatures are used.<sup>[1]</sup> The presence of the grain size variation would be detrimental to any deep drawing operation. Uniform grain size is an important variable, because uniformity is necessary for successful drawing.<sup>[2]</sup> Anisotropic mechanical properties through the thickness of the material

In order to verify that the variation in grain size was influencing the mechanical properties, microhardness testing was conducted. Microhardness measurements were acquired on the metallographically prepared cross section of the fractured bladder cup half section. The sample was acquired from the flat rim, a region that would undergo minimal or no plastic deformation during the drawing process. An approximate hardness value of 86 HRB was measured near the surface (large grains), while an approximate value of 92 HRB was measured near the midthickness (small grains).

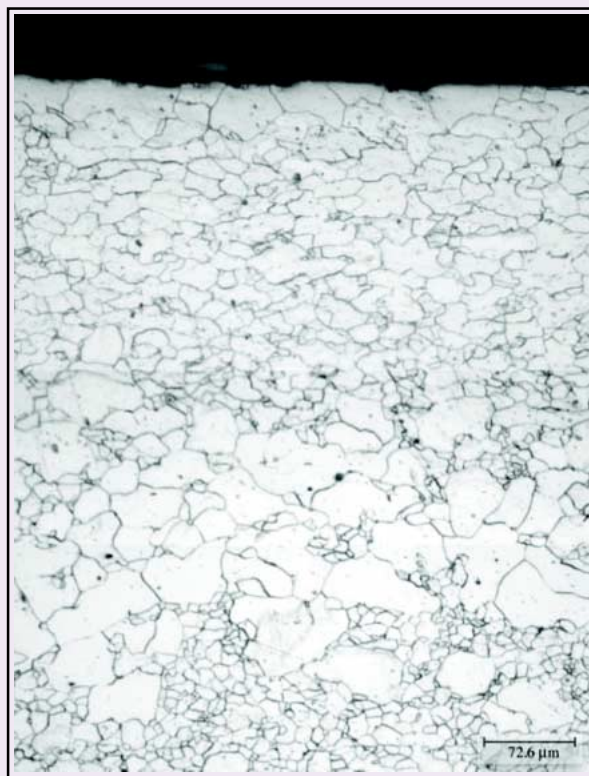
**Fig. 7** Higher-magnification micrograph of a cross section through the fractured bladder cup half section. A significant variation in grain size is evident in the depicted region associated with the surfaces. The sample was acquired in the flat rim of the bladder cup. Nital etchant. Original magnification 350x

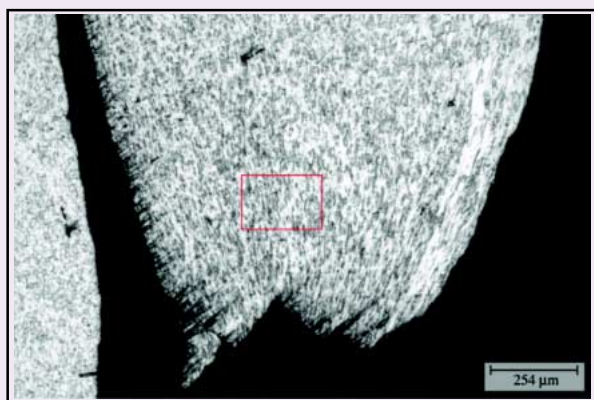
In addition to the grain size variation, a slight variation in pearlite content was observed. Examination of the microstructure through the fracture revealed that the material split into two sections (Fig. 8). The division was associated with segregation of pearlite (Fig. 9). The segregation resulted from slight variations in carbon content and is related to steel production.<sup>[1]</sup> The variation in pearlite would result from carbon segregation during rolling and would contribute to the anisotropy in mechanical properties and drawing difficulties.

**Fig. 8** Micrograph illustrating the slight segregation of pearlite associated with the fracture in the fractured bladder cup half section. Enlarged grains are visible at the right edge of the sample. Decreased pearlite content is discernible immediately adjacent to the enlarged grains and on the material at the left edge of the micrograph. A higher-magnification micrograph (Fig. 9) was acquired in the highlighted region. Nital etchant. Original magnification 100×

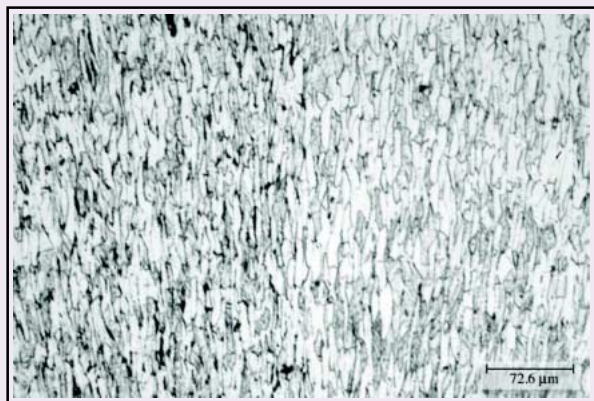
**Fig. 9** Higher-magnification micrograph of highlighted region in Fig. 8, illustrating the pearlite segregation. Nital etchant. Original magnification 350×

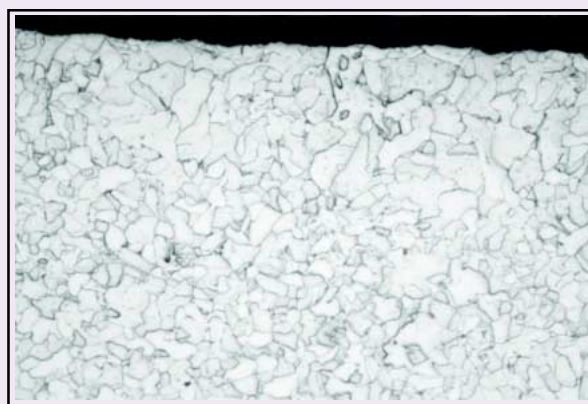
Metallographic specimens were acquired from two circular blanks in order to compare the microstructures. One was from material that was fracturing during the drawing operation. The second was material from another supplier that was able to be successfully drawn. A gradient with respect to grain size was observed within the coil that fractured during drawing (Fig. 10). No evidence of enlarged surface grains was observed in the microstructure of the successfully drawn material (Fig. 11).

**Fig. 10** Micrograph from Sample B, a blank from the material experiencing fracture during drawing

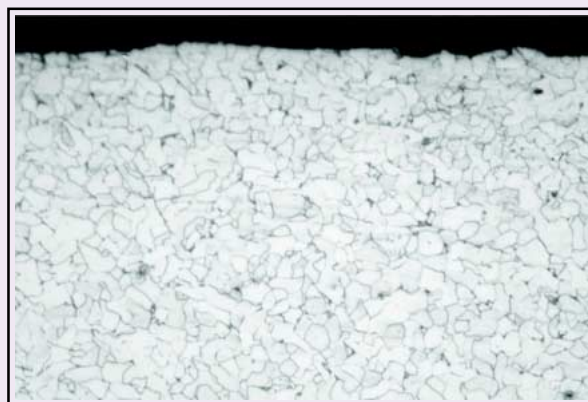
**Fig. 11** Micrograph from Sample C, a blank from the material drawn successfully

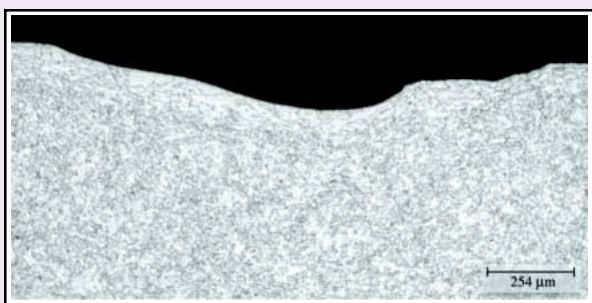
Metallographic examination of the apparent pitting depicted in Fig. 3 and 4 was conducted. Examination of a cross section through one of the “pits” revealed evidence of localized plastic deformation. Additionally, enlarged grains were observed at the surface of the blank. The grain flow, which included the larger grains, followed the contour of the “pit” (Fig. 12, 13), thus indicating that the surface defect was not the result of

corrosion (no material loss) but was caused by plastic deformation that occurred at some point after the coil was hot rolled. The presence of debris (possibly scale) during the coiling operation is considered the most likely cause of the “pitting” problem. Surface discontinuities serve as stress concentrations and are therefore detrimental to deep drawing operations.

Fig. 12 Micrograph through an apparent pit observed on the circular blank

Metallographic evaluation of the apparent pitting revealed that no material loss had occurred. Evidence of localized plastic deformation (indentations) in the surface was observed. The indentations likely resulted from the presence of surface debris during coiling of the steel sheet.

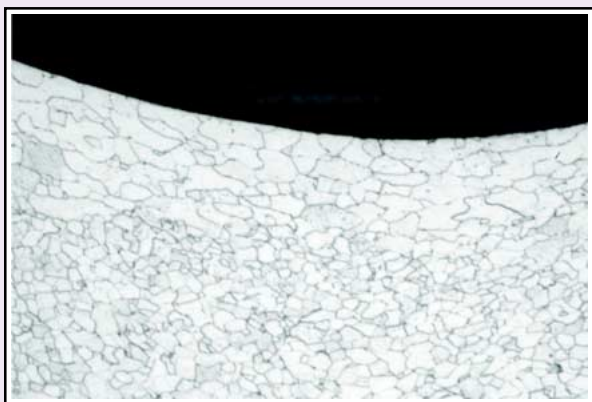
Fig. 13 Higher-magnification micrograph through an apparent pit observed on the circular blank
