**ACCIDENT**

<b>Aircraft Type and Registration:</b>	DJI Matrice M210 Version 1 (UAS, registration n/a)	
<b>No &amp; Type of Engines:</b>	4 electric motors	
<b>Year of Manufacture:</b>	2017 (Serial no: 0G0DECG0230007)	
<b>Date &amp; Time (UTC):</b>	19 November 2020 at 1150 hrs	
<b>Location:</b>	Poole, Dorset	
<b>Type of Flight:</b>	Emergency services operations	
<b>Persons on Board:</b>	Crew - None	Passengers - None
<b>Injuries:</b>	Crew - N/A	Passengers - N/A
<b>Nature of Damage:</b>	Damage to right leg and propeller blades	
<b>Commander's Licence:</b>	Other	
<b>Commander's Age:</b>	38 years	
<b>Commander's Flying Experience:</b>	14 hours (of which 5 were on type) Last 90 days - 2 hours Last 28 days - 1 hours	
<b>Information Source:</b>	AAIB Field Investigation

**Synopsis**

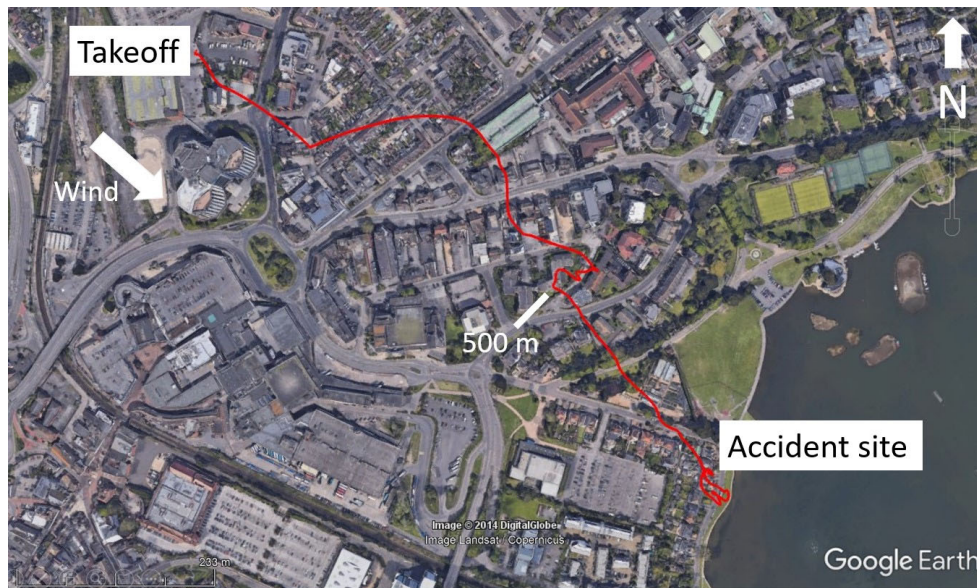
**Figure 1**

The pilot was now very concerned and activated the '*Return to home (RTH)*' feature on the controller, but it did not appear to engage despite being operated multiple times. RTH then appeared to activate but the aircraft did not move any closer. The pilot then switched to '*Sport Mode*' as per their emergency procedure which he expected would give him a top speed of 51 mph, allowing a greater ability to overcome the headwind. This cancelled the RTH feature so he pressed RTH again, but it would not re-engage. The remote pilot asked the observer to try engaging it using his slave controller, but this did not work either. At this stage neither the pilot nor the observer could see the aircraft, but they could see it on the moving map heading slowly towards Poole Park boating lake in a south-easterly direction (Figure 1). Both controllers then lost communication with the aircraft.

Accident flight ground track  
Underlying image © Google Earth™

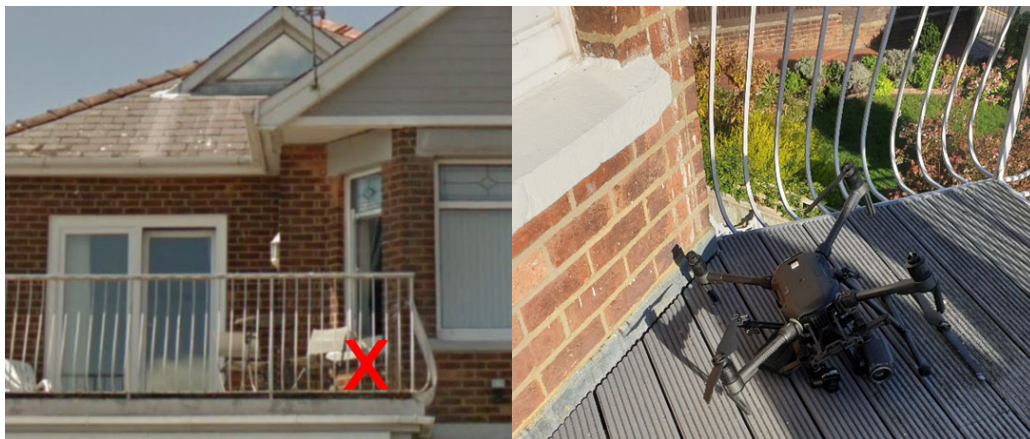
**Figure 2**

The pilot and observer packed their kit and drove to the last location of the aircraft shown on the map display. When they arrived in the area of the last position, the controllers regained communication with the aircraft and displayed its GPS coordinates. They found the aircraft on a first-floor balcony of a house (Figure 2). There was no one at the front of the property but there was light foot traffic along the path by the lake, about 30 m from the aircraft's location. The aircraft's right leg had snapped at the mounting bracket, three propeller blades had shattered, and one propeller had detached but was located next to the aircraft.

Accident site location and damage to UA

When the battery 2 level dropped to 23% the UA entered an auto-land mode but was unable to avoid the wall of a house resulting in damage to the propeller blades and a subsequent impact with the balcony. If the balcony had been occupied, people could have been seriously injured by the propeller blades.

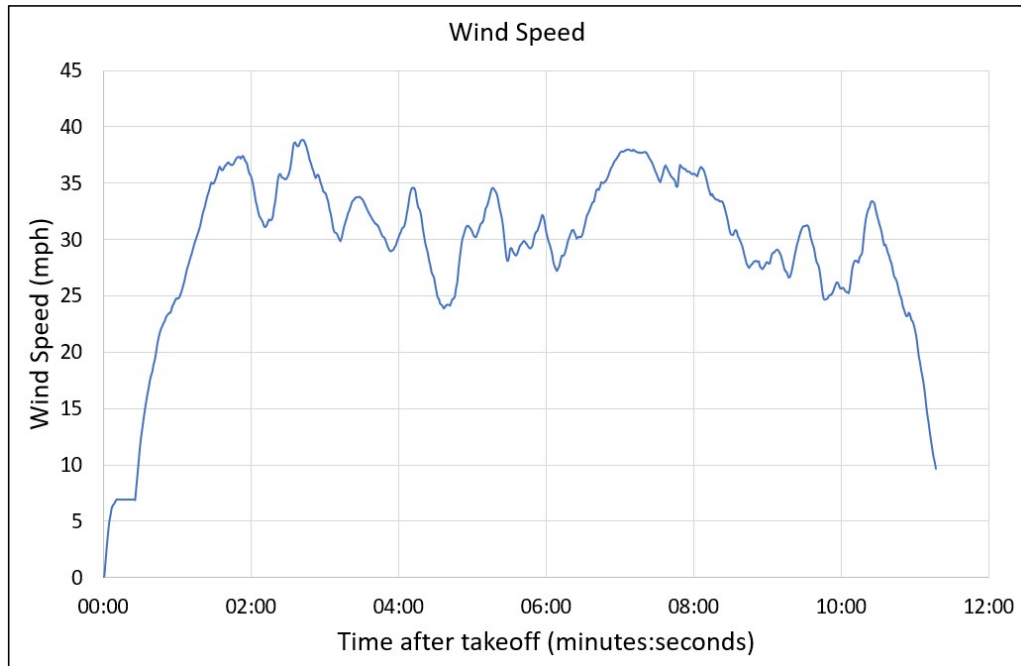
**Figure 3**

The UA calculated wind profile for the flight is shown at Figure 3.

Calculated Wind Speed recorded by UAS (mph)  
Peak wind is 39 mph at time 02:41

The wind at 400 ft increased beyond the 24 mph speed forecast by the pilot's UAS weather forecast app. The wind reached a calculated peak of 39 mph, but varied mainly between 25 mph and 35 mph. The UA's top speed in P-mode was either 35.8 or 38 mph. If it had been able to achieve 38 mph then it would not have drifted away in the wind. Even at a top speed of 35.8 mph there were periods when it would have made progress back towards the home point. However, with the restricted pitch attitude that was about 10° less than normal, this was not possible. The pilot's attempt to use S-mode as per the operator's emergency procedure did not allow an increase in speed as the restricted pitch limit also applied in S-mode.

It is recommended that DJI amend the DJI Pilot and DJI GO4 apps to warn the remote pilot when the wind limit has been exceeded and that the UA should be landed as soon as possible.

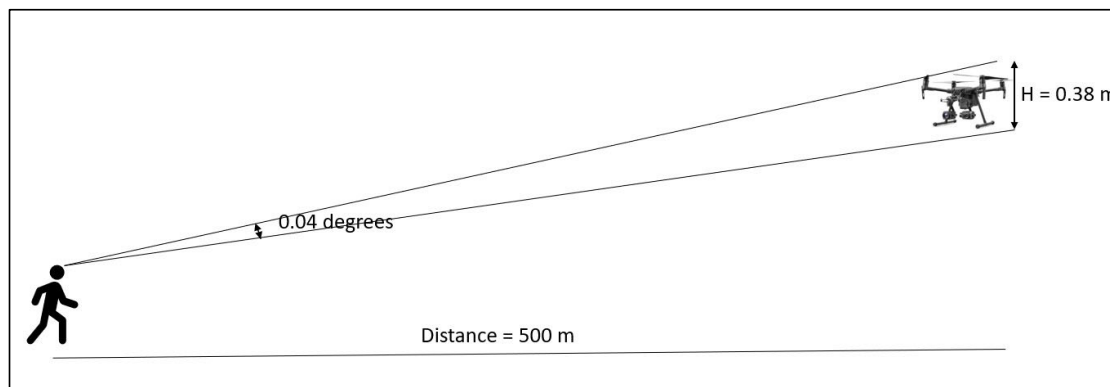
**Figure 4**

The Matrice M210 has dimensions of 0.51 x 0.51 x 0.38 m without the propellers. Its height is 0.38 m so when it is flying level and viewed from a distance, it presents a profile of 0.51 m by 0.38 m. At a horizontal distance of 500 m this dimension would present an angular size of  $0.06^\circ$  by  $0.04^\circ$ <sup>7</sup>. On a piece of paper held at a normal reading distance<sup>8</sup> of 35 cm, the size of the Matrice can be represented by a small square of dimensions 0.4 by 0.3 mm.

Angular height of Matrice M210 at a distance of 500 m

It is recommended that the Civil Aviation Authority review the Visual Line of Sight distance figures in CAP 722 and amend the guidance to make it clear that just being able to see an unmanned aircraft is not sufficient for Visual Line of Sight operations and that pilots need to be able to demonstrate that at the distance they are flying, they can manoeuvre it rapidly to avoid a collision and can also land the unmanned aircraft safely following a loss of position-holding without reference to video or telemetry.
