SERIOUS INCIDENT

Aircraft Type and Registration:	Tekever AR5 Evolution Mk 2, G-TEKV	
No & Type of Engines:	2 3W 2-stroke piston engines	
Year of Manufacture:	2019 (Serial no: E505)	
Date & Time (UTC):	29 December 2020 at 1446 hrs	
Location:	Lydd Airport, Kent	
Type of Flight:	Commercial operations (UAS)	
Persons on Board:	Crew - None	Passengers - None
Injuries:	Crew - None	Passengers - N/A
Nature of Damage:	None	
Commander's Licence:	Other	
Commander's Age:	33 years	
Commander's Flying Experience:	1,514 hours (of which 665 were on type) Last 90 days - 105 hours Last 28 days - 34 hours	
Information Source:	Field Investigation

Synopsis

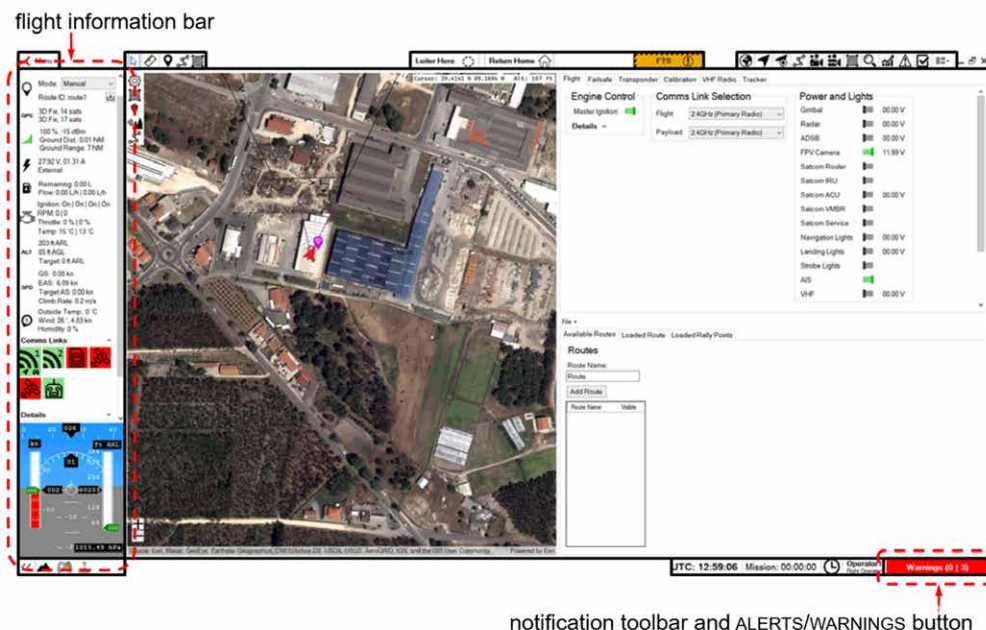
Figure 5

fGCS Primary display – MiSt screen

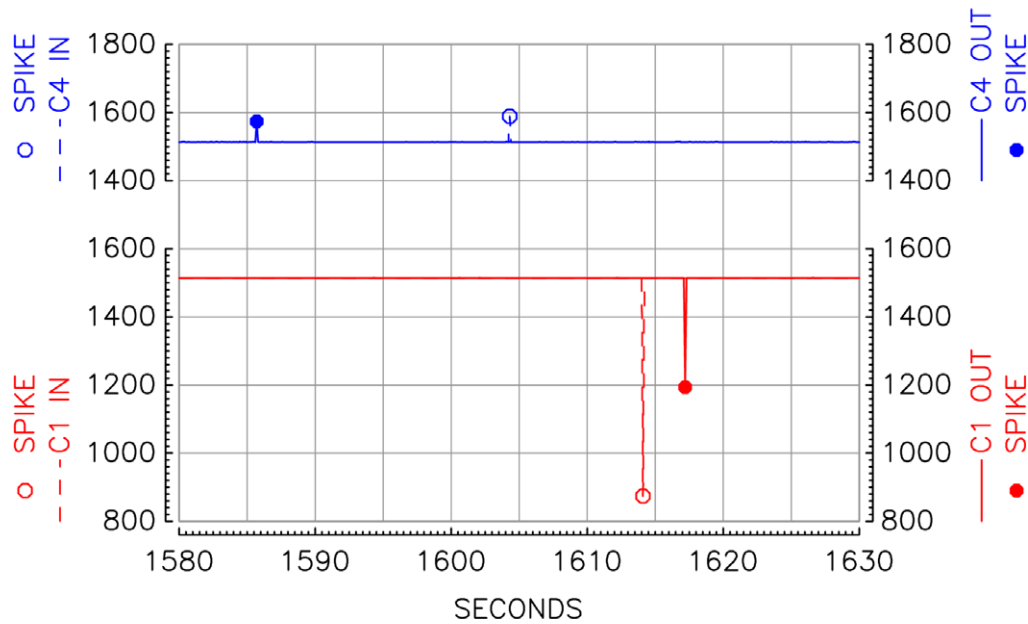
Figure 7

After further testing, the operator identified erroneous values, in the form of bit errors, within the data passed from the multiplexer via the ACE to the autopilot (Figure 7) and began an investigation to understand how and where these signal errors were being introduced.

Data from the aircraft log file showing spikes on the control channels in and out of the autopilot for Aileron (C1) and Rudder (C4) for the June 2020 event

1. A new SBUS multiplexer hardware revision was released in June 2020 that fine-tuned the internal PCB design and some components to minimise the impact of external interference. It was noted that it was '*not fully protected against noise*'; however, the inadvertent engine shutdown event could not be reproduced during tests. This revision was embodied on the entire AR5 fleet, including G-TEKV which was modified in June 2020.
2. The GPU was redesigned to reduce Electromagnetic Interference (EMI) emissions. The GPU redesign was based on the standards of STANAG 4703, and tests were performed to comply with CISPR25 – Class 1.⁹ This work was completed in the second quarter of 2021 and the new GPUs are being installed on new build aircraft and on those returned to the factory for maintenance.

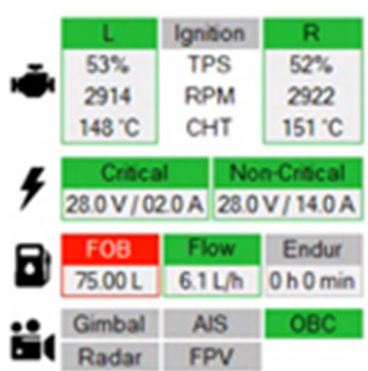
Figure 8

Revised flight information bar extract

The review recommended the implementation of a revised warning system with a notification/warning message bar which would identify the alert without user action or intervention, and which would ensure that the information remained visible. In addition, the corresponding parameter on the flight information bar would be highlighted in red. From April 2021, the operator started to implement the revised system status reporting within the GCS software. This includes two alert levels (caution and warning) and a revised flight information bar with parameters colour coded according to status (an extract is shown in Figure 8).
