ACCIDENT

Aircraft Type and Registration:	DJI Phantom 4 RTK (UAS, registration n/a)	
No & Type of Engines:	4 electric motors	
Year of Manufacture:	2020 (Serial no: 0V2GDC6RA30246)	
Date & Time (UTC):	2 December 2020 at 1209 hrs	
Location:	Newtongrange, Dalkeith, Midlothian	
Type of Flight:	Commercial Operations (UAS)	
Persons on Board:	Crew - N/A	Passengers - N/A
Injuries:	Crew - N/A	Passengers - N/A
Nature of Damage:	Damage to motors, propellers, arms, landing gear and fuselage	
Commander's Licence:	Other	
Commander's Age:	50 years	
Commander's Flying Experience:	98 hours (of which 98 were on type) Last 90 days - 5 hours Last 28 days - 2 hours	
Information Source:	AAIB Field Investigation

Synopsis

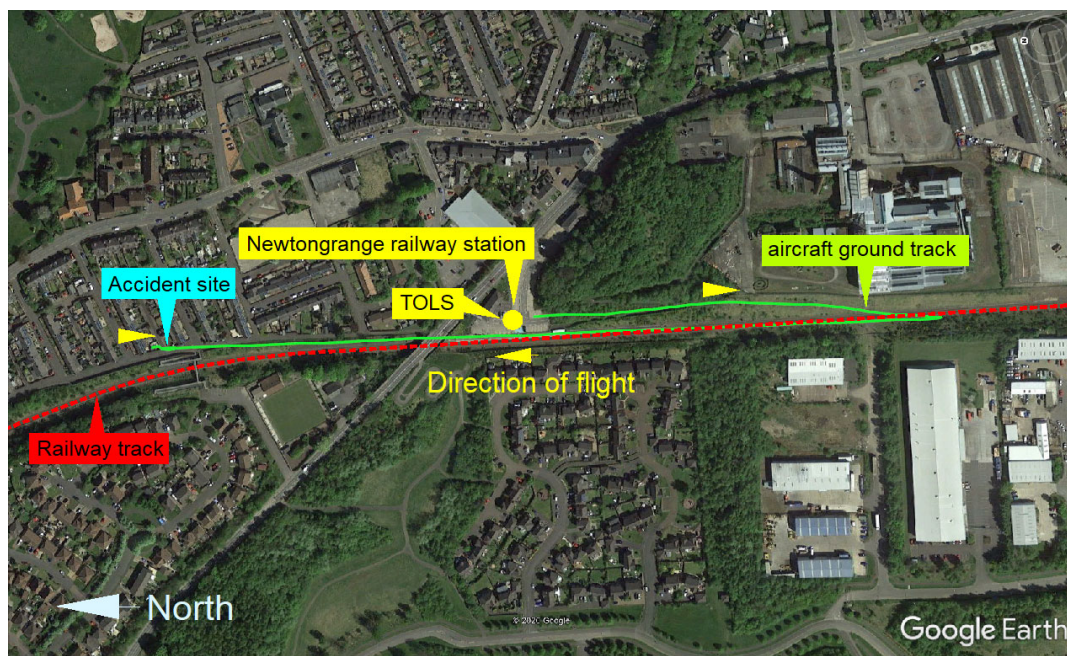
Figure 2

The aircraft took off at 1206 hrs (Figure 2) and followed the programmed route, whilst the pilot and observer monitored its progress. At 1209 hrs, the aircraft reached its northerly turning point, where it slowed and commenced its turn back towards the TOLS. This coincided with the aircraft's camera capturing a survey photograph of the railway track and houses below (Figure 3). Shortly after this, the pilot reported that the UAS controller emitted a short "beep". Whilst the observer continued to watch the aircraft, the pilot checked the controller, but no error messages were displayed. The aircraft then rapidly descended vertically. As the aircraft neared the ground, the pilot and observer lost sight of it and, shortly after, a series of error messages were displayed on the controller.

Aircraft ground track during the accident flight
© 2020 Google, Image © Maxar Technologies
