Accident

Aircraft Type and Registration:	VA-1X, G-EVTL	
No & Type of Engines:	8 Equipmake HTM-1900 electric motors	
Year of Manufacture:	2022 (Serial no: 1)	
Date & Time (UTC):	9 August 2023 at 0715 hrs	
Location:	Cotswold Airport (Kemble), Gloucestershire	
Type of Flight:	Experimental flight test	
Persons on Board:	Crew - None	Passengers - None
Injuries:	Crew - None	Passengers - N/A
Nature of Damage:	Damage to right wing, fuselage, landing gear and engine pylon	
Commander's Age:	60 years	
Commander's Flying Experience:	More than 4,300 hours (of which 3 were on type) Last 90 days - 6 hours Last 28 days - 0 hours	
Information Source:	AAIB Field Investigation

Synopsis

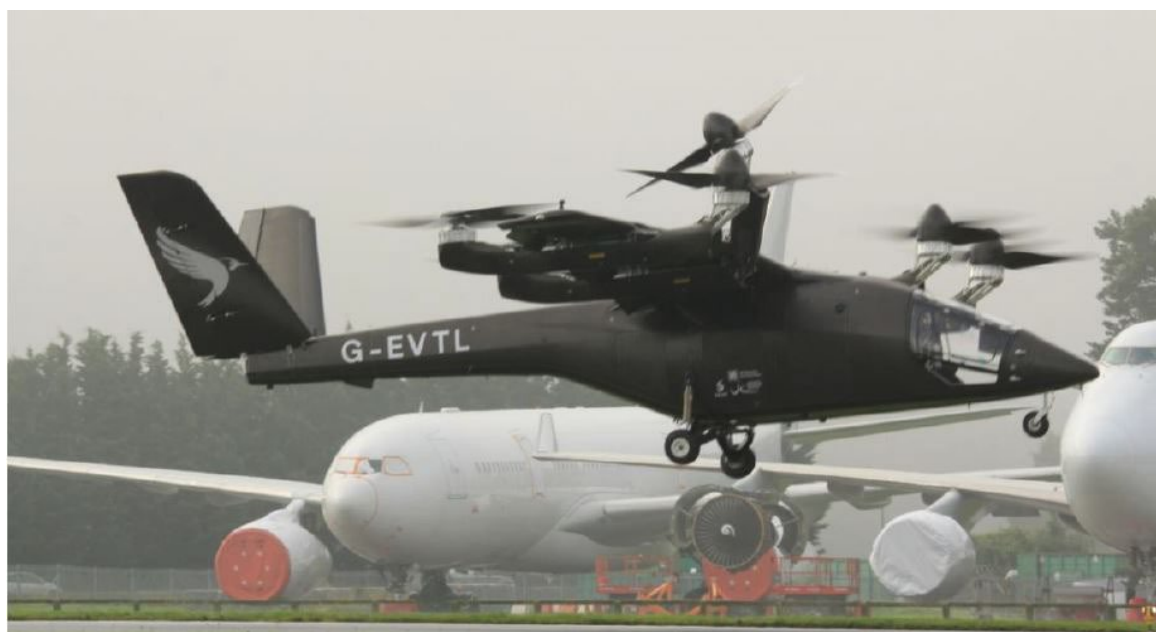
Figure 1

The resulting imbalance caused the structural failure of the right inboard pylon (pylon 3). Despite EPU1 restarting automatically the aircraft was unable to maintain height and at 0715:50 hrs it struck the ground on the left edge of the runway with a vertical descent rate of 19.45 ft/sec. During the impact the right wing failed outboard of pylon 3, the nose gear collapsed and there was other structural damage. There were no injuries and no damage to any third party.

Pylon 3 failure following the release of a propeller blade from EPU3
(courtesy of manufacturer)

Pylon 3 had failed in overload due to high out-of-balance loads caused when the EPU3 propeller blade released, allowing the forward section of the pylon to initially rotate vertically upwards under residual propeller thrust. This movement damaged the wiring harnesses where pylon 3 was attached to the wing front spar, severing the CAN bus C1 and C2 wiring. Low voltage wires providing power and return feeds to the EPU3 inverter were open circuit within a connector, due to cable strain. Damage to the high voltage wiring consisted of phases U and W pulling out of their connectors at the EPU3 motor and phase V pulling out of its connector to the inverter, with electrical arcing damage between the cable and the connector body.

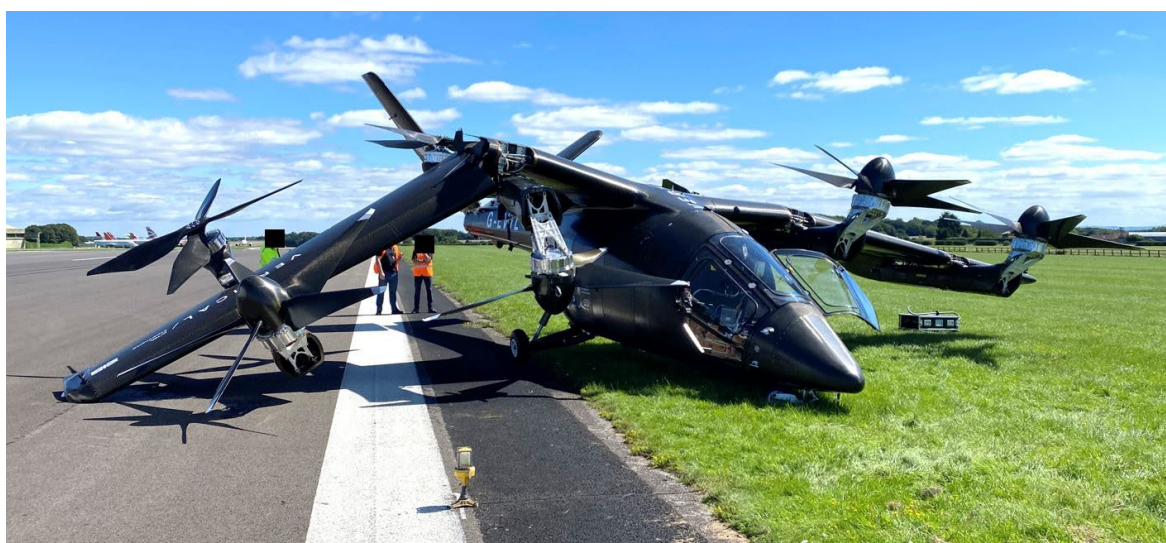
Figure 2

The aircraft hit the southern edge of Runway 26 in a level attitude with the right mainwheel on the paved runway surface and the left mainwheel and nosewheel on the grass. The right wing had broken at the inboard pylon but remained attached to the aircraft by wiring harnesses. Two propeller blades had detached from EPU3, with the blade sheath that separated in flight coming to rest 50 m from the aircraft, at its seven o'clock position. A section of blade spar that had also released came to rest close to where the sheath had landed. A second blade had detached during the ground impact as EPU3's propeller was still rotating when the aircraft touched down.

G-EVTL after the accident

The nose landing gear had collapsed and the left main landing gear oleo remained fully compressed. A number of skin-to-frame fasteners had pulled through the fuselage skin around the right main landing gear upper fitting. The right wing had failed in downward bending overload at the inboard pylon station.

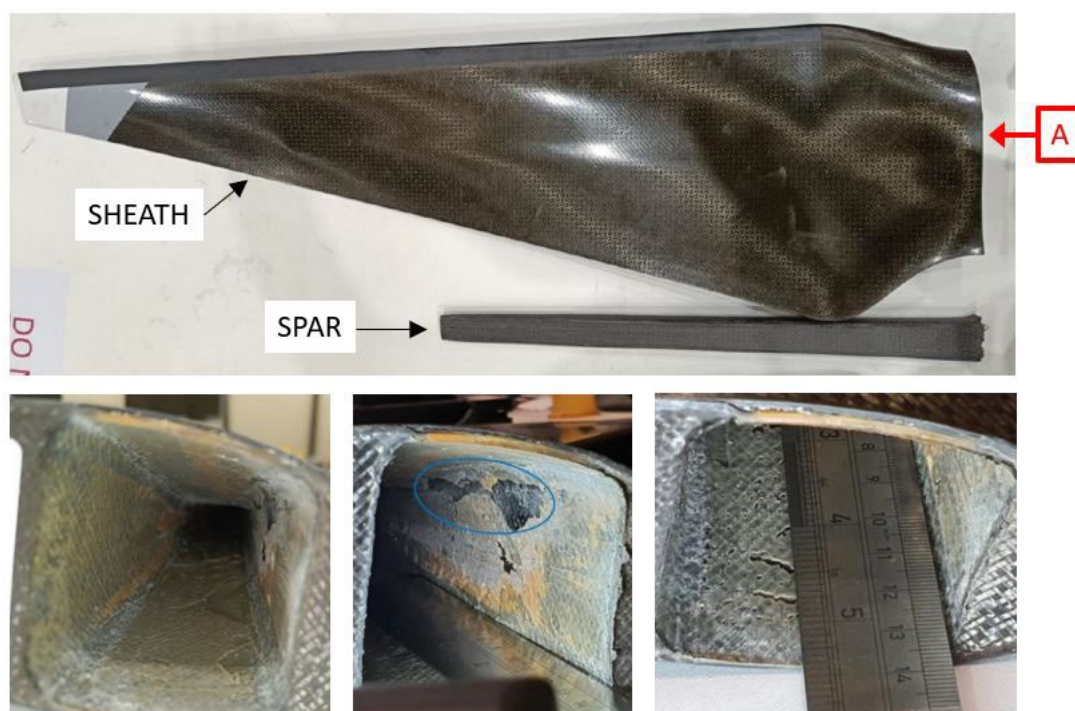
Figure 3

The blade sheath that released during flight showed evidence of poor bonding between the sheath and the blade spar (Figure 3). Most of the adhesive remained attached to the internal sheath surface with very little present on the blade spar.

Released propeller blade including failed spar-to-sheath adhesive bond (lower three images, viewed in direction 'A')
(courtesy of manufacturer)

The released propeller blade was operating within its normal rpm and loading levels when it detached, without any increased vibration or foreign object impact prior to release. The blade sheath detached due to failure of the adhesive bond between the blade sheath and spar. Stress analysis performed by the manufacturer showed that only 5% of the spar-to-sheath bond area was required to retain the sheath at the centrifugal loading condition when the bond failed. It is therefore likely that progressive degradation of the bond occurred during operation prior to the blade release.

The manufacturer inspected two other similar propeller blades from its spares pool using CT scanning. Voids were widespread in the bond line in both blades, as were variations in the shape of the blade spar cross section. A review by the manufacturer determined that the blade structural design, and the relevant manufacturing control, quality assurance processes and verification programme were contributory factors to the blade release.

- The remaining 'Generation 1' propeller blades were withdrawn from use and, subject to a satisfactory inspection, will only be used for ground testing.
- The manufacturer was in the process of introducing a new 'Generation 2' propeller blade when the accident occurred that, amongst other things, eliminated the bonding failure mode that caused the blade release.
- Having completed its internal accident investigation, the manufacturer identified 36 product and process improvements. These include improvements in quality control, supplier qualification, design and verification processes, flight control laws, CAN bus architecture and the routing of wiring harnesses.
