## Accident

<b>Aircraft Type and Registration:</b>	UAS Malloy Aeronautics T150	
<b>No &amp; Type of Engines:</b>	8 Electric motors	
<b>Year of Manufacture:</b>	2023 (Serial no: 120)	
<b>Date &amp; Time (UTC):</b>	27 June 2023 at 1443 hrs	
<b>Location:</b>	Field in South Scarle, Lincoln	
<b>Type of Flight:</b>	Training	
<b>Persons on Board:</b>	Crew - None	Passengers - None
<b>Injuries:</b>	Crew - N/A	Passengers - N/A
<b>Nature of Damage:</b>	Destroyed	
<b>Commander's Licence:</b>	General Visual line of sight Certificate (GVC)	
<b>Commander's Age:</b>	45 years	
<b>Commander's Flying Experience:</b>	150 hours (of which 2 were on type) Last 90 days - 5 hours Last 28 days - 5 hours	
<b>Information Source:</b>	AAIB Field Investigation

## Synopsis

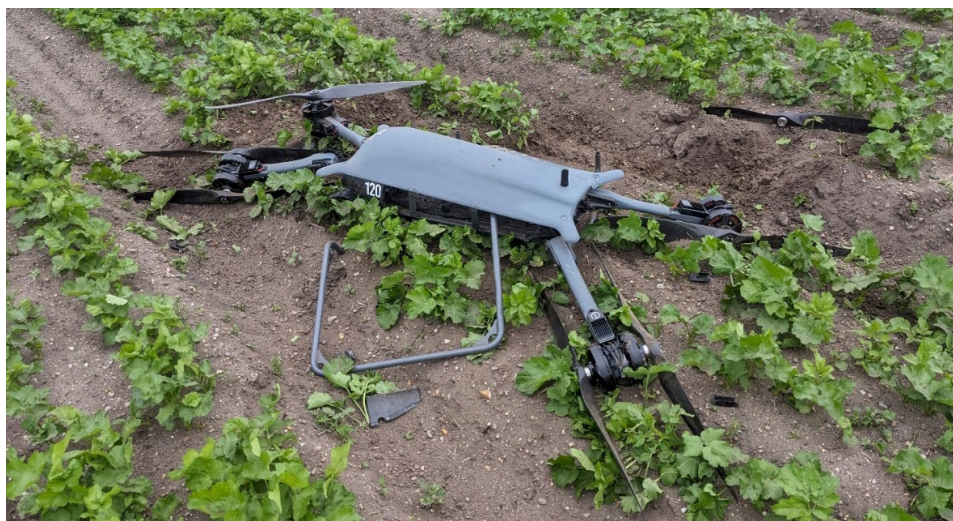
**Figure 1**

The aircraft diverged from level flight and was seen to follow an erratic flight path unfamiliar to the RP, during which it achieved a maximum pitch of  $-41^\circ$  and  $-60.9^\circ$  of roll. To regain control the RP increased the throttle to 100% which caused the aircraft to overcorrect, and it then pitched to  $85.3^\circ$  with  $60^\circ$  of roll before descending rapidly from a height of 37 m. The RP realised he could not regain control and switched to an automated mode (LOITER mode) but by this time the aircraft was heading towards the RP's ground position and he decided to close the throttle, bringing it to the ground (Figure 1). Twelve seconds had passed from the geofence breach before the aircraft struck the ground approximately 50 m from the RP's position and within the horizontal boundary of the geofence (Figure 2).

Malloy T150 unmanned aircraft at the accident site

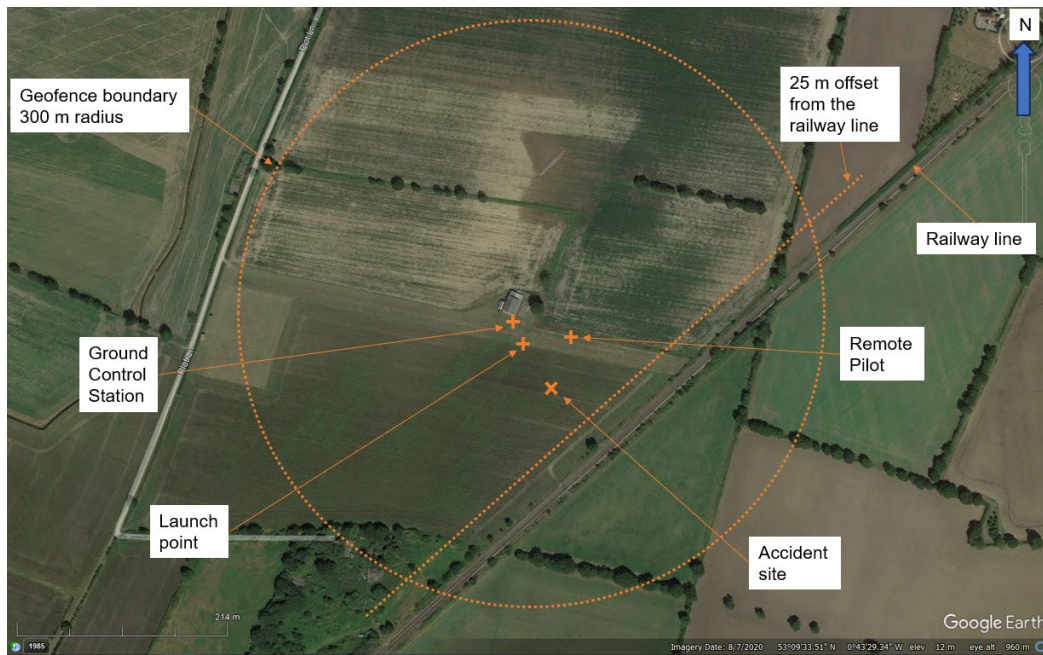
**Figure 2**

circuits in Stabilised flight mode (STAB mode) at a training ground. It is a remote site on farmland used by the organisation he was contracted to fly with as an R&D and training pilot. The geofence for the flight was 40 m high by 300 m radius with the centre on the takeoff point (Figure 2). The dimensions of the geofence were not considered by the RP and GCS operator prior to the flight but accepted as a standard training envelope.

Accident site and geofence

of the geofence been set higher the initiating event would not have occurred. The lack of a definition of what is an ‘appropriate’ geofence contributed to this. The investigation also noted that the 300 m radius geofence encompassed a railway line despite the OSC stating that flights should not come within 25 m of the railway line. The operator relied on the RP to ensure overflights did not occur, but the OSC stated that a ‘Geofence will be used to maintain the aircraft within designated airspace’.

An internal review by the operator after this event highlighted that a larger geofence could have been set as there were no airspace restrictions at the training site and their OA allowed them to operate with an operational volume of 120 m high by 500 m radius.

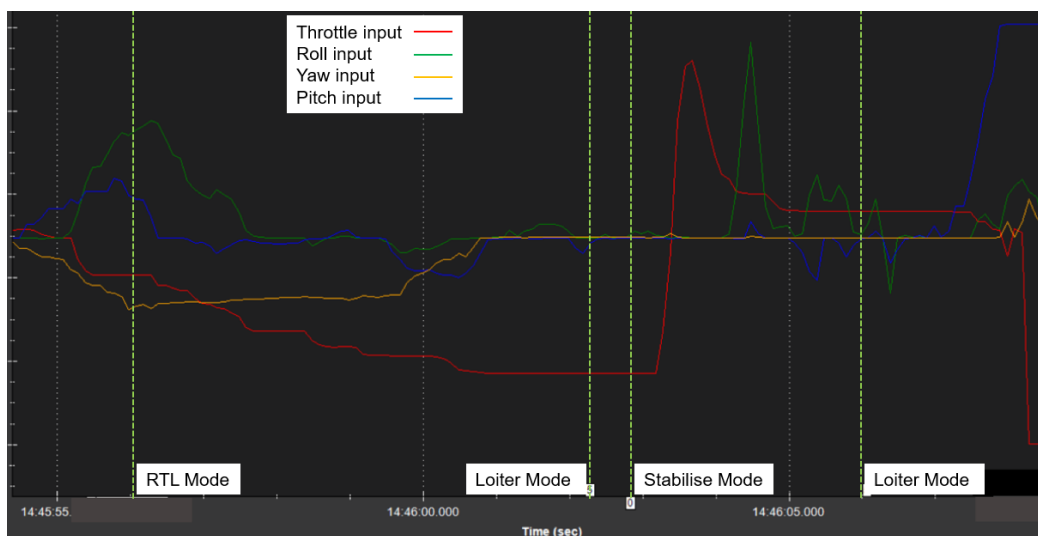
**Figure 3**

Data downloaded from the UA showed that at 1445:56 hrs (local) the aircraft entered RTL mode (Figure 3) and the throttle input was recorded as having reduced to 2.6% from an RP input; this had no effect in RTL mode. The mode then changed to LOITER for approximately 600 ms before going back to STAB where the throttle increased to 100% in less than 1 sec. A large roll input was recorded after which the mode was changed to LOITER. The aircraft deviated from normal flight attitude and was not under control. The throttle was recorded as reducing to zero. The aircraft then pitched up but as it was inverted, it struck the ground.

Pilot inputs

As the aircraft approached 40 m agl the RP was already reducing the throttle and as the aircraft climbed further in RTL mode it was reduced to a minimum of 2.6% to counteract the climb. The GCS operator alerted the RP of the mode change to RTL and the RP cycled the flight mode switch on the transmitter from STAB to LOITER and back to STAB. This cancelled the RTL mode and returned the aircraft to the manual STAB mode but with only 2.6% throttle applied. The RP stated that as he was aware that the aircraft had penetrated the geofence and he saw no need to allow the aircraft to RTL. By cycling the mode switch, he could regain control of the aircraft and continue with the flight.

The aircraft was not able to maintain stable level flight with such a low throttle setting and immediately descended with roll which the RP countered by applying full throttle. This was followed by a large roll input. The aircraft is capable of 240 kg of thrust but only weighed 55 kg as there was no payload attached for the training flight. This abundance of thrust resulted in the RP over correcting the roll attitude and the aircraft further departing controlled flight. Upon reflection the RP considered that it was unusual that he had applied so much throttle in such an uncoordinated manner. It is possible to adjust the length of the control sticks of the transmitter and on the accident flight he recalled that they were at their shortest setting. He was used to flying with much longer sticks where the distance from neutral to full deflection would have been further. It is his opinion this is why he applied full throttle instead of an intermediate amount of throttle to correct the descent.
