BlueNRG/BlueNRG-MS device limitations

Silicon identification

This errata sheet applies to the STMicroelectronics BlueNRG and BlueNRG-MS devices.

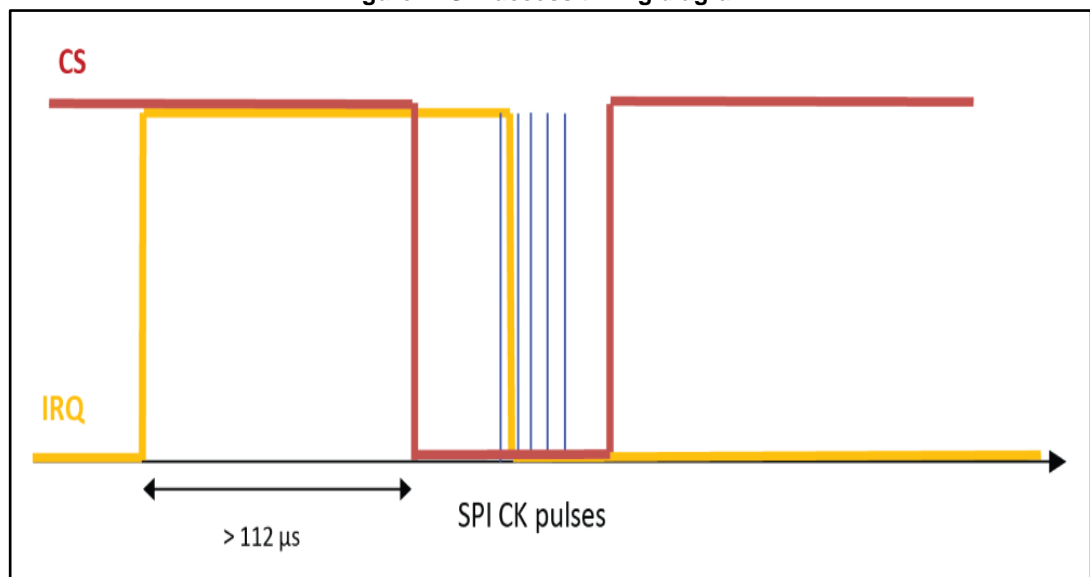
Figure 1: SPI access timing diagram

If SPI CSN is asserted while BlueNRG is going to sleep, the device can enter a lock state and no longer reply to SPI commands. The only way to recover the device is to perform a hardware reset. A software workaround is available to eliminate the problem.

The workaround involves using the IRQ signal to indicate that the external microcontroller is going to access the SPI. The details are:

- Use BlueNRG firmware 6.3 or later.
- Before asserting CS line (CS low), IRQ line must be driven high by the MCU at least 112 μ s. IRQ line should be set again as an input (with pull-down) after the first byte is on the SPI bus (See [Figure 1: "SPI access timing diagram"](#)).
