# AURIX™ TC39x errata sheet

Marking/Step: (E)ES-BD, BD

10585AERRA

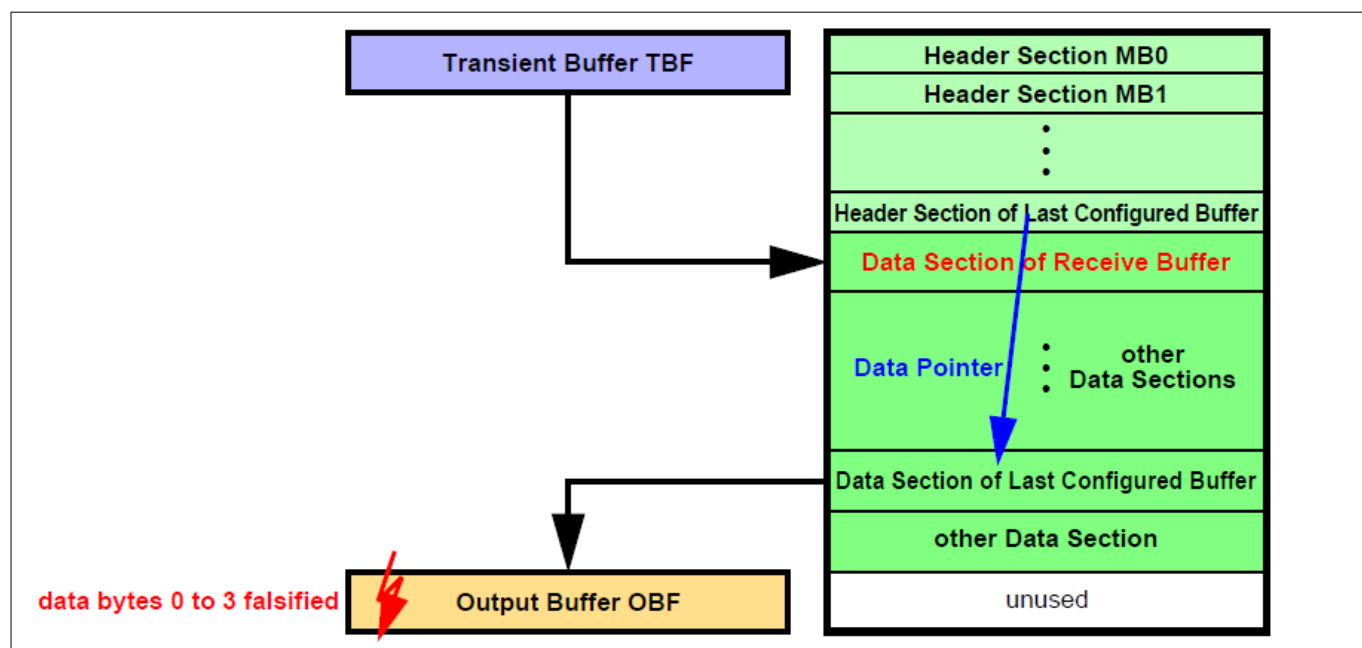
**Figure 2** Message buffer transfer from Message RAM to OBF

When the message buffer has its payload configured to maximum length (`PLC = 127`), the OBF word on address 00h (payload data bytes 0 to 3) is overwritten with unexpected data at the end of the transfer.

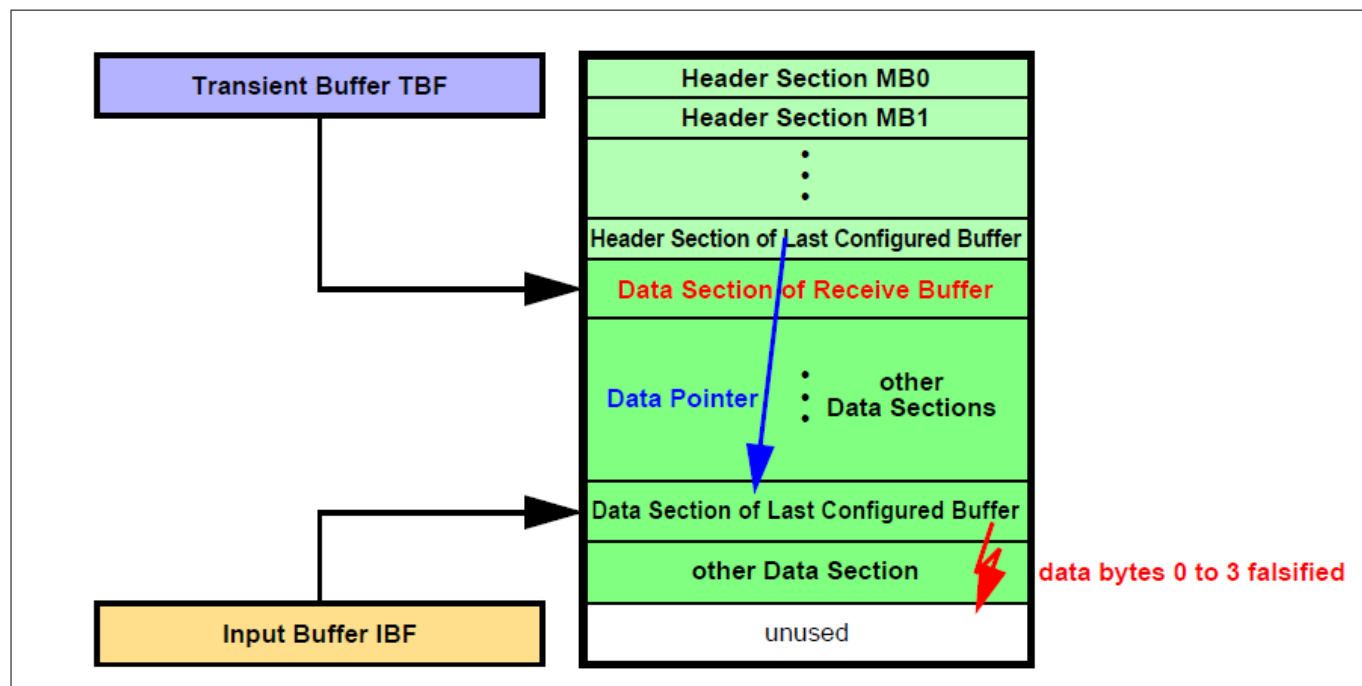
**Figure 3** Message buffer transfer from IBF to Message RAM

After the Data Section of the selected message buffer in the Message RAM has been written, one additional write access overwrites the following word in the Message RAM which might be the first word of the next Data Section.

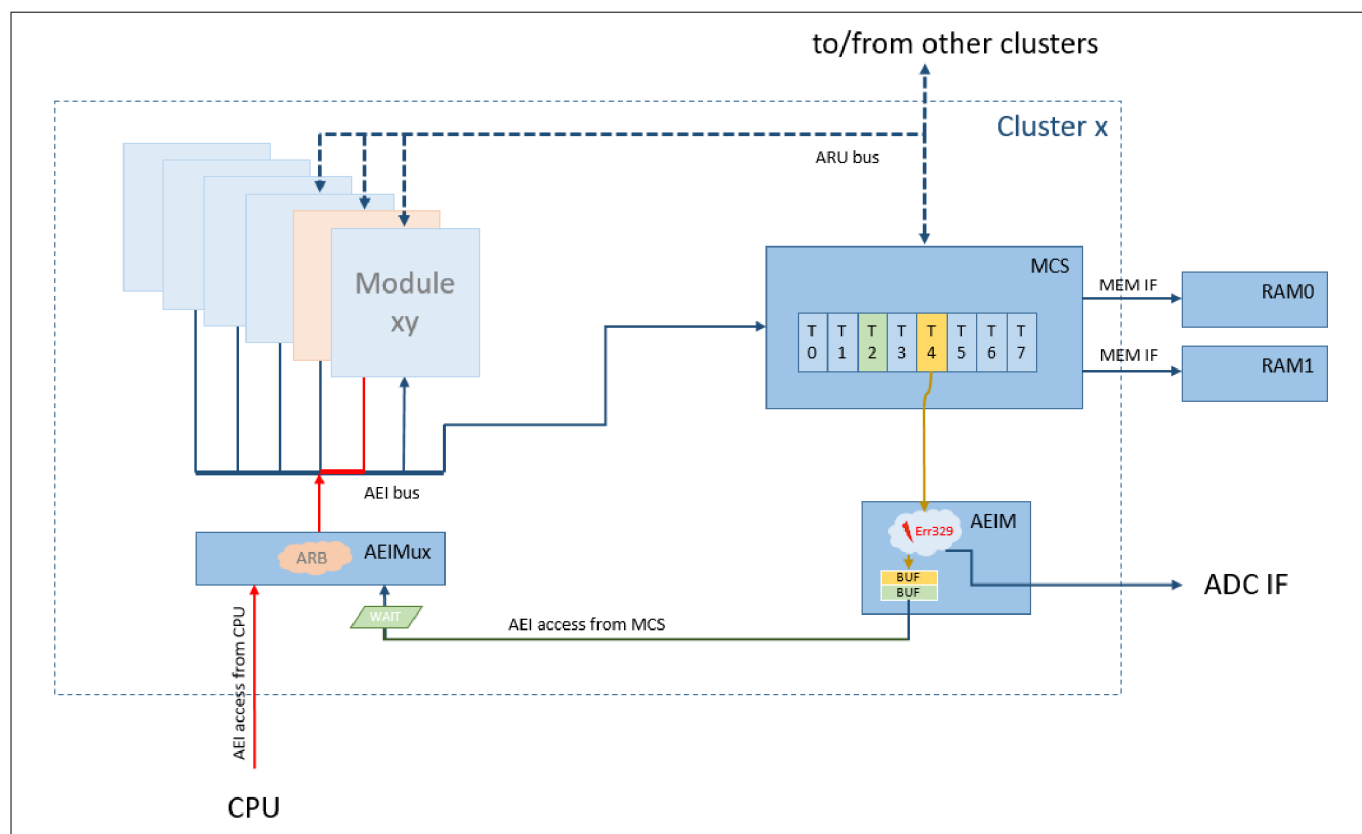
**Figure 7 Critical MCS AEI master scenario**

In [Figure 7](#), a potential risk for the occurrence of problem GTM\_AI.329 is illustrated. Here the first buffer of the AEIM (green) is still waiting for the access to the AEI bus while a second AEI bus access from MCS arrives at the AEIM (yellow access path). Under certain, but for the user unpredictable timing conditions, this second AEI bus access arriving at the AEIM can trigger the misbehavior described in problem GTM\_AI.329.

The workarounds described in the 'Workaround' section will ensure that not more than one AEIM buffer will be filled and therefore the occurrence of problem GTM\_AI.329 is avoided. All workarounds have been tested and proven correct.

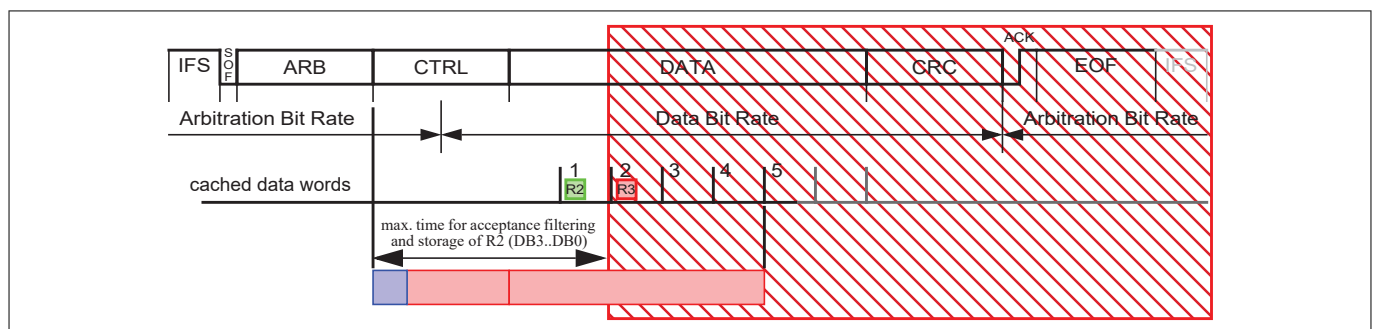
**Figure 11 CAN Frame with DLC > 4**

The figure that follows shows how the available time for acceptance filtering and storage is reduced.

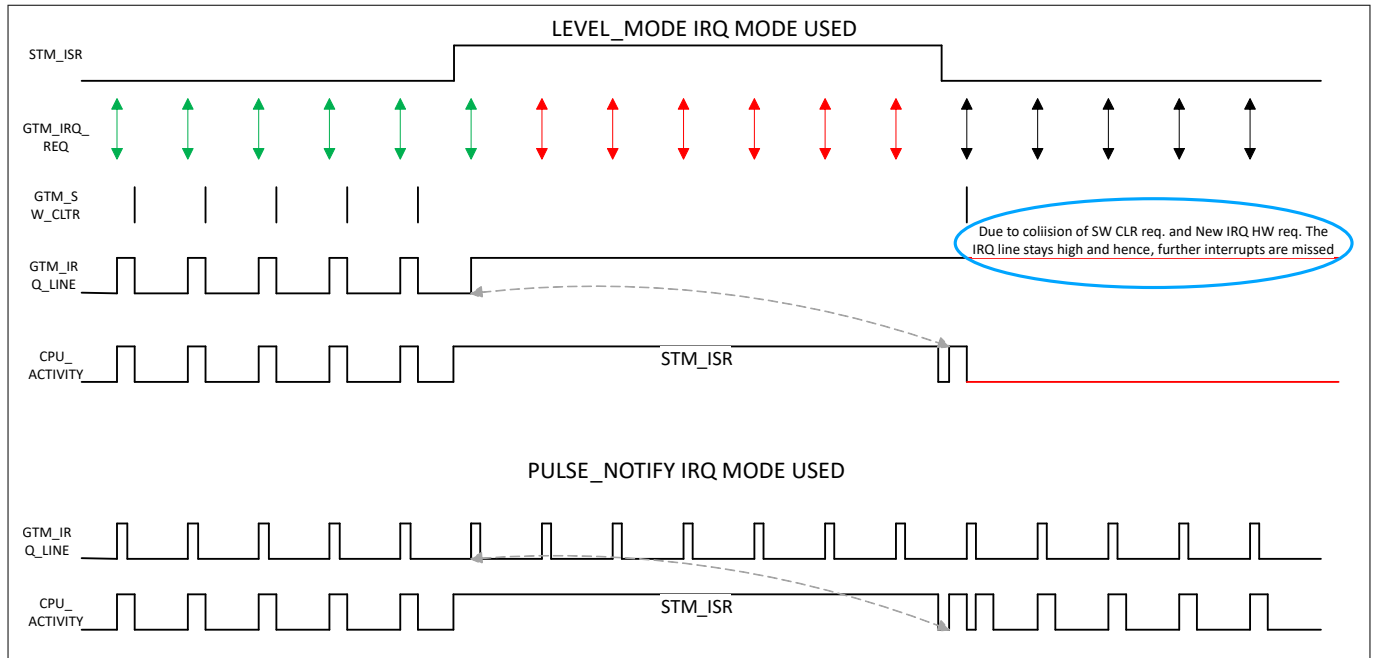
**Figure 12** Interrupt Level vs. Pulse-Notify mode - Corner Case Example

interrupt and clear events), GTM\_IRQ\_XXX is not cleared and remains high. As a consequence, the IR observes no transition on GTM\_IRQ\_XX. Thus, any forthcoming interrupt events in this scenario are lost as there is no chance to release the CPU IRQ when a collision happens as shown in Figure below.

If Pulse-Notify mode is selected, every internal trigger will be forwarded to the IR, irrespective of the time of occurrence and the clear event, as the pulse-notify leads to set and reset of GTM\_IRQ\_XXX as compared to only setting of the GTM\_IRQ\_XXX line in Level mode.

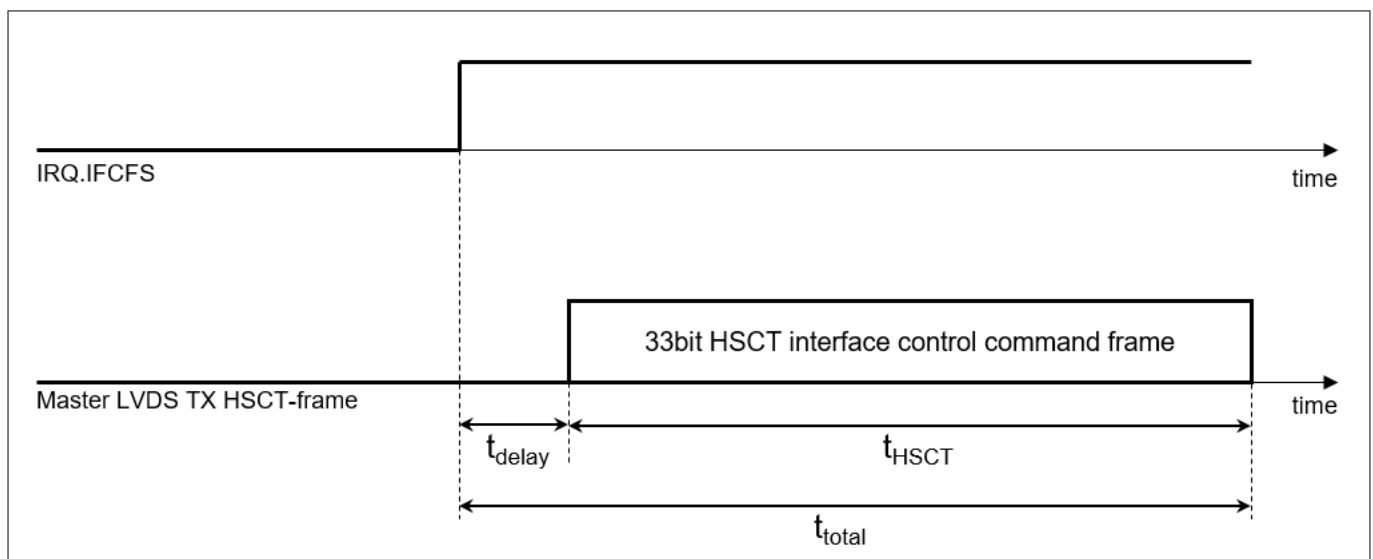
**Figure 13** Timing of LVDS TX interface command sending in relation to IRQ.IFCFS

the user might falsely assume that also the actual sending on the LVDS TX port has already occurred once the IRQ.IFCFS flag is set, which is not true.

Instead the timing shown in the following figure applies.

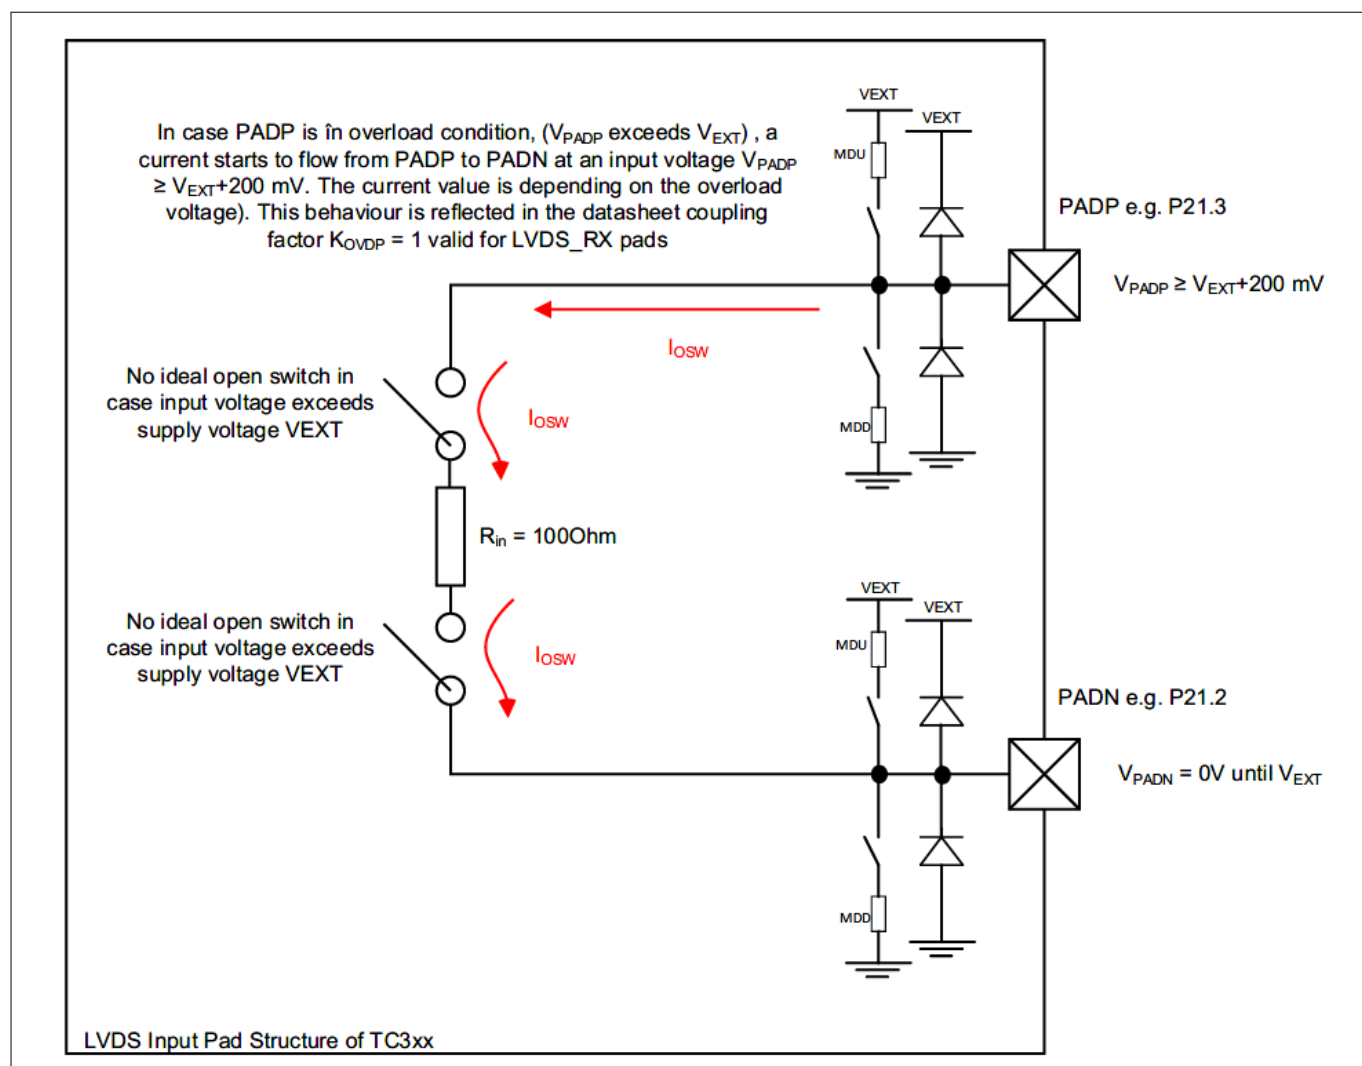
**Figure 14** Positive overload on P-pad of a LVDS RX pin pair (both used as inputs)

The overload current  $I_{OSW}$  through the non-ideal open switch significantly increases when  $V_{PADP} \geq V_{EXT} + 200 \text{ mV}$ .

**Note:** In general, the effect will also occur if the N-pad is used as output, or for a negative overload condition on either the P-pad or the N-pad.
