EMERGING TECHNOLOGIES AGAINST FIRES AND EXPLOSIONS

FIRE IN A TANK STORAGE FACILITY CASE STUDY

**Training for the prevention of fires and explosions through the use of data analysis and simulation
Project TSP2021\100311**

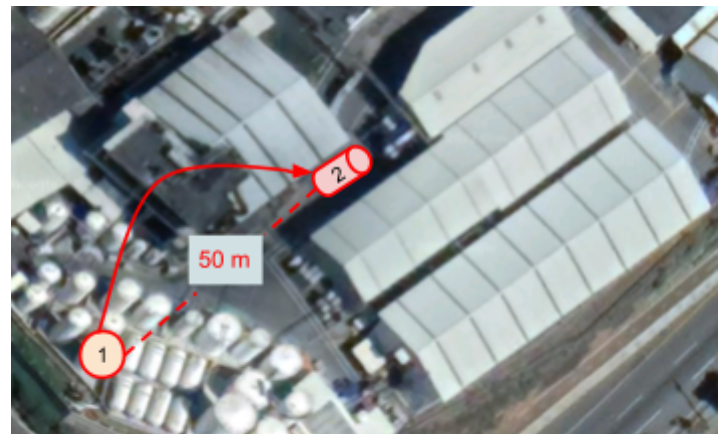
being carried out to install brackets on the upper part of the tank, carrying out hot work such as welding and polishing. Some of the sparks from this work caused the xylol tank to explode, which fell from its base and traveled through the air like a projectile, leaving a trail of fire and falling 50 m into a courtyard between two plants. production, [Figure 1](#). At this location the tank caused minor damage and the fire did not spread, [Figure 2](#).

Figure 1. Location of the xylol tank (1). Place where it fell after the explosion (2)

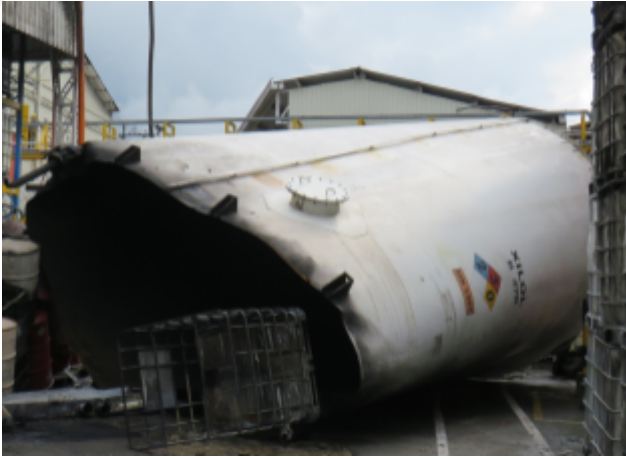
Figure 2. Courtyard between the plants where the xylol tank fell.

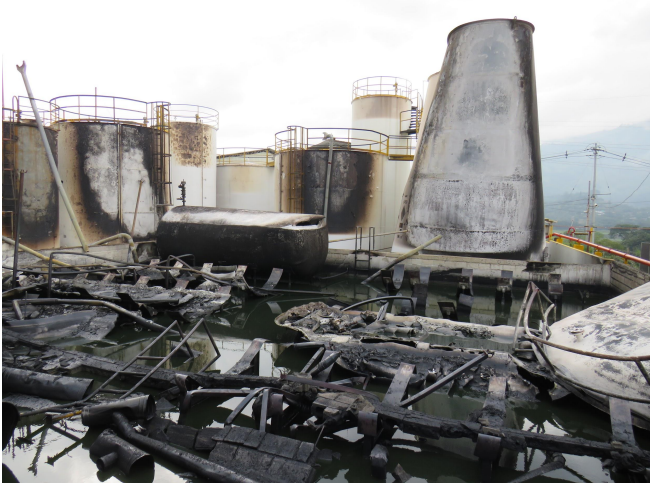
However, in the place where the tank was installed, a large fire was caused by the spilled xylol in the dam area, generating large losses and subsequent fire in the tanks near the containment zone, as shown in [Figure 3](#). There were three human casualties during the event.

Figure 3. Fire location on the containment dam.

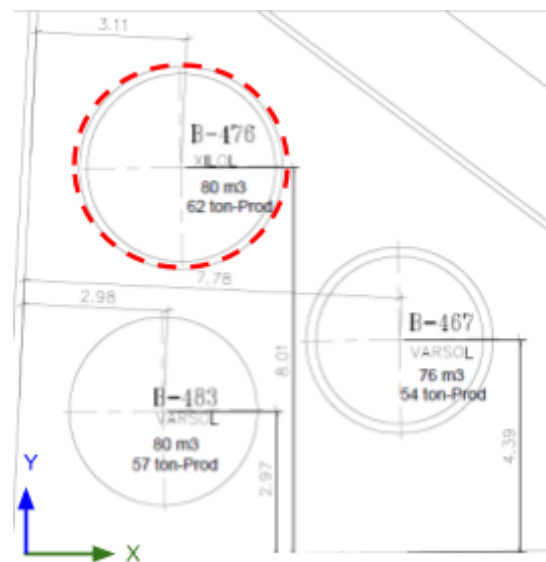
In the area marked in red, a detail shown in [Figure 5](#), there are two tanks that contained varsol, and the other tank with xylol that exploded. In [Figure 6](#), the varsol and xylol tanks are shown before the explosion and fire. The size of these tanks vary between 3 - 4 m in diameter and 5 - 8 m in height, with capacities to contain between 70 - 80 m³ of flammable liquids.

Figure 5. Detail of the storage tanks where the explosion occurred.

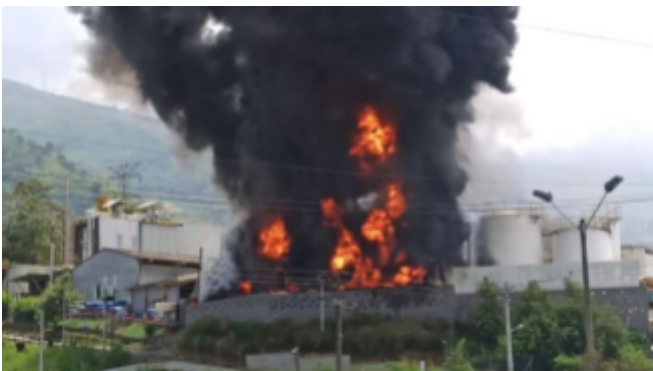
After the explosion and detachment of the tank, the fire was generated and was located mainly in the area of the storage tanks. During the fire, a large amount of smoke and high flames were evident as shown in the photo taken by local authorities, [Figure 7](#).

Figure 7. Fire in storage tanks. Taken from Twitter Corantioquia (June 2021)

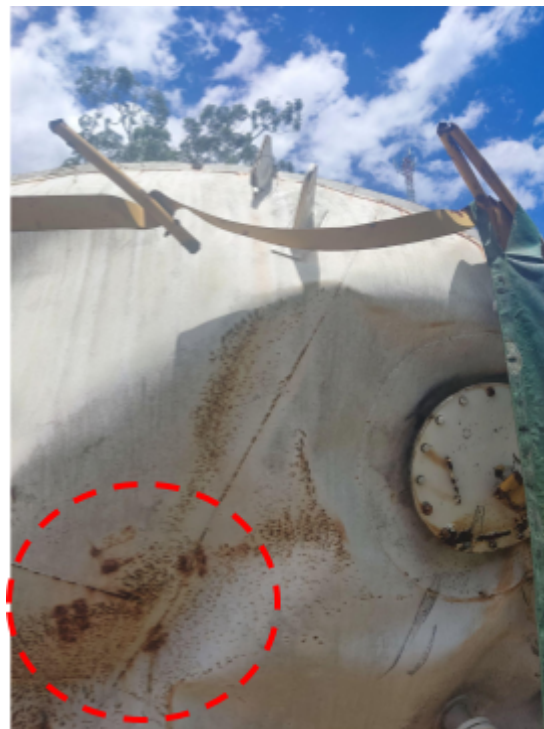
The video records inside the plant revealed the metal welding and polishing work carried out by two contractors on the top of the tank for the installation of the brackets, which would serve as support for the installation of a platform. At the time of the explosion, projection of sparks was observed, without being able to identify whether they were from surface polishing work or from the welding of the brackets. [Figure 8](#) shows spark marks that show the polishing work that was carried out on the tank. These zones account for possible hot spots that could have started the explosion.

Figure 8 . Polish spark marks on xylol tank

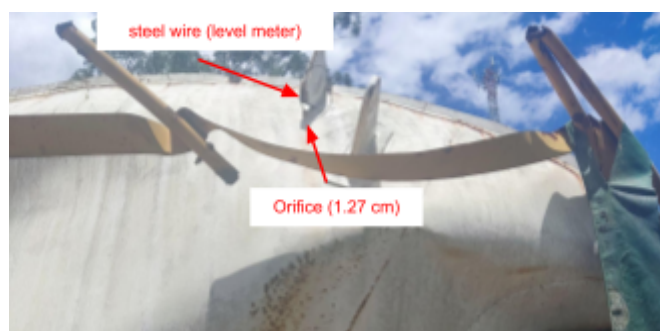
arrester systems, however one of the hypotheses that were handled during the investigation is that there were leaks in the tank, which allowed flammable gases to escape to the outside. It was recognized that the xylol tank had access to a wire through a 1.27 cm hole to measure the liquid level. This hole did not have flame arrester systems and possibly xylol vapor came out of that hole. In [Figure 9](#). The orifice and the steel wire that was used in the level meter are evident.

Figure 9. Level meter orifice location.

It should be noted that the tank was only 30% full, and there was a xylol liquid-vapor mixture inside in the remaining volume. For the environmental conditions in the geographical area where the plant is located, and at the time of the event, the atmospheric pressure is around 651.1mmHg and the average ambient temperature is around 22°C. The pressure vapor of xylol is around 9 mmHg. For the above conditions, it can be determined that the concentrations of xylol in the vapor are 1.38 % v/v, a concentration that is within the range of the flammability limits of xylol (LFL1.1% - UFL 6.6%). With a spark close to the gas outlet area, the explosion could possibly start.

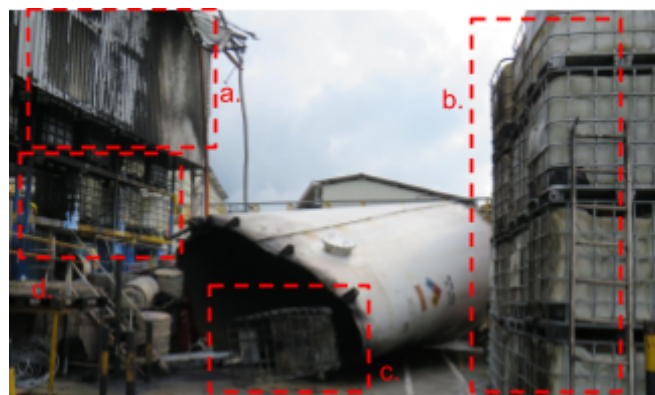
At the location where the tank fell, the photo in [Figure 10](#) shows that the fire in this area did not spread to the surrounding production plants. Soot marks are evident in these areas [Figure 10 a](#). Most

of the units in the caged plastic tanks failed to melt. [Figure 10 b](#), only the cage of one unit is observed next to the tank that possibly melted. [Figure 10 c](#). Marks that show the melting of plastics are shown in [Figure 10 d](#). in greater detail in [Figure 11](#).

Figure 10. Damage to the place where the xylol tank fell.

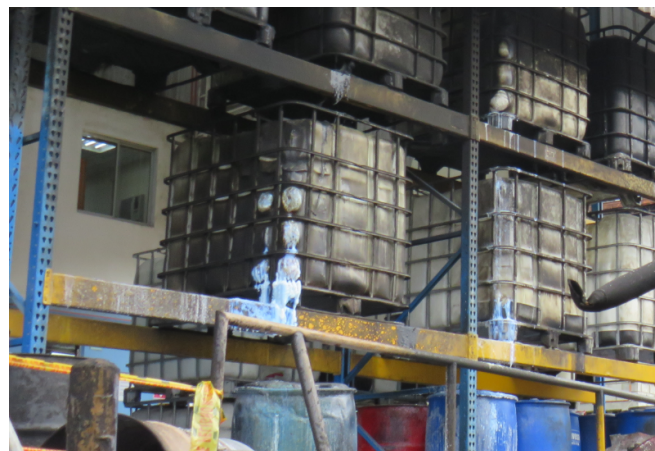
Figure 11. Detail of evidence of plastic melting. Possibly from a caged tank

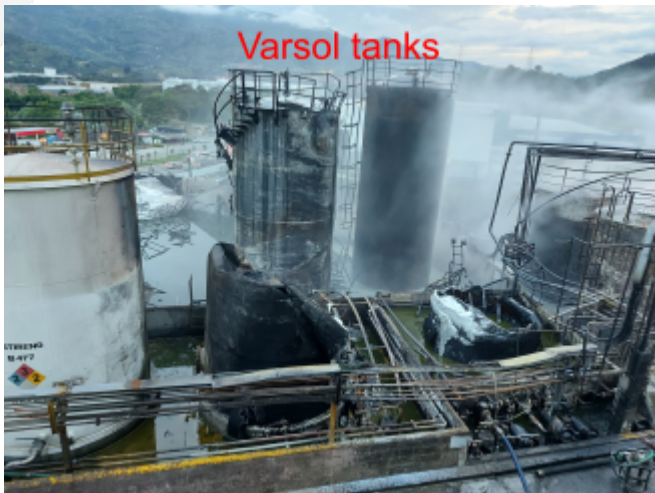
In the area of the storage tanks, it was the place that was most affected by the fire. In the photos of [Figure 12](#) and [Figure 13](#), the total loss of several tank units is evidenced, others partially. In [Figure 12](#), it can be seen that the varsol tanks remained standing. However the later tanks were completely consumed.

Figure 12. Effects of the fire in the area of the storage tanks.

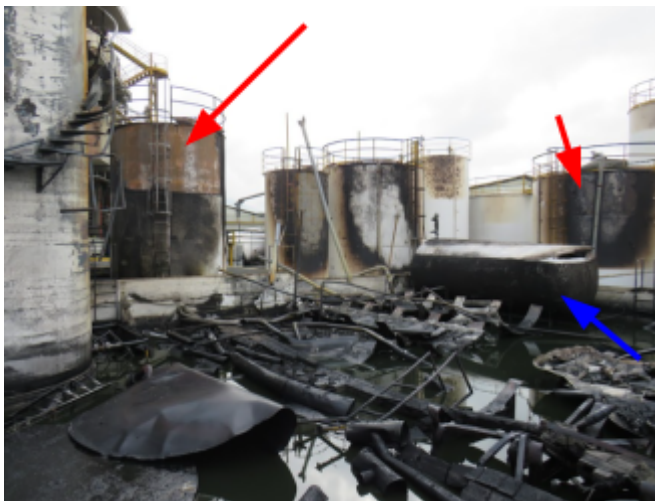
Figure 13. Bottom of the xylol tank and horizontal tanks area.

In [Figure 13](#), it can be seen that only one horizontal storage tank remained standing (blue arrow), the other 7 were completely lost. In [Figure 13](#), the red arrows show the oxidation in the metal tanks, which shows the high temperatures that occurred in the fire and the direct contact of the flames with the surface. [Figure 14](#) shows the general plan of the storage tank area, where the tanks that had a total

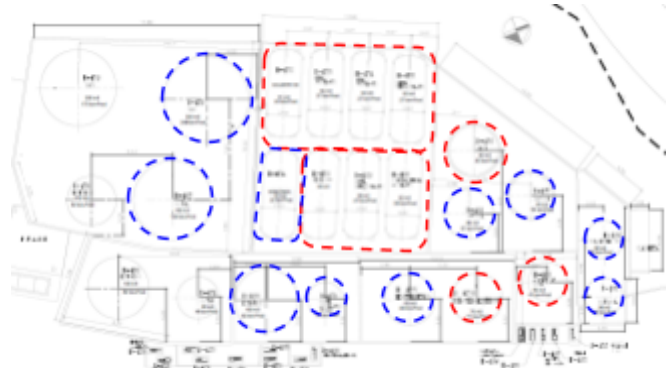
loss are demarcated in red. In blue, tanks that show evidence of a partial leak or only traces of flame on the surfaces.

Figure 14. Tanks with major damages, in red.
