Mold Growth Cause and Origin Assessment and Mold Remediation Protocol

Blanck Residence
2212 Tuscany Way
Boynton Beach, FL 33435

AirSpec Project # ML18111215

Southern Oak Insurance Claim # 37997

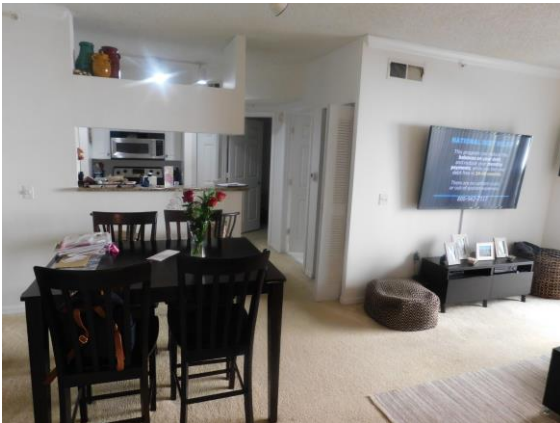
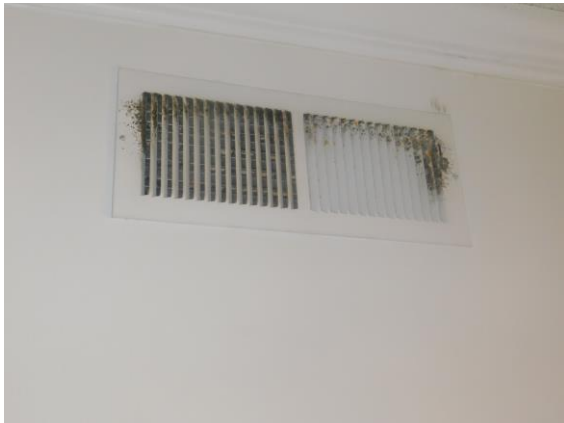
- Supply Vents: Visible particulate adhesion (that may include mold spores) was found on the air supply diffusers and downwind ceiling surfaces particularly in the TV room, kitchen, bathroom, and bedroom. The filth pattern (ghosting) is in the direction of the airflow out of the diffusers. This finding indicates that the filth is emanating from the ducts and air handler and adhering to the ceiling surface. Ultimately, these particles originate in the residence or from the outdoor environment. This ghosting effect is commonly caused by improperly fitted filters, the absence of a filter, dirty filters that allow air bypass, loose fitting panel covers that allow air bypass around the cover, or a combination of some, or all of these configurations. These are all related to a lack of maintenance and cleaning deficiencies. The particles are deposited on the cooler diffuser and ceiling surfaces as a result of electrostatic forces, vapor pressure, direct impingement, and temperature differentials. This diffuser and ceiling filth can be cleaned from the diffuser and ceiling surfaces with a detergent and a soft brush. Gaps between the supply vents and ceiling drywall resulted in warmer air from the ceiling cavity mixing with the cooler air from the HVAC system, forming condensation and facilitating mold growth.

Causation No 2: Based on our findings it is Air Spec's professional opinion that the cause of the mold growth on the supply air vents is a result of chronic* lack of maintenance and gaps between the vent and drywall.

Left and Right Pictures: These pictures show a view of the living room and dining room with superficial mold growth on the supply vent.

- Supply Vents: The supply vents should be removed and cleaned with a mild detergent (and water) or appropriate anti-microbial solution. While removed the underlying ceiling drywall should be inspected for underlying superficial mold growth. If mold growth is encountered, HEPA vacuum the ceiling drywall then clean the area with a mild detergent (and water) or appropriate anti-microbial solution. After it dries, apply a stain-blocker primer and latex paint with a mold-inhibitor additive. Replace any ceiling drywall unable to be cleaned.
- Inspect the inside of the wall and/or ceiling cavities around the remediated areas for any further mold colonization. If additional mold growth is found, remove and/or clean the affected building materials as necessary.
- Clean all building material debris from the work area. Use a minimal amount of water in the cleaning process.

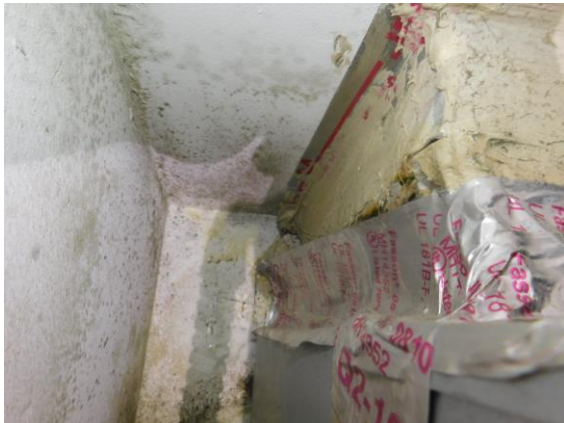
- Air Handler Closet: Superficial visible mold growth was observed on the closet drywall. Seam tape deficiencies and holes in the main supply duct were seen. This condition is allowing cool air to escape into the closet resulting in the formation of condensation on the AHU closet drywall.

Causation No. 1: Based on our findings it is Air Spec's professional opinion that chronic* condensation formation from gaps in the supply ductwork has resulted in mold growth on the AHU closet drywall.

Left Picture: This picture shows the AHU. Right Picture: This picture shows seam tape deficiencies and holes in the supply ductwork and superficial mold growth on AHU closet drywall.

- Repair any gaps or voids in the HVAC supply system and around air supply vents.
- Have the HVAC system serviced and restored to a fully operational state. Once repaired, routine maintenance should be conducted, ie: clean the air handler, air returns, and ductwork. Replace the filters. *A full cleaning of the HVAC system should be conducted about every 5-7 years.*

- Air Handler Closet: Clean the closet drywall with a HEPA vacuum and then a mild detergent (and water) or appropriate anti-microbial solution. After it dries, apply a stain-blocker primer and latex paint with a mold-inhibitor additive. Remove and replace the drywall that is unable to be cleaned.

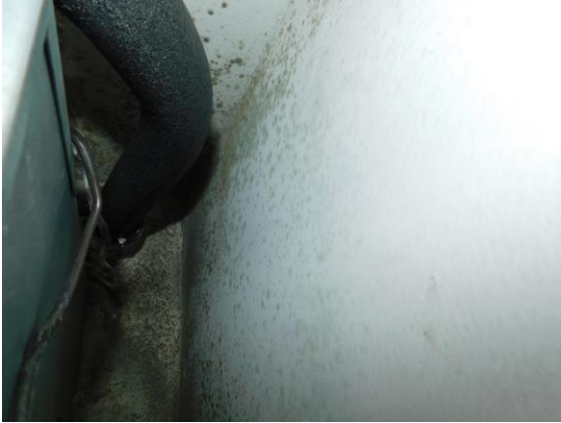
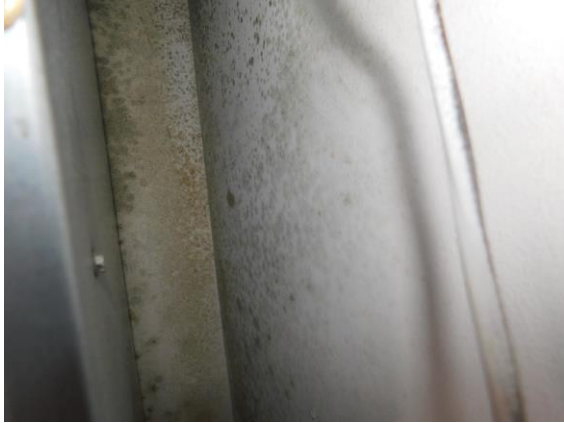
Left and Right Pictures: These pictures show additional superficial mold growth on AHU closet drywall.

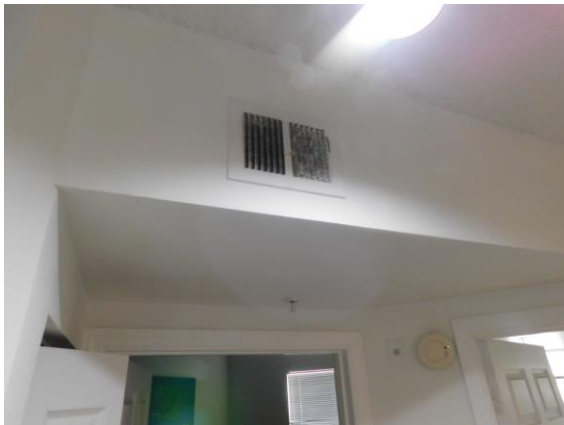
Left Picture: This picture shows the kitchen. Right Picture: This picture shows superficial mold growth on kitchen supply vent.

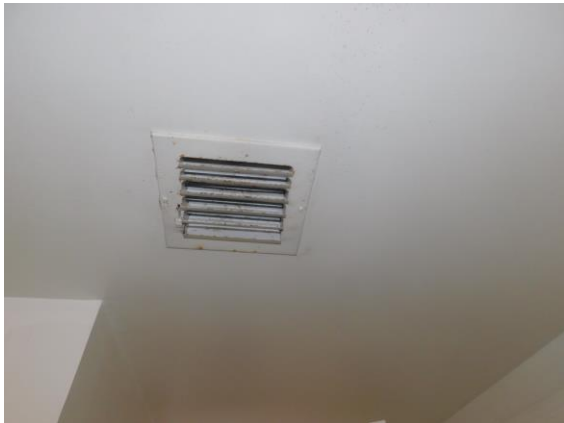
Left Picture: This picture shows the bathroom. Right Picture: This picture shows superficial mold growth and oxidation on the bathroom supply vent.

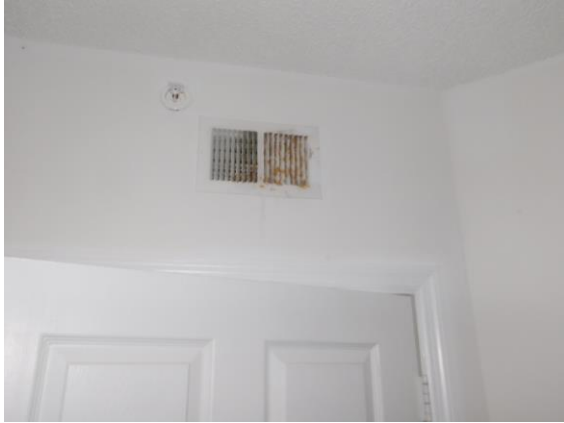
Left Picture: This picture shows the bedroom. Right Picture: This picture shows superficial mold growth and oxidation on bedroom supply vent.

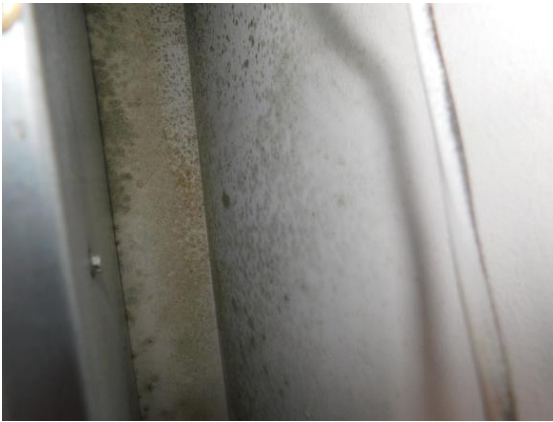
Surface Sample 181127I006

Location: HVAC Closet Drywall

Observation: This location was chosen because of suspect visible mold growth on the surface.

Interpretation of sample result: Confirms *Aspergillus/Penicillium* spp. mold colonization.

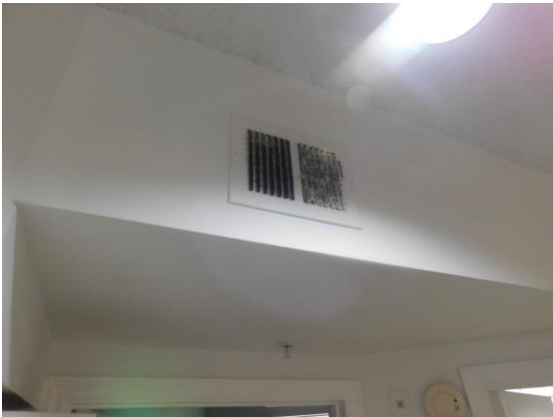
Surface Sample 181127I007

Location: Kitchen Supply Vent

Observation: This location was chosen because of suspect visible mold growth on the surface.

Interpretation of sample result: Confirms *Aspergillus/Penicillium* spp. mold colonization.

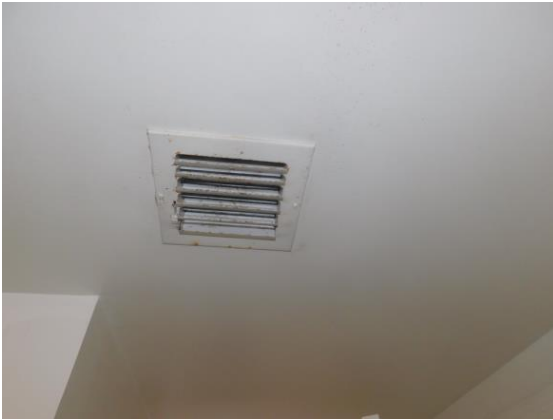
Surface Sample 181127I008

Location: Bath Supply Vent

Observation: This location was chosen because of suspect visible mold growth on the surface.

Interpretation of sample result: Confirms *Aspergillus/Penicillium* and *Cladosporium* spp. mold colonization.
